## Technical evaluation of wood wool/cement slabs made from *Pinus caribaea* grown in Fiji (L48)

**Technical evaluation of  
wood wool/cement slabs  
made from *Pinus caribaea*  
grown in Fiji**

A. J. Hawkes and A. P. Robinson

February 1978

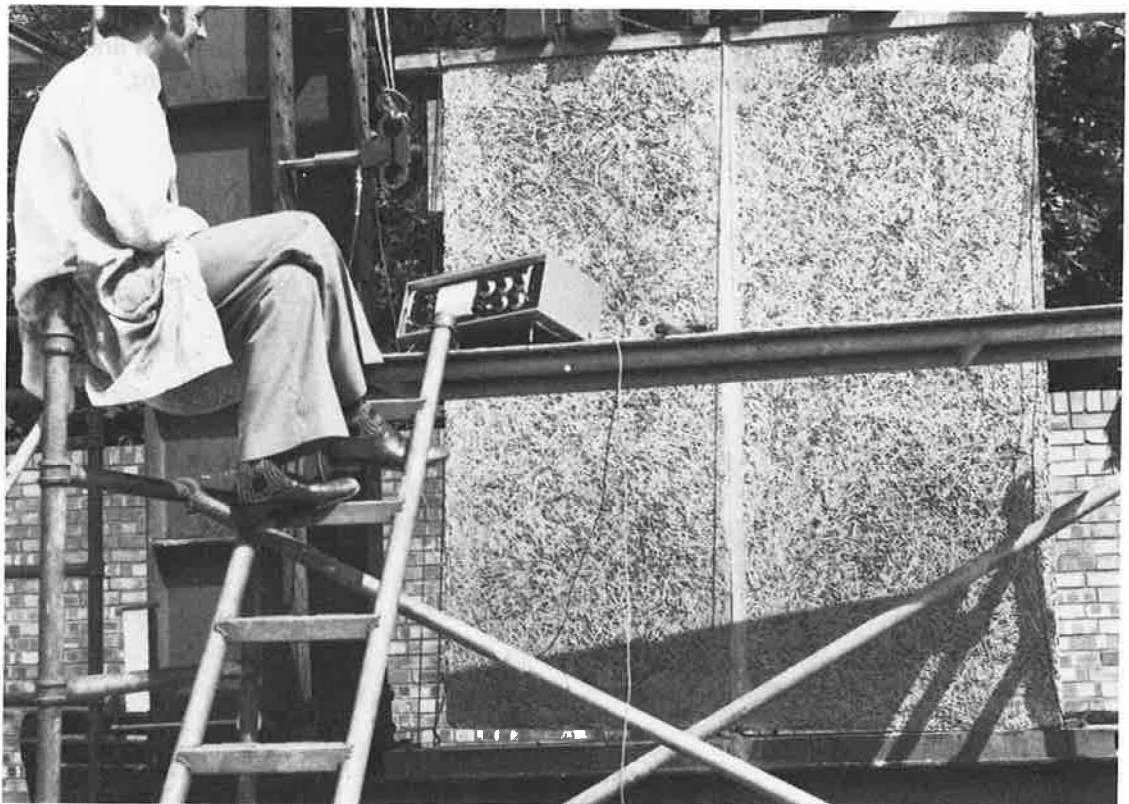
Specimen at failure. Test no. 2

In the Stanger report, a clear difference can be seen in the second test with its modified method of fixing. In test 1 (wire tie roof-dowel, wire tie dowel-foundation) the applied load to rack the panels only reached 99 lbf. In test 2 (wire tie directly from roof-foundation) the load reached 1700 lbf. This is the recommended method of construction, otherwise likely imposed forces due to winds and earthquakes will not be resisted. It should be used at every joint in the construction, particularly at the corners, and careful attention must be paid to the method of fixing the roof to the wall plate — preferable the wires from the foundations should go right round the roof members.
