FAILURE OF A PRECAST RC BUILDING DUE TO EMILIA-ROMAGNA EARTHQUAKES

This paper deals with the seismic assessment of a real precast RC industrial building with friction connections. The structure is located in Emilia-Romagna region and it was severely damaged during the second seismic event on May 29th. Structural columns exhibited cracking and yielding at the base as well as significant rotations along one direction. Moreover, relative displacements were recorded in both beam-to-column connections and in roof-to-beam connections and several loss of support phenomena occurred for the roof elements.

The investigated case study is a precast RC one-story building with friction connections, located in Mirandola (Modena, Italy). This building was hit by two earthquakes, occurred in Emilia-Romagna region on May 20th and 29th, 2012. The structure was designed and built in 1990 for industrial and commercial purposes.

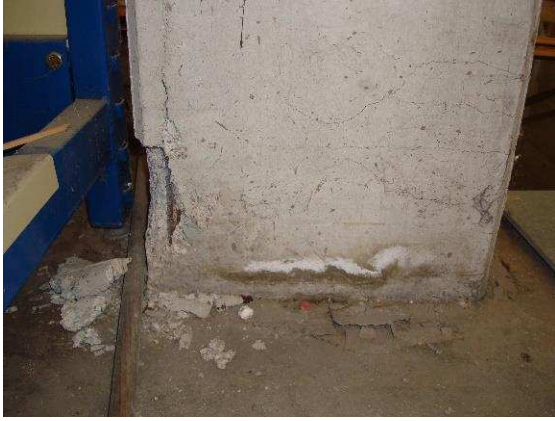
Fig. 6 Damage at the column base after the event on May 29th

Precast columns experienced significant rotations around the global Y-axis at the base: large cracking and spalling of the concrete demonstrated the attainment of the yielding strength of the RC columns, i.e. either the yielding of the steel bars or the attainment of the ultimate strain in the compressed cover concrete (Fig. 6). The columns damage caused an evident rotation of the structure around the global Y-axis (Fig. 7).

Fig. 17 and Fig. 18 show the moment-rotation curves of the plastic hinges at the columns base, obtained under the three components of the May 29th event. The results confirm the field observation: visible rotations occurred in the columns around the global Y direction during the May 29th event. It is worth noting that the columns rotation are slightly larger than the yielding limit value; however, the large yielding rotations of precast slender columns (around 2%) justifies the recorded drift. This result also agrees with the observed structural response, which did not show a global collapse due to large column rotations.

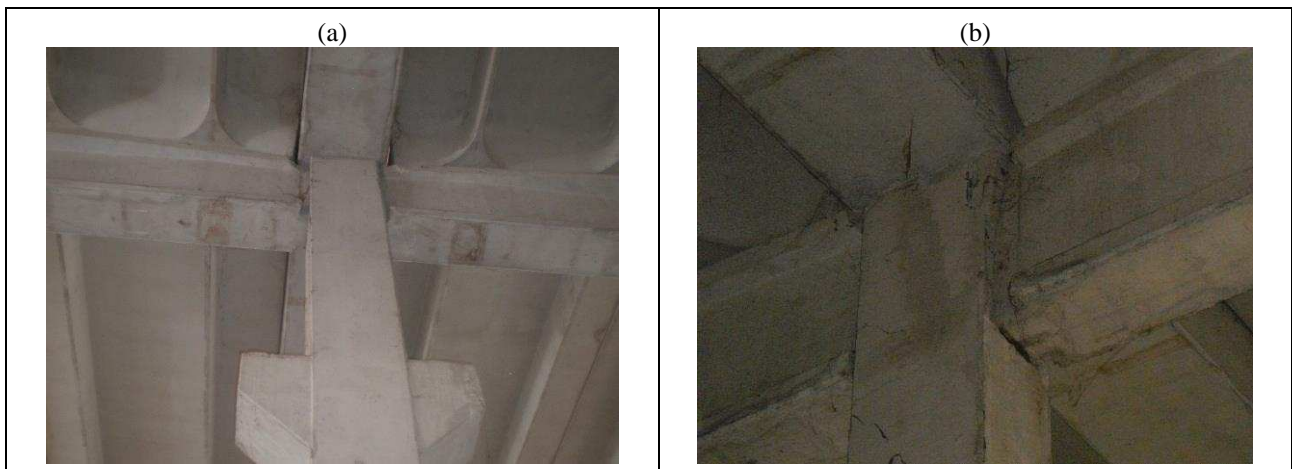
Fig. 8 Damage of the beam-to-column connections after the event on May 29th

The main damage was recorded in the connections of the horizontal structural elements. The principal beams experienced small relative displacements with respect to the supporting columns (Fig. 8). The amplitude of the experienced displacements did not exceed the contact surface of the beams (23cm): no loss of support phenomena of principal beams occurred in the structure after the two seismic events. On the contrary, the roof elements experienced significant relative displacements (Fig. 9a) and some elements collapsed because of the loss of the support (Fig. 9b).
