The lesson learnt after Emilia-Romagna earthquakes on precast RC structures: a case-study

M. Ercolino¹

G. Magliulo, G. Manfredi

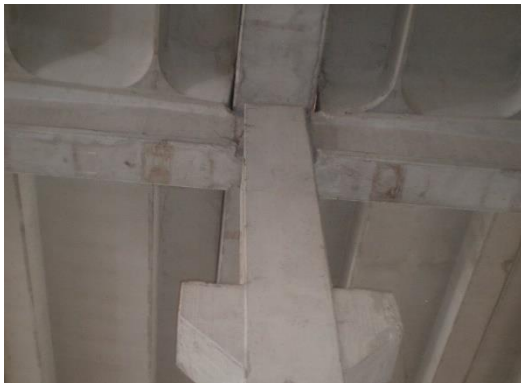
- Precast columns experienced significant rotations at the base: large cracking and spalling of the concrete demonstrated the attainment of the yielding strength of the elements (Figure 3). The columns damage caused an evident rotation of the structure along the X direction (Figure 4 4).
- The principal beams experienced small relative displacements with respect to the supporting columns (Figure 5(a)). The amplitude of the experienced displacements did not exceed the contact surface of the beams (23cm): no loss of support phenomena of principal beam occurred in the structure after the two seismic events.
- The roof elements experienced larger relative displacements with respect to the supporting principal beams and some elements collapsed because of the loss of the support phenomenon (Figure 5(b)).

Figure 5. Damage of the connection systems after the event on May 29th: (a) relative displacement between beam and column and (b) loss of support of the roof elements

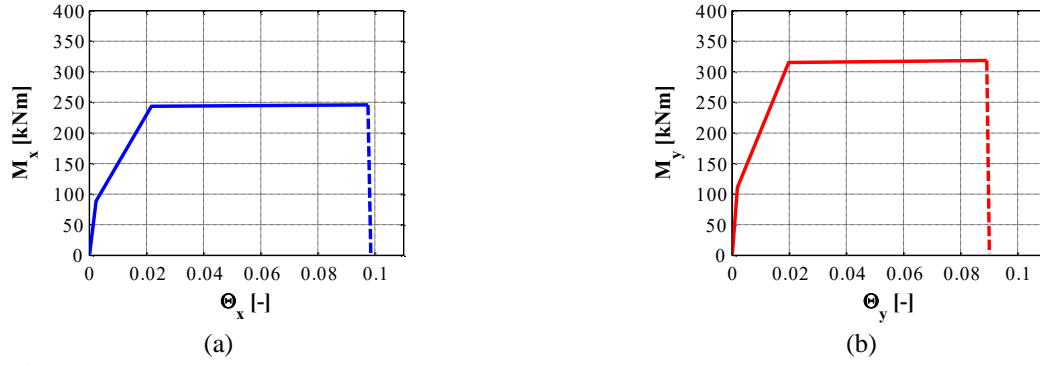
The dissipative behavior of the structure is concentrated at the base of the precast columns, whereas all the horizontal structural elements (beams, girders and roof elements) are introduced in the model as elastic elements. A lumped plasticity approach is assumed in order to simulate the inelastic response of the columns. The moment-rotation envelope of the columns hinges consists of three characteristic points: the cracking, the yielding and the ultimate point. The cracking point (moment and rotation) is defined based on the gross section properties. A fiber analysis of the cross-section provides the yielding moment value, whereas the ultimate moment is defined by considering a very low hardening (1%) value, assumed only for numerical purposes. The yielding and ultimate rotations are evaluated according to Fardis and Biskinis (2003). The hysteretic rule follows the indications given in Ibarra et al. (2005). Fig.6-Fig.8 show the moment-rotation curves for the columns in the case-study around the two horizontal directions.

Figure 6. Moment-rotation envelopes of the column A around (a) the X direction and (b) the Y direction

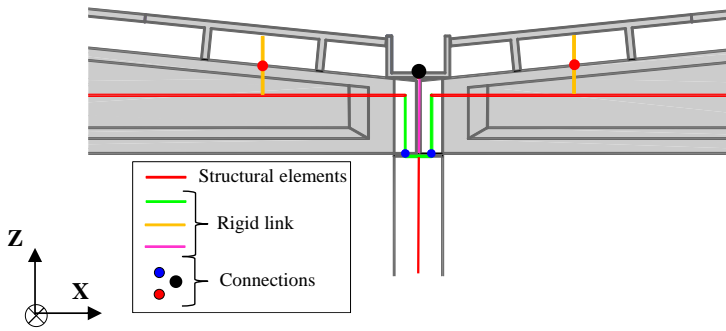
Fig.9 and Fig.10 show the layout of the elements and the considered eccentricities for all the connection systems. The connections are defined by “equal DOF” constraints between the two linked elements. With regards to the beam-to-column connection (blue circles in Figure 9), the translational degree of freedom along the X direction is not constrained: in this direction a model of the friction connection is implemented. Similarly, the translational degree of freedom along the Y direction is not fixed for the roof-to-beam connections (red circles in Figure 9 and in Figure 10). Moreover, in both these two connections, the translational degree of freedom along the Z direction is not constrained, in order to evaluate the influence of the vertical components of the earthquakes. The frictional connections between the structural elements are introduced in the nonlinear model by means of the “Flat slider bearing” element of the OpenSees library. A Coulomb model is assumed for the frictional behavior and the initial elastic stiffness is defined as the shear stiffness of the neoprene pad ($G=2.7\text{MPa}$). In the vertical direction (Z direction), the neoprene compressive stiffness is assigned, while a free displacement is allowed in the opposite direction, in order to capture the element uplift. The compressive stiffness is evaluated by assuming Young’s modulus equal to 6MPa . The friction coefficient (μ) are evaluated according to Magliulo et al. (2011). The beam-to-column connections have a friction coefficient equal to 0.12 and 0.14 for the largest and the lowest axial force, respectively. The roof-to-beam connections have a friction coefficient equal to 0.12 in the case of the big roof elements and 0.13 for the small ones.

Concerning the connection between the secondary beams (girders) and the columns (black circle in Figure 9), a hinge is assumed, according to the features of the connection system. Therefore, the girder-to-column connections are able to avoid the relative displacements between the two connected elements in the Y direction.

Figure 9. Structural elements layout and connections position in the X direction

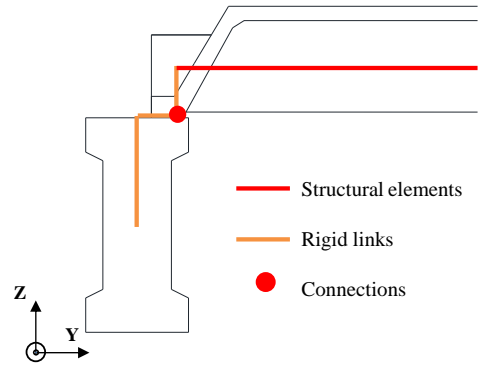
Figure 10. Structural elements layout and connections position in the Y direction

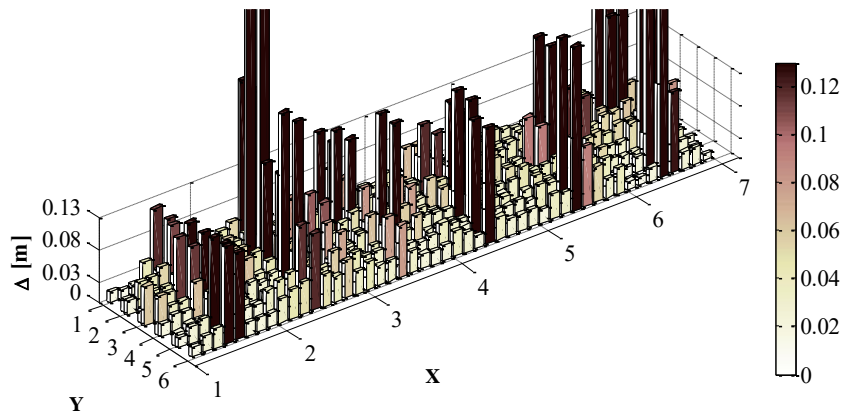
Fig.12 shows the roof-to-beam relative displacements along the Y global direction (i.e. the longitudinal direction of the roof elements) under the three components of the second earthquake (May 29th): each bar of the histogram corresponds to one roof connection and its height represents the relative displacement amplitude. According to these results, during the second event occurred in Emilia-Romagna, many roof elements experienced dislocations and some elements lost their support since the relative displacement is larger than the contact surface (13cm). This evidence agrees with the real response of the roof elements. The main cause of this damage is given by the strong seismic action in the vertical direction, recorded during this event. Such an excitation significantly decreased the frictional strength of the connections, as demonstrated by the many elements experiencing uplift phenomena during the nonlinear analysis. This evidence is demonstrated by the outcomes of the analyses performed by neglecting the vertical component of the earthquake. Fig.13 shows the relative displacements of the roof-to-beam connections recorded without the vertical earthquake component: the displacements of the friction connections are always smaller than 5cm.

Figure 12. Relative displacements at the roof-to-beam frictional connections under the three components of the earthquake on May 29th

It is worth underlining that the recorded failures of the roof elements in the analysis do not perfectly match the real loss of support cases. This limit of the study can be overcome by simulating the elements collapse during the analysis.

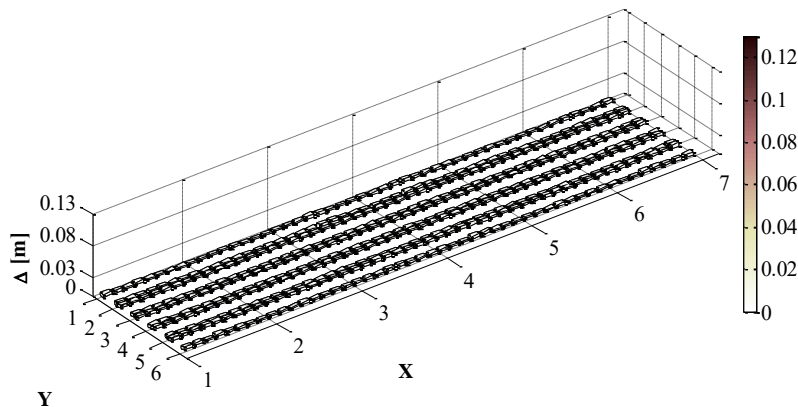
Figure 13 Relative displacements at the roof-to-beam frictional connections under the two horizontal components of the earthquake on May 29th

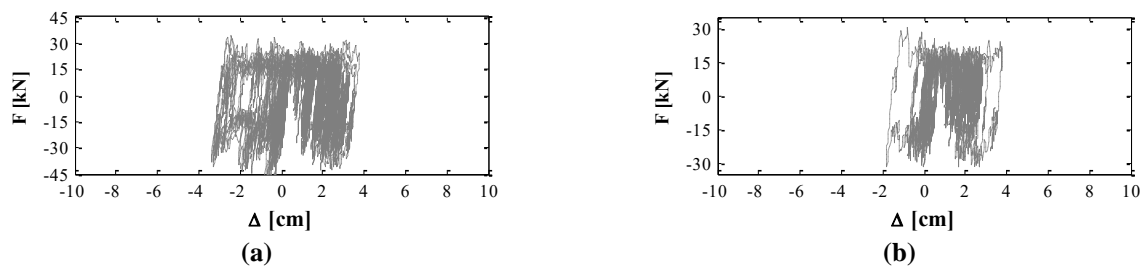
Fig.14 shows the force-displacements envelopes for some representative beam-to-column connections. In these envelopes, the deformation is the relative displacement between the beam and the column and the force is the shear force in the connection in the X direction (i.e. the longitudinal direction of the principal beams). These results are obtained by the dynamic analysis with the records of the second event (May 29th). The results agree with the experienced damage: the beam experienced some relative displacements with respect to the column; however, these displacements never achieved the width of the supporting base (23cm). The numerical results justify the absence of unseating phenomena of the principal beams. The occurrence of two consecutive severe seismic events at the same site can cause more severe damage due to the cumulative effect. In the investigated case study, the cumulative damage is not considered. This assumption is justified by the low damage recorded during this event. If the dynamic analysis is performed with the accelerograms of the first earthquake (May 20th), small relative displacements (about 2cm) of both roof elements and principal beams are recorded; moreover, during the first event the columns do not experience any inelastic excursions. These results are not reported in this paper for the sake of brevity. Further details are reported in Ercolino et al. (2016).

Figure 14. Force-deformation envelopes of the beam-to-column frictional connections under the records of the earthquake on May 29th: (a) columns A and (b) columns B
