1 Cyclic shear tests on RC precast beam-to-column connections retrofitted with a 2 three-hinged steel device

13 A new connection system is employed as a retrofitting solution for a damaged beam-to-column
14 connection and its cyclic shear performance is investigated by means of two cyclic shear tests on
15 two different configurations. In both the experimental tests, the results demonstrate an efficient
16 behavior of the retrofitted connections under horizontal cyclic loads. The comparison between the
17 performance of the investigated connection and the response of a typical beam-to-column dowel
18 connection allows to discuss the main critical features of the dowel connection system.

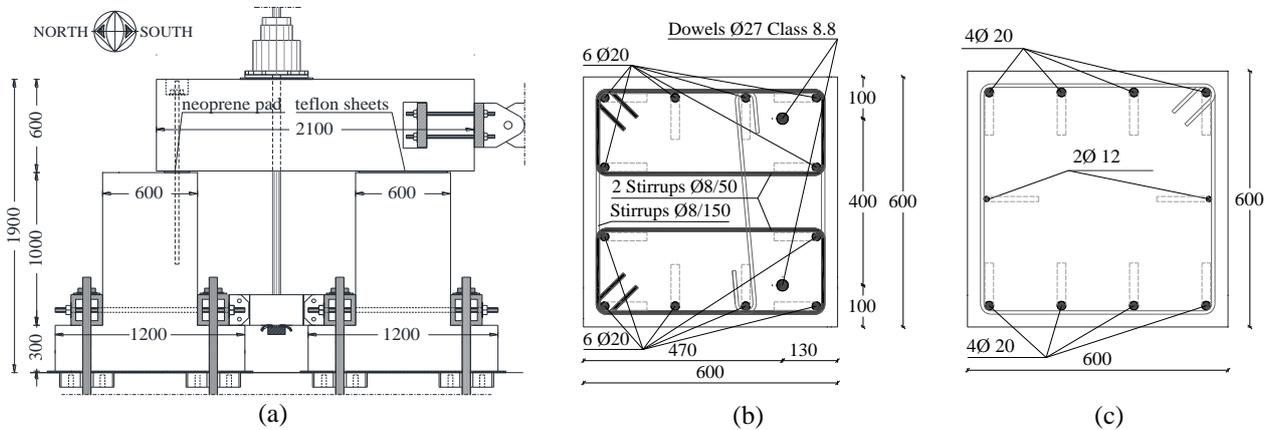
16 **Fig. 1** Setup of the cyclic shear test on the dowel connection: (a) specimen dimensions (in mm), (b) column and (c)
 17 beam cross section details

6 The specimen consists of a horizontal beam, connected to the North column (left side in Fig. 1a) by
 7 a dowel connection and simply supported on the South column (right side in Fig. 1a). The concrete
 8 elements were designed according to European provisions (CEN 2004; CEN 2005b): the
 9 reinforcement details for both the column and the beam are reported in Fig. 1b and Fig. 1c,
 10 respectively. The concrete characteristic cubic compressive strength was equal to 37N/mm^2 ,
 11 whereas the reinforcement characteristic yielding strength was equal to 450N/mm^2 . In order to
 12 avoid large local stresses at the column-to-beam contact, a neoprene pad (15cmx60cmx1cm) was
 13 placed on the dowels side (left side in Fig. 1a), designed according to CNR provisions (CNR 10018
 14 1999). On the South side of the specimen (right side in Fig. 1a) two teflon sheets avoided additional
 15 frictional strength at the beam-to-column surface.

18 The specimen was tested under vertical and cyclic horizontal loads. The vertical load was provided
 19 by a vertical jack with a rate of 3kN/s up to the maximum value of 450kN , as recorded by a specific
 20 load cell. The vertical load remained constant during the application of the cyclic horizontal load
 21 and it was evaluated according to the seismic combination of actions in CEN (1990), by considering
 22 dead and live loads in the seismic design situation for an internal beam of a typical geometrical
 23 configuration of an industrial one-story building ($w=5\text{kN/m}^2$; tributary area equal to 90m^2). The
 24 vertical jack was restrained to a pre-stressed metallic bar that crosses the precast beam through a
 25 hole; a sleigh anchorage system was placed at the other side of the metallic pre-stressed bar, in
 26 order to avoid undesirable restraining effects (Fig. 1).

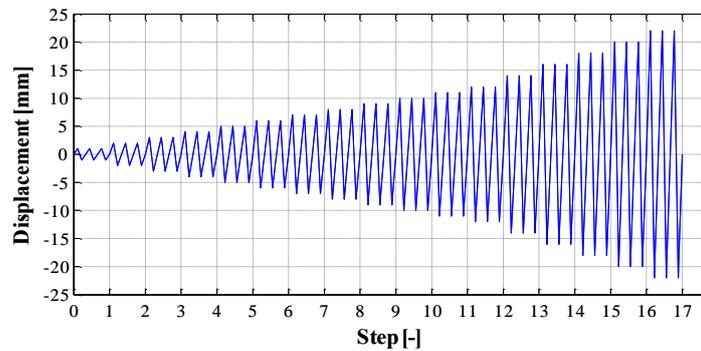
19
 20 **Fig. 2** Loading protocol of the cyclic shear test on the dowel beam-to-column connection

27 The horizontal load was applied along the beam longitudinal axis by means of a hydraulic actuator,
 28 controlling the displacements. Fig. 2 shows the protocol displacements recorded by the actuator
 29 load cell: in this figure, the negative values correspond to horizontal displacements from North to
 30 South, i.e. pulling the dowels against the column frontal cover (from left to right in Fig. 1);
 31 conversely, positive values correspond to the horizontal displacements in the opposite direction
 32 (from right to left in Fig. 1). The adopted loading protocol consisted of 17 displacement steps and,
 33 for each step, three complete cycles (negative and positive semi-cycles) were performed. From the
 34 first to the 12th step, the load was applied with a rate of 0.02mm/s and from the 13th step to the test
 35 end the load rate was equal to 0.04mm/s . Additional details are given in Magliulo et al. (2015).

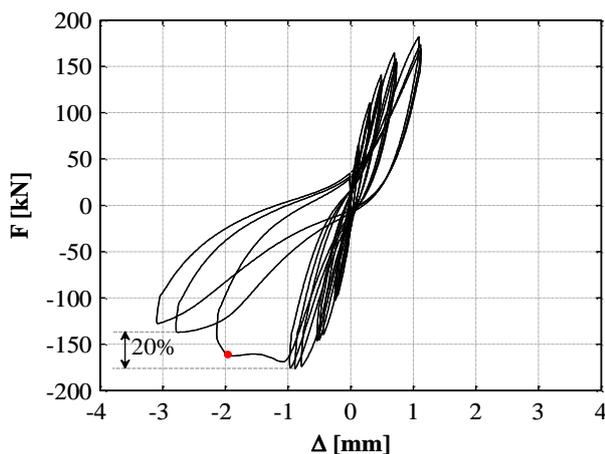
Fig. 3 Force-displacement curve for the dowel connection up to the 20% of the shear strength degradation

36 The effective connection response is described in Fig. 3 up to loading step in which the 20% of
 37 shear strength reduction was reached, i.e. the connection collapse. Fig. 3 shows the horizontal shear

1 force along with the beam-to-column relative displacement: the negative values of both forces and
 2 displacements correspond to pulling loads (i.e. displacements from North to South in Fig. 1a),
 3 whereas the positive values of both forces and displacements correspond to pushing loads (i.e.
 4 displacements from South to North in Fig. 1a).
 5 For pushing loads, the connection exhibits larger shear strength and a quite limited stiffness
 6 degradation with respect to the results under pulling loads. A significant strength degradation occurs
 7 pulling loads after the attainment of the peak shear strength (176.57kN). This peak value
 8 corresponds to the occurrence of the first crack in the column concrete cover (red marker in Fig. 3).
 9 The connection failure occurs for very low beam-to-column relative displacements (2mm), due to
 10 the high initial stiffness of the connection system.
 11 Several cracks occurred in the cover of the column, up to the broad spalling of the concrete at the

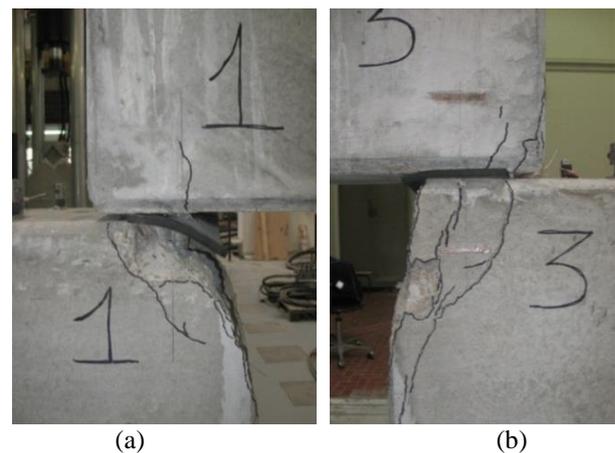
Fig. 4 Final damage pattern of the tested dowel connection: (a) West and (b) East view

12 end of the test. Fig. 4 shows the final configuration of the damage pattern on both the beam and the
 13 column. The connection failure was caused by two main reasons: 1) the small concrete cover of the
 14 steel dowels with respect to the dowel diameter (Vintzeleou and Tassios 1986; Zoubek et al. 2013)
 15 and; 2) the low concrete confinement due to the large depth of the first stirrup at the column top
 16 (Magliulo et al. 2014a).
 17 A more accurate description of both the reference dowel connection and the experimental results of
 18 the cyclic test is reported in Magliulo et al. (2015).

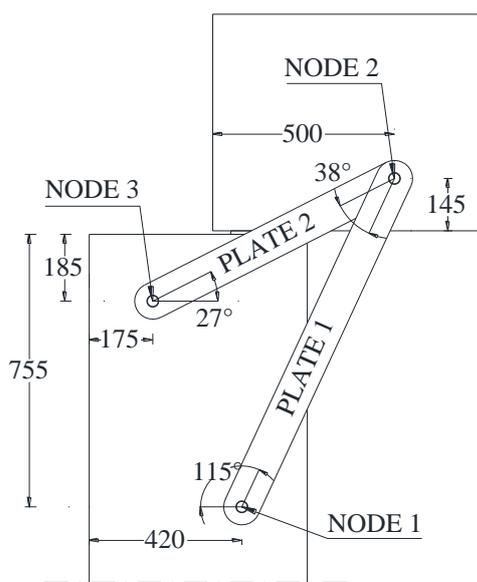
Fig. 5 Connection system configuration (dimensions are expressed in mm)

20 The design of the retrofitting system was performed according to Eurocodes provisions (CEN
21 2005a; CEN 2005b) and considering some specific rules for beam-to-column connections of precast
22 structures with cantilever columns in the Italian building code (D. M. 14/01/2008 2008).
23 The geometrical features of the retrofitting system are reported in Fig. 5. In the following, these
24 terms are adopted: i) the node on the beam is defined as “node 2”; ii) “node 1” and “node 3” are the
25 lower and the upper node on the column, respectively; iii) the steel plate from node 1 to node 2 is
26 referred to as “plate 1” and iv) the steel plate from node 2 to node 3 is the “plate 2”. An optimum
27 inclination of the steel plates was chosen in order to limit their axial force, avoiding their buckling
28 failure and the shear failure of the horizontal steel dowels.
29 The three dowels for the steel plates anchorage consist of threaded bars with a diameter of 30mm

30 and with a characteristic yielding strength of 640N/mm^2 (Class 8.8). The mechanical properties of
31 the steel dowels were verified by means of two tensile tests and they assume the following values:
32 effective cross section area $A_{\text{res}}=560\text{mm}^2$, nominal diameter $\phi_{\text{eq}}=26.7\text{mm}$, mean values of yielding
33 tensile strength $f_{\text{ym}}=685\text{N/mm}^2$, mean Young’s modulus $E_{\text{m}}=176660\text{N/mm}^2$ and mean axial strain at
34 yielding $\varepsilon_{\text{ym}}=0.003878$. The steel dowels were designed according to the provisions for pin
35 connections (CEN 2005a; CNR 10025/98 2000).
36 The design of the steel plates ($f_{\text{yk,plate}}=275\text{N/mm}^2$, $E_{\text{y,plate}}=210000\text{N/mm}^2$) was performed according
37 to the geometrical requirements of Eurocode 3 (CEN 2005a) for pin ended members and their
38 buckling failure was also prevented according to Eurocode 3 (CEN 2005a). Fig. 6 shows the

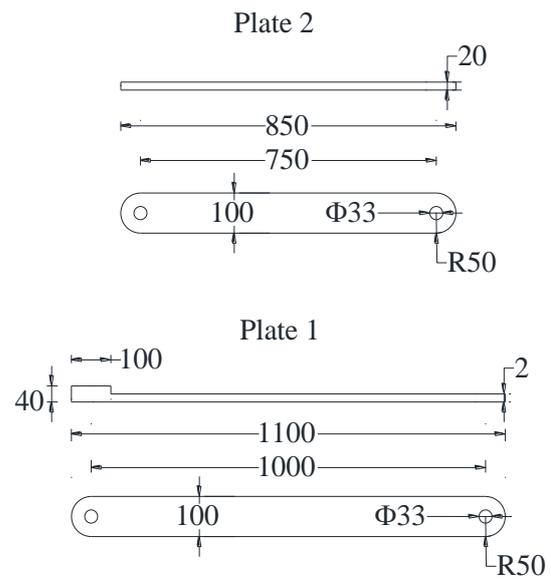
Fig. 6 Geometrical configuration of the steel plates (dimensions are expressed in mm)

39 geometrical features of the two steel plates: Φ is the hole diameter and R is the radius of the plate
40 edges. The plate 1 has a greater thickness at the node 1 in order to allow a planar configuration.
41 The neoprene pad between beam and column was replaced after the cyclic test on the dowel
42 connection; it was designed according to the CNR provisions (CNR 10018 1999), resulting in the
43 same dimensions of the replaced pad (15cmx60cmx1cm).

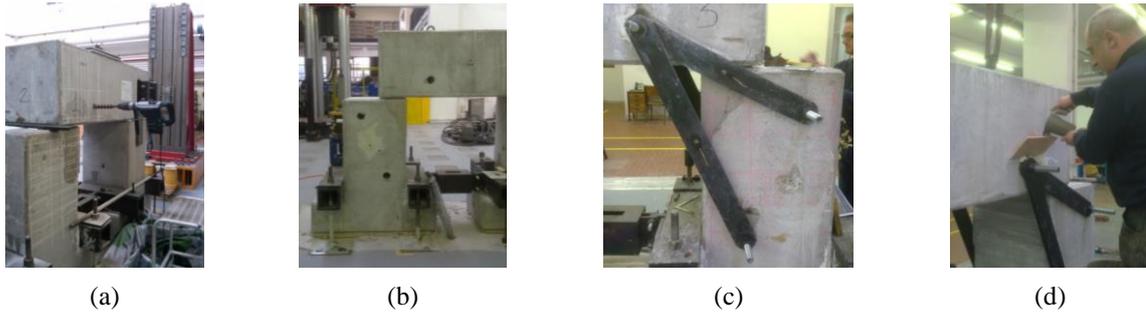
1 **Fig. 7** Installation phases: (a) reported location of the reinforcement bars; (b) anchorage holes; (c) installation of steel
 2 plates and dowels; (d) cast in situ of high strength grout

11 The installation steps of the retrofitting system are described in the following (Fig. 7).

12 a. The preliminary identification of the reinforcement in beam and column was performed
 13 through a magnetic rebar locator test, in order to choose the location of the holes without interfering
 14 with the existing steel elements (Fig. 7a).

15 b. The anchorage holes for the steel dowels were created in the concrete elements (Fig. 7b).

16 c. The system components, i.e. the dowels and the two plates, were installed (Fig. 7c). In the
 17 test 2 the rubber hose was also inserted in the holes.

18 d. The connection between the dowels and the concrete elements was provided by filling the
 19 holes with high strength grout. In order to guarantee the grout filling, the drilled hole diameter is
 20 2cm greater than the dowel diameter (Fig. 7d).

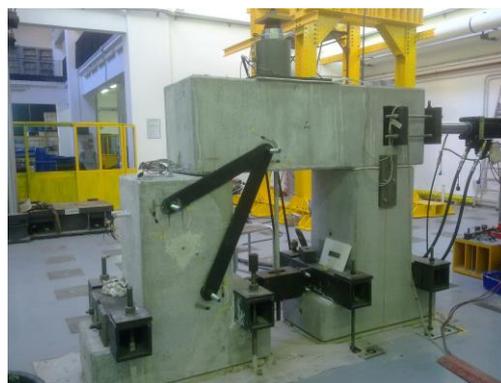
Fig. 8 Setup of the cyclic test on the retrofitted
 beam-to-column connection

15 considerations, a 2mm rubber hose was adopted. The two retrofitted connections and the retrofitting
 16 systems have the same geometrical and mechanical features.
 17 The same vertical and horizontal loads were applied in both tests according to the loading protocols
 18 described in section 2. Since in retrofitted existing structures the gravity loads are applied to the
 19 structure before the installation of the retrofitting system, in the performed tests the vertical load
 20 was applied before tightening the connection device by means of nuts and washers.

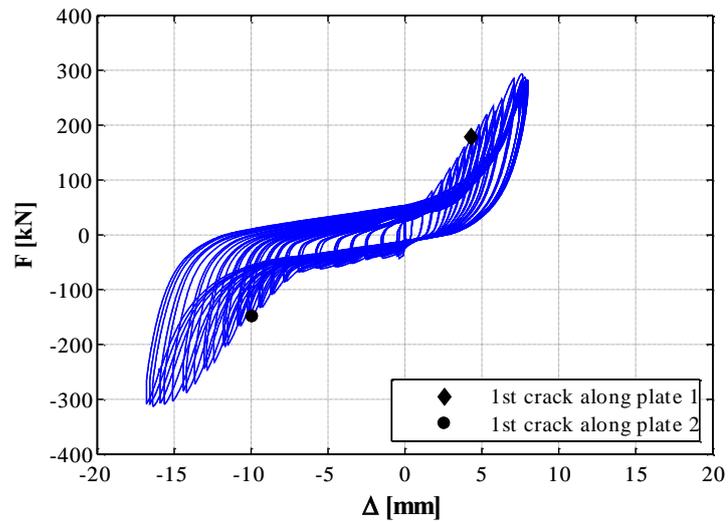
Fig. 9 Force-displacement curve for the cyclic shear test 1 on the retrofitted specimen

17 In Fig. 9 the behavior of the retrofitted connection during the test 1 (without rubber hoses around
18 the horizontal dowel) is shown in terms of force-displacement curve, i.e. the shear forces and the
19 relative displacements between beam and column. The blue curve in Fig. 9 includes both the shear
20 strength of the retrofitting connection systems, placed on both the East and the West sides of the
21 tested specimen, and the concrete-to-neoprene friction forces, depending on both the contact surface
22 features and the acting vertical loads (Magliulo et al. 2011).

23 The negative values of forces and displacements correspond to pulling loads, i.e. horizontal loads
24 against the column frontal cover. The connection behavior is not symmetric in the two loading
25 directions because of an asymmetric distribution of the local stresses in the concrete. This evidence
26 can be justified by installation defects of the horizontal dowels and it is also demonstrated by the
27 different crack patterns in the two loading directions (Fig. 10). In the case of pushing loads (positive
28 values), a lower damage of the concrete corresponds to a higher initial stiffness with smaller relative
29 displacements than in the case of pulling loads. Concerning the pulling loads (negative values), the
30 force-displacement curve shows a clear pinching effect up to a relative horizontal displacement
31 equal to 7mm, due to the concrete damage around the horizontal dowels.

32 The diamond and circle markers in Fig. 9 correspond to the formation of the first crack in the node
33 2 on the beam concrete surface, along the steel plate 1 and 2, respectively. The cracks occurrence is
34 defined when the recorded axial strain ε on the beam surface (strain gauges B1-II and B2-II in Fig.
35 11) reached the axial strain value at the concrete tensile strength (f_{ctm}), i.e. $\varepsilon_t=0.01\%$ (Fig. 12). The
36 first crack along the plate 1 appeared during the first cycle of the 8th step, for a positive shear load
37 equal to 178.74kN, which corresponds to tensile axial forces for plate 1 and compressive axial
38 forces for plate 2. Instead, the first crack along the plate 2 appeared during the first cycle of the 11th
39 step, for a negative shear load equal to 149.42kN, which corresponds to tensile axial forces for plate
40 2 and compressive axial forces for plate 1.

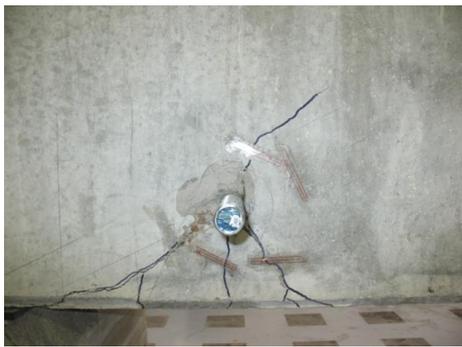
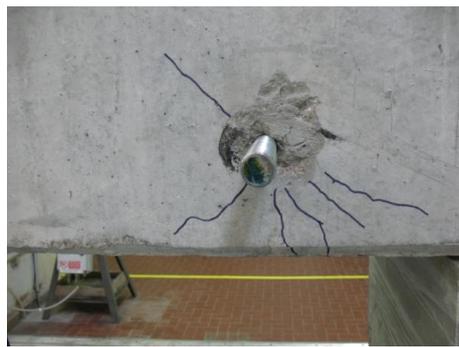
Fig. 10 Cracking pattern around the node 2 after the test 1: (a) West and (b) East side

3 Fig. 10 shows the cracking pattern on both the sides of the beam (node 2) at the end of the test.
4 Most of the cracks were recorded at the node 2 due to the large compressive and tensile axial forces,
5 transmitted by both the two steel plates during the cyclic test. The concrete cracks propagated up to
6 the bottom of the beam (Fig. 13). Fig. 14 shows the final state of the column: few cracks, with
7 limited length and width, were recorded.

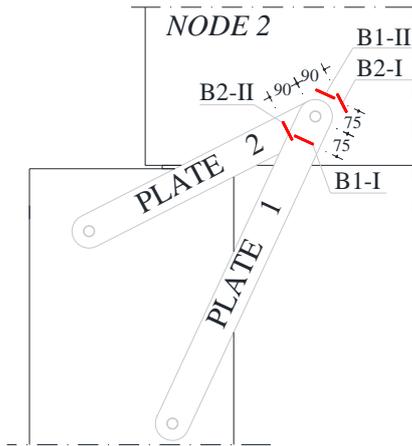
Fig. 11 Layout for strain gauges around node 2 (on the beam), along the plate 1 and plate 2

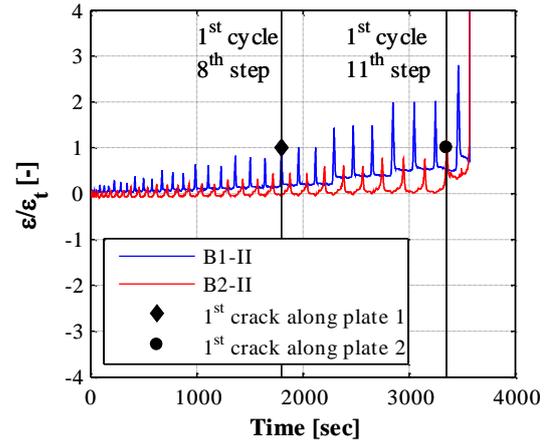
Fig. 12 Axial strain on the concrete surface around node 2 (test 1)

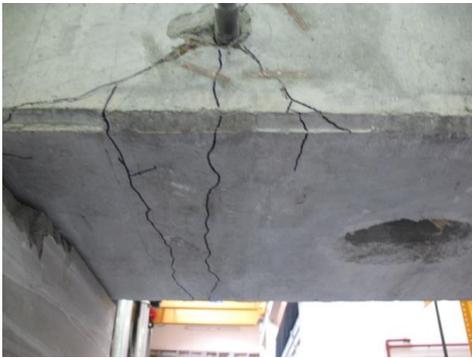
Fig. 13 Cracking pattern on the West side-bottom surface of the beam (test 1)

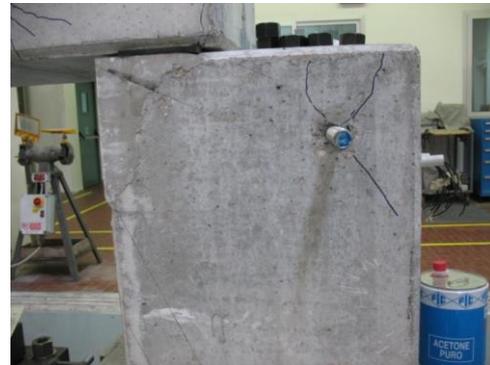
Fig. 14 Cracking pattern around the node 3 East side (test 1)

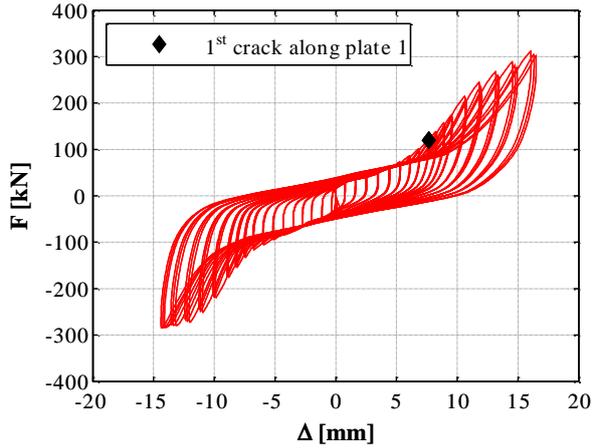
Fig. 15 Force-displacement curve of the cyclic shear test on the retrofitted connection (test 2)

10 later step of the load protocol (i.e. during the first cycle of the 10th step) at a larger beam-to-column
 11 relative displacement (8mm) and at a lower shear force in the connection, equal to 119.86kN. After
 12 the attainment of the first crack, the retrofitted connection still showed an increasing shear strength
 13 with a maximum shear force equal to 311.32kN for pushing loads (positive values). The maximum
 14 shear strength of the retrofitted connection for pulling loads (negative values) was equal to
 15 284.54kN.

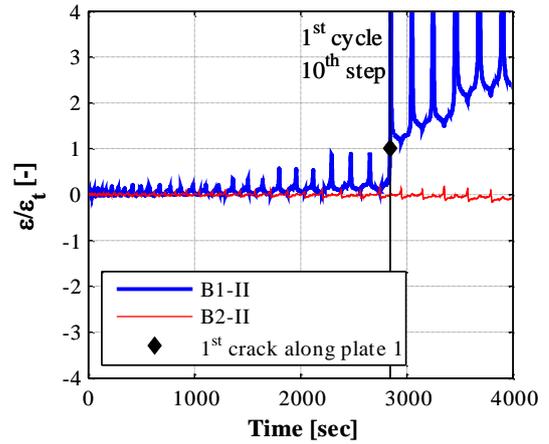
Fig. 16 Axial strain on the concrete surface around node 2 (test 2)

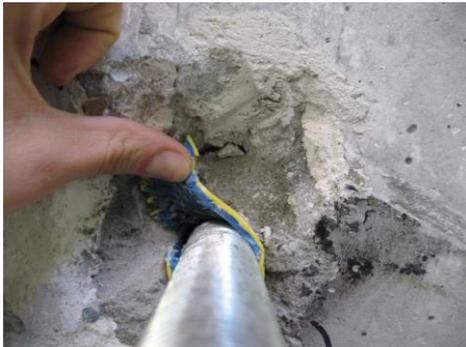
Fig. 17 Rubber hose damage (test 2)

1 The rubber hose around the steel dowel in the beam (node 2) was significantly damaged (Fig. 17) at
 2 the end of the test and the surrounding grout crushed. Moreover, the neoprene pad showed large
 3 deformations due to the large compressive loads (Fig. 18). Several inclined cracks appeared in the
 4 concrete around the node 2 at both the sides of the specimen (Fig. 19). However, in this test the
 5 width and the length of the crack were smaller than in the test 1 because of the positive effect of the
 6 rubber.

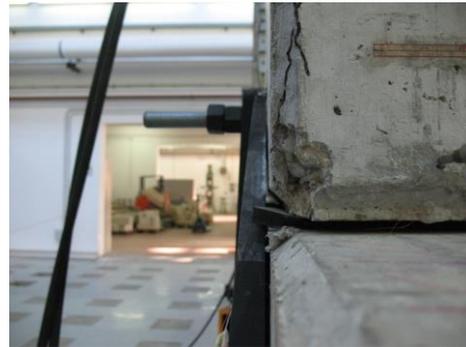
Fig. 18 Neoprene pad deformation (test 2)

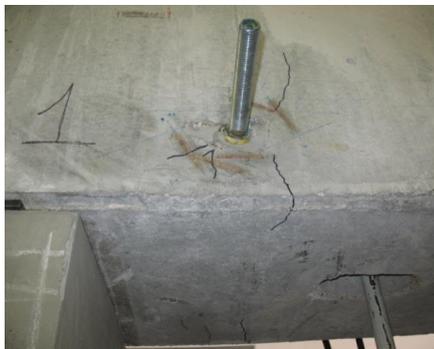
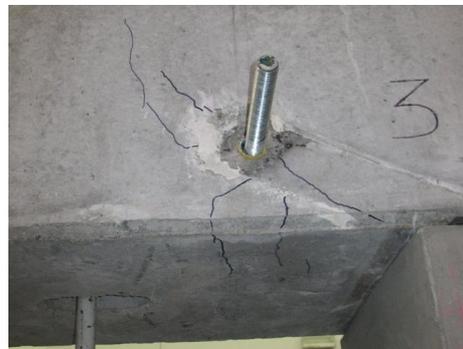
Fig. 19 Cracks pattern at the node 2 at the end of the test 2: (a) West and (b) East view

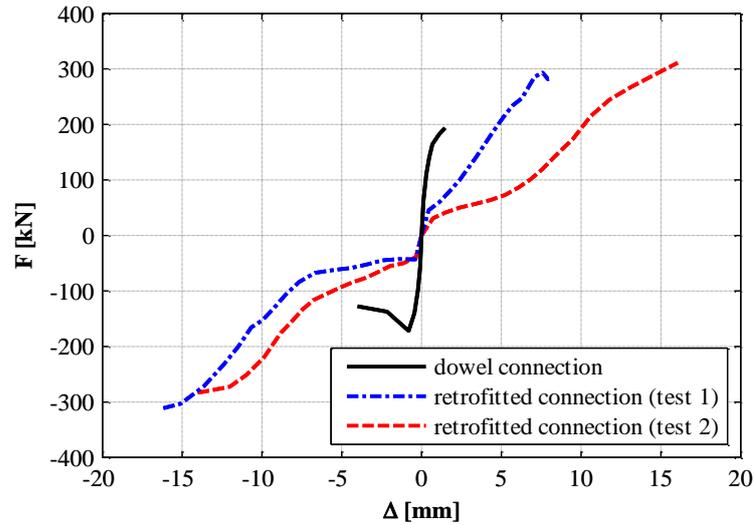
Fig. 20 Force-displacement envelopes of the tests on the dowel beam-to column connection (black solid curve) and on the two retrofitted connections, i.e. without (blue dash-dot curve) and with (red dashed curve) the rubber hose around the horizontal dowel

10 Fig. 20 shows the envelopes of the force-relative displacement curves of the three investigated
11 cyclic tests. For all the investigated tests, the load protocol consisted of increasing displacement
12 steps and, for each step, three complete cycles (negative and positive semi-cycles) were performed.
13 Since, at each step, the maximum value of the shear force was reached at the first cycle, the
14 envelope takes into account only the first cycle of each step. Moreover, in Fig. 20 the envelope of
15 the shear test on the dowel connection (black solid curve) is showed up to the 20% strength
16 degradation, assumed as the attainment of the connection failure (see section 2). The comparison
17 demonstrates that the retrofitted connections (blue dash-dot and red dashed curves in Fig. 20) show
18 lower initial stiffness with respect to the dowel connection (black solid curve in Fig. 20). This is due

19 to the geometrical tolerance between the steel elements in the connections and to the rubber hose
20 deformations (such as for the test 2 in the red dashed curve in Fig. 20). In particular, the initial
21 stiffness for pushing loads is equal to 508.13kN/mm for the dowel connection, equal to
22 99.54kN/mm for the retrofitted connection without rubber hose and equal to 42.92kN/mm for the
23 retrofitted connection with rubber hose. Instead, for pulling loads, the initial stiffness is equal to
24 828.94kN/mm, 113.63kN/mm and 116.5kN/mm, respectively.

25 In terms of maximum recorded shear forces, the dowel connection performed the lowest shear
26 strength in both the considered load directions. Moreover, the cyclic behavior of the dowel
27 connection is strongly not symmetric in the two loading directions; a sudden strength and stiffness
28 deterioration was recorded for pulling loads after the concrete cover failure. The first tested
29 retrofitted connection (test 1, blue dash-dot curve in Fig. 20) shows a larger shear strength with
30 respect to the dowel connection in both the directions. Moreover, the similar performance in terms
31 of maximum shear strength, for both the loading directions, demonstrates the efficiency of the
32 retrofitting system. However, it is worth to underline that this connection shows larger relative
33 displacements for pulling loads (force negative values) with respect to pushing loads, due to a
34 significant damage around the horizontal steel dowels for this load direction.

35 The retrofitted connection of test 2 (red dashed curve in Fig. 20) shows a good cyclic performance,
36 with both large shear strength values and a quite symmetric response. The rubber hose around the
37 horizontal dowel in the beam led to a lower initial stiffness (about 60%) in test 2 than in test 1 for
38 pushing loads (force positive values) because of its flexibility; on the contrary, for pulling loads the
39 initial stiffness of the two systems is quite similar, because of the significant concrete damage
40 around the beam dowel in test 1.

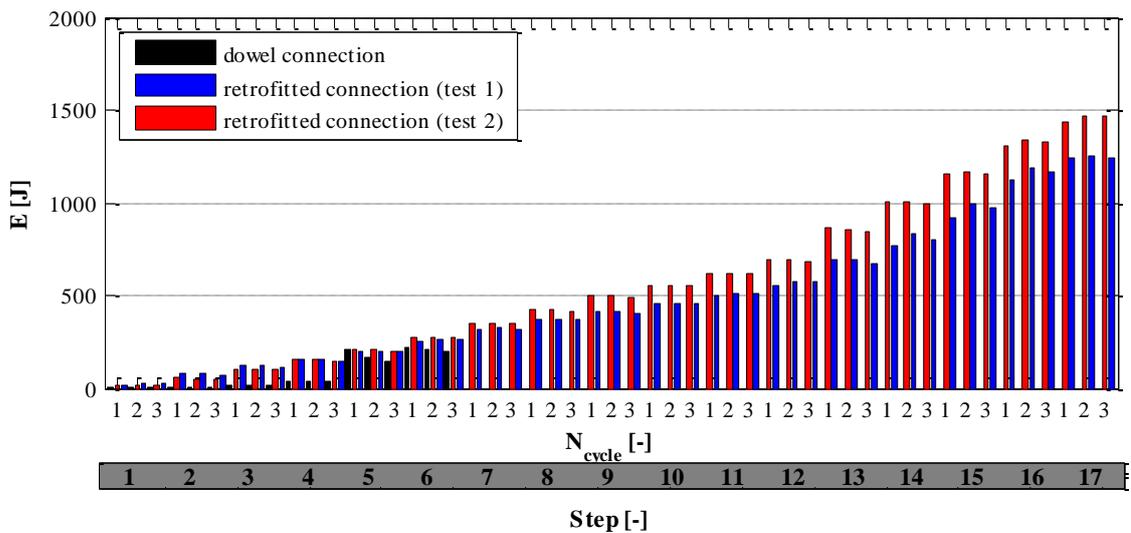
Fig. 21 Dissipated energy during the negative semi-cycles of the shear tests on the dowel beam-to column connection (black bars) and on the two retrofitted connections, without (blue bars) and with (red bars) the rubber hose

5 Fig. 21 shows the dissipated energy at each negative semi-cycle, corresponding to pulling loads, for the three investigated tests: the dowel connection (black bars), the retrofitted connection without the rubber hose (blue bars) and the retrofitted connection with the rubber hose (red bars). The dissipated energy of the dowel connection is plotted only for the first six steps, i.e. until the assumed failure of the connection. Up to the fourth step of the test on the dowel connection (i.e. the step which corresponds to the first crack formation), its dissipated energy was strongly lower than the dissipated energy in the retrofitted solutions because of the large initial stiffness. After the first concrete crack, the dissipated energies in the dowel connection and in the retrofitted solutions were quite similar, because of the increased deformability of the dowel connection due to the concrete damage. The dissipated energy in the two retrofitted connections increased up to the end of the shear tests; moreover, the deformation of the rubber hose around the horizontal dowel in the beam led to larger relative displacements (lower stiffness of the beam-to-column connection) and dissipation. This evidence resulted in larger values of the dissipated energy for test 2 than for the test 1.

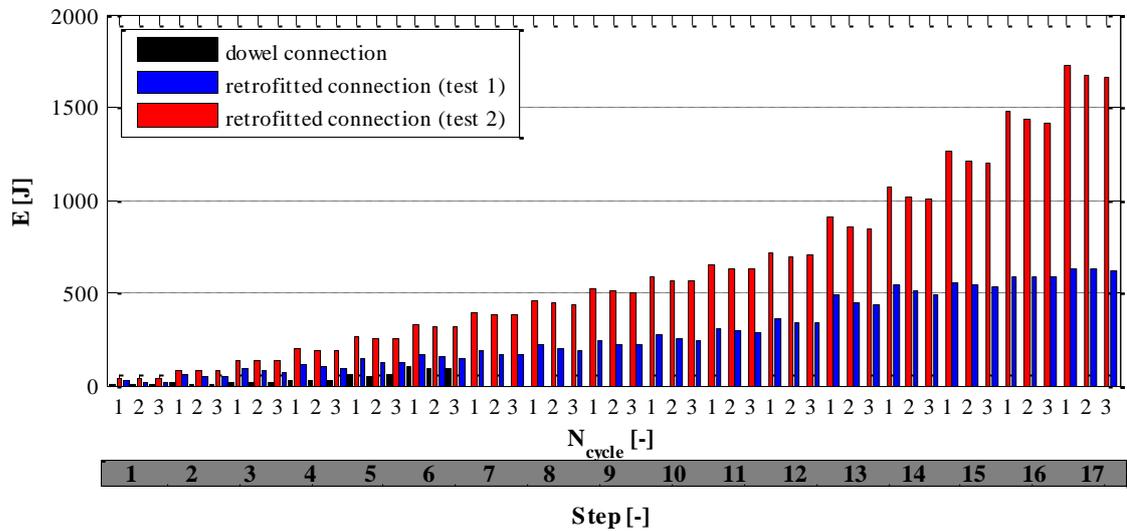
5
 6 **Fig. 22** Dissipated energy during the positive semi-cycles of the shear tests on the dowel beam-to column connection
 7 (black bars) and on the two retrofitted connections, without (blue bars) and with (red bars) the rubber hose

1 Fig. 22 shows the dissipated energy at each positive semi-cycle (i.e., pushing loads) for the three
 2 investigated connection systems. The dissipated energy of the dowel connection is much lower than
 3 the one recorded in the retrofitted solutions. Furthermore, the dissipated energy values recorded
 4 during the test 1 are significantly lower than the values recorded during the test 2.

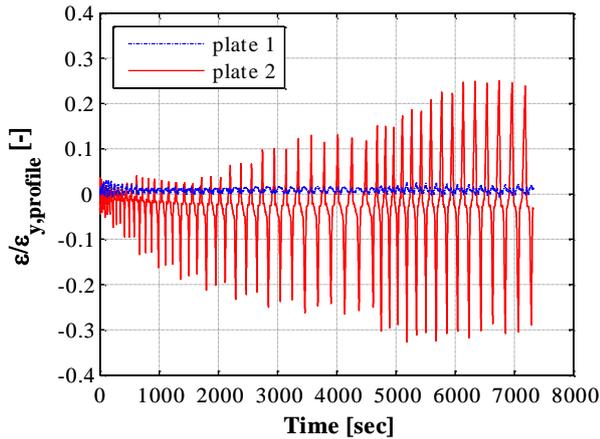
Fig. 23 Records of the strain gauges on the steel plates on the East side (test 1)

8 The good performance of the retrofitted connections can be also demonstrated in terms of local
 9 strains in the steel and the concrete elements.
 10 The axial steel strains, recorded along the inclined steel plates and along the horizontal steel dowels,
 11 confirm the three-hinge arch mechanism and the dowel action. Fig. 23 and Fig. 24 show the ratio
 12 between the recorded axial strains ε on the steel plates (plate 1 and plate 2) of the East side system
 13 and the yielding value $\varepsilon_{y,plate}$ corresponding to the adopted steel for both the test 1 and 2. In both the
 14 tests, the strain values of the plate 2 (red solid line in Fig. 23 and Fig. 24) were larger than those
 15 ones of the plate 1 (blue dashed line in Fig. 23 and Fig. 24) due to the geometrical configuration.
 16 However, both the steel plates did not reach the yielding limit up to the end of the tests. Moreover,
 17 the axial strain trend of the two steel plates confirms the effectiveness of three-hinged arch

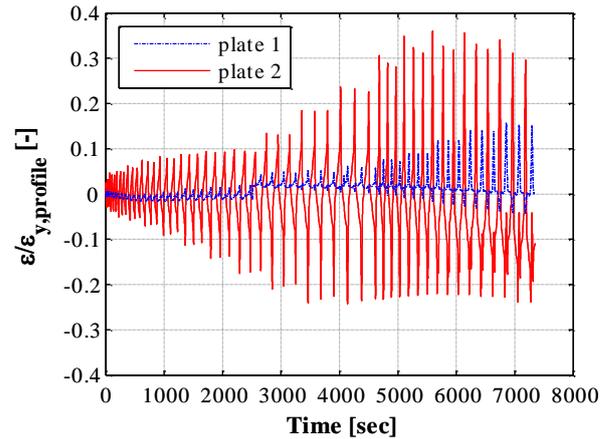
Fig. 24 Records of the strain gauges on the steel plates on the East side (test 2)

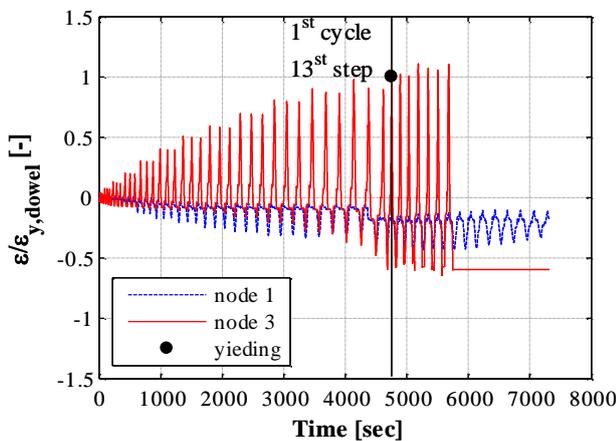
Fig. 25 Records of the strain gauges on the horizontal steel dowels in the column (test 1)

1 Fig. 25 and Fig. 26 show the ratio between the axial strains ε recorded along the steel dowels (Fig.
 2 5) in the column (in the node 1 and the node 3) and their limit yielding value, $\varepsilon_{y,dowel}$. The values
 3 recorded in the node 3 (red solid line in Fig. 25 and Fig. 26) were larger than the strains recorded in
 4 the node 1 (blue dashed line in Fig. 25 and Fig. 26). This result confirms the large forces in the plate
 5 2 during the cyclic test. In particular, during the test 1 the horizontal dowel in the node 3 reached
 6 the yielding strain for large values of the shear force in the connection (270.88kN), during the first
 7 cycle of the 13th step (4755 sec). Lower values are recorded during the test 2: this confirms that the
 8 presence of the rubber hose around the horizontal steel dowel in the beam (node 2) leads to a lower
 9 shear force in the column (node 1 and 3). The recorded axial strains in the horizontal dowel passing

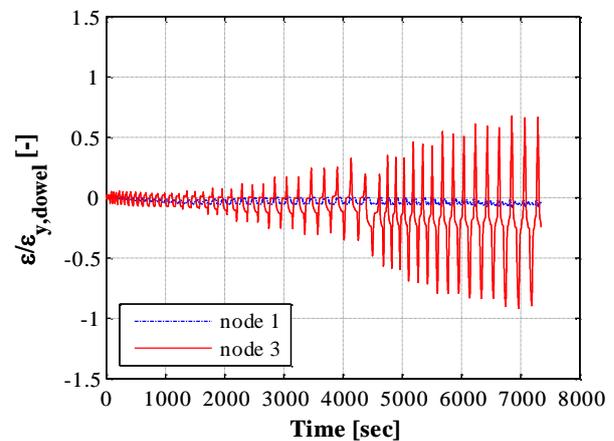
Fig. 26 Records of the strain gauges on the horizontal steel dowels (test 2)

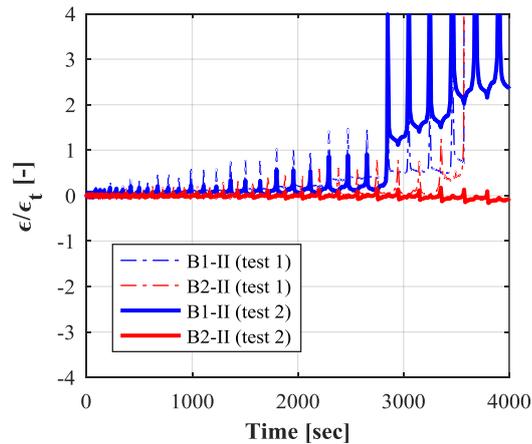
3
4 **Fig. 27** Axial strain on the concrete surface around node 2 during test 1 and test 2

12 The good performance of the retrofitting system also results in a less developed damage pattern for
 13 the retrofitted connection systems with respect to the dowel connection. The records of the strain
 14 gauges on the concrete beam surface (node 2 of Fig. 11) can describe the development of the
 15 damage during the test. Fig. 27 shows the ratio between the recorded strain values (ε) on the
 16 concrete surface (for the beam) and the concrete tensile strain which corresponds to the attainment
 17 of the concrete tensile strength (f_{ctm}), i.e. $\varepsilon_t=0.01\%$. The instrumentation records represented by
 18 dashed and thinner lines correspond to the test 1, whereas the solid and thicker ones correspond to

1 test 2. It can be pointed out that the presence of the rubber hose around the horizontal steel dowel
2 reduces the concrete damage in the beam.
