# Building Classification and Seismic Vulnerability of Current Housing Construction in Malawi

## Abstract

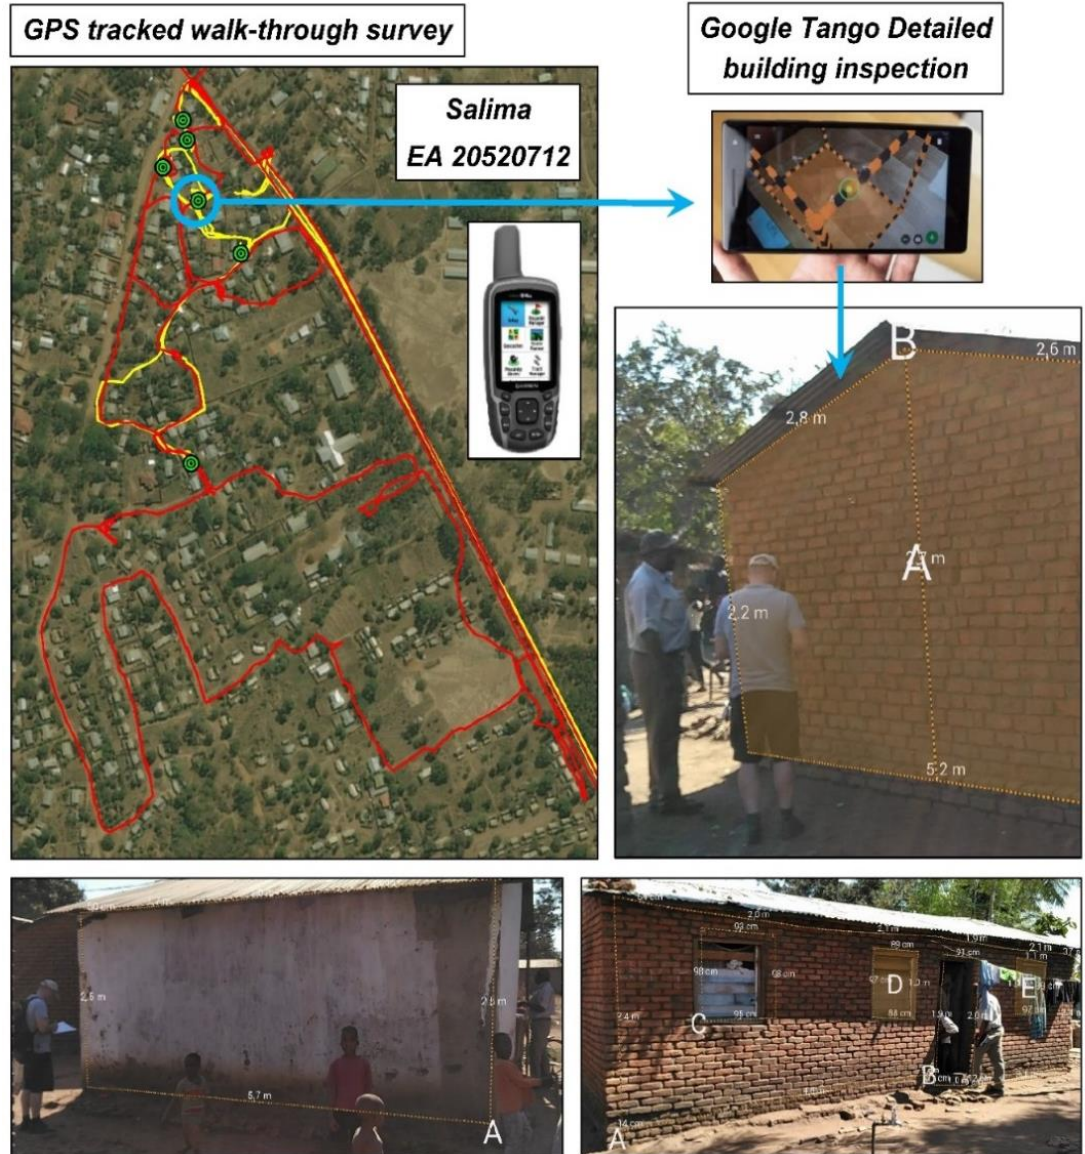
**Figure 2:** Quick walk-through and detailed building inspections in Salima EA20520712.

In each EA, two types of building surveys, i.e. quick walk-through surveys and detailed surveys of individual buildings were performed. During the surveys, GPS tracking was used to record the locations of the inspected buildings and areas. Typical examples of the walk-through and the detailed surveys of individual buildings are presented in Figure 2, for Salima, EA 20520712. The walk-through survey was aimed at counting and classifying all buildings in the EA in a way similar to the 2008 Census procedure, based on wall material types: i.e. mud (traditional), unburnt brick (UB/semi-permanent), and fired brick (FB/permanent). In addition, other structural characteristics that affect seismic vulnerability were considered, such as wall thickness (single-skin or double-skin walls), the presence of lintels above openings and their types (wooden, concrete, or concrete ring beam), connections between walls (strong or weak) the building shape on plan (regular or irregular), and the roof shape (mono-pitched, gable or hipped). Regarding foundations, which were visually inspected on site, in traditional buildings these are completely absent, while in permanent and semi-permanent buildings, they are built as follows: plinth filled with compacted soil, plinth walls with concrete strip footing, plinth beams or slab (Novelli et al., 2018).

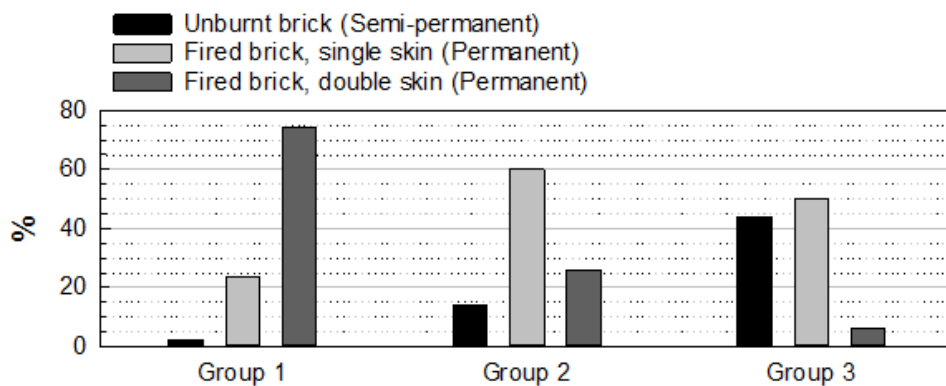
**Figure 3:** Results of the 2017 building survey summarised per area group.

Compared with the 2008 Census data, the summarised results for the three groups presented in Figure 3 indicate that the proportions of permanent buildings (i.e. fired brick masonry) are significantly greater than those indicated in the Census data. The characteristics of the housing stock, especially in urban areas have moved towards the permanent housing type. The percentages of the traditional housing type in all areas were negligible; normally less than 1%. In Table 1 they are included along with unburnt brick (semi-permanent) buildings. Semi-permanent buildings were known to be less common than the national average in secondary-urban areas in Central and Southern Malawi (Ngoma, 2005; UN-Habitat, 2010). They remain prevalent in rural areas, but their percentages are decreasing continuously (e.g. from 71% in 1998 to 43% in the 2008 Census, nationwide), since new structures are predominantly made of fired bricks.

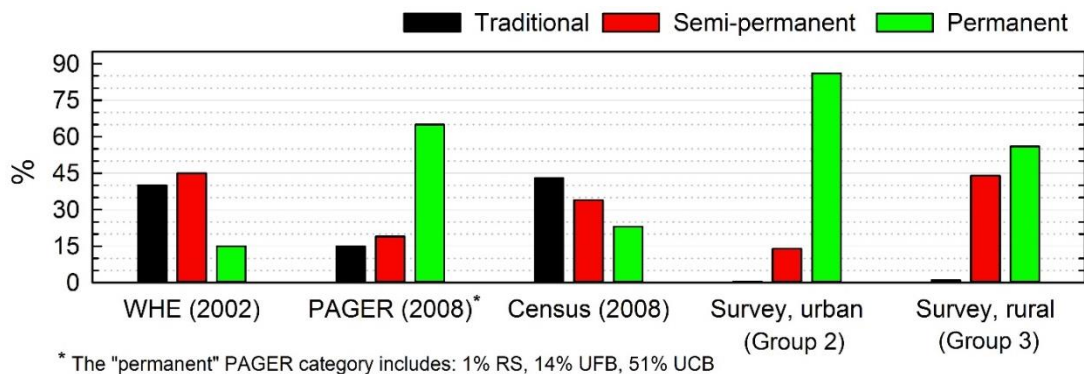
**Figure 4:** Comparison of housing stock information from the 2002 WHE database, Jaiswal & Wald (2008), the 2008 Malawi Census, and the 2017 survey results.

The discrepancies between the above sources regarding the housing stock in Malawi are illustrated in Figure 4. The results from the 2017 building surveys are also included in the figure. The 2002 WHE dataset is comparable to the 2008 Census data, but there is clear evidence of changes in housing conditions over the years, indicating that housing conditions change rapidly in Malawi, traditional/semi-permanent houses being replaced with more permanent ones. On the other hand, there are considerable differences between the Census and PAGER inventory datasets, both in terms of material and typology. Although from Figure 4 it seems that PAGER and the 2017 building survey give similar data in terms of the traditional, semi-permanent, and permanent classifications, the results for seismic risk could be significantly different because there are significant variations of the seismic vulnerability between buildings that are categorised as 'permanent' according to the Malawi census. In this regard, more specific information about the buildings is needed, as demonstrated in the following section.

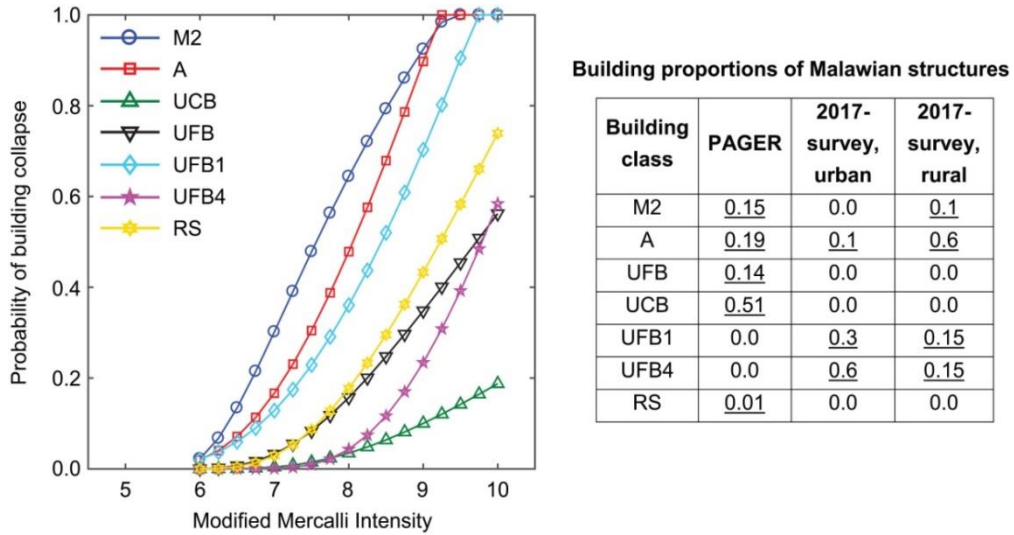
**Figure 5:** Comparison of the empirical seismic fragility functions for M2, A, RS, UFB, UCB, UFB1, and UFB4 by Jaiswal et al. (2011) in terms of MMI.

The importance of using realistic building data for seismic risk assessment in Malawi is evident, when comparing the predictions of the vulnerability models based on the global and local building data. PAGER adopts empirical seismic fragility curves for building collapse, as a function of modified Mercalli intensity (MMI), which is a common seismic intensity parameter (Jaiswal et al., 2011). Such seismic fragility curves are presented in Figure 5 for the building types that are relevant to Malawian structures. M2, A, and UFB1 are more vulnerable than the other building typologies. It is important to highlight the notable higher fragility of UFB1 (mud mortar) which is almost comparable to A, as opposed to class UFB4 (cement mortar). UCB exhibits significantly lower seismic vulnerability than the other classifications, but whereas PAGER assumed 51% of buildings in Malawi were of this type, the survey indicated these were very rare. Therefore, it can be expected that using the global building classifications underestimates the seismic risk for Malawi.
