Evaporative cooling and air conditioner cooling: maintenance, improvements and data collection

Back-to-office report prepared by Marcelo Precoppe

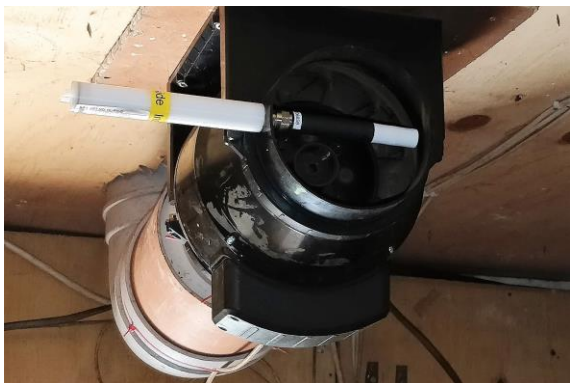
After repairs and improvements were concluded, sensors (HC2A-S, Rotronic; Bassersdorf, Germany) were placed to record temperature and relative humidity inside and outside the storage unit. Figure 1 shows the sensor placed inside the unit at the point where the cooled air enters the store. Data was collected for 2.5 weeks and can be used to determine the system efficiency and guide improvements.

Figure 1 Measurement of temperature and humidity of the air cooled by evaporative system.

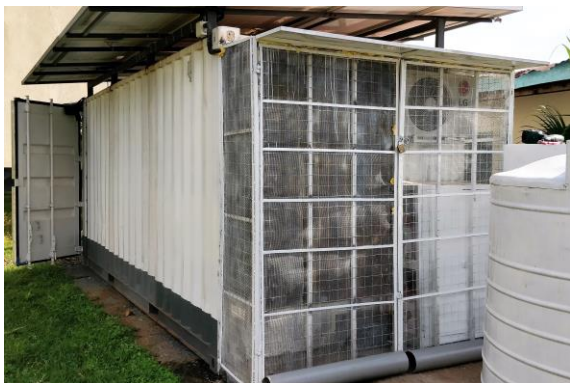
Figure 3 Installation of physical barriers, repellent and traps to protect electrical installation.

To avoid future damage with rodents, all the electrical components were protected by a fine wire mesh (Figure 3). In addition, ultrasonic rat repellents were installed, as well as glue traps.

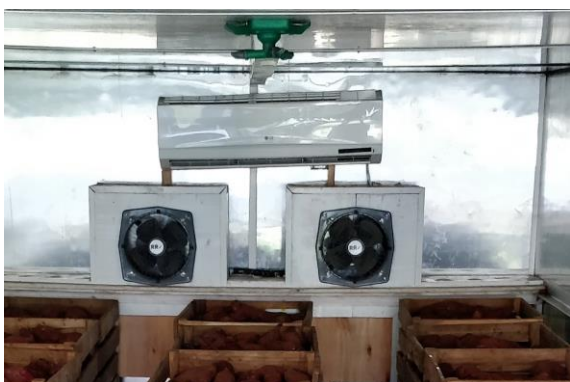
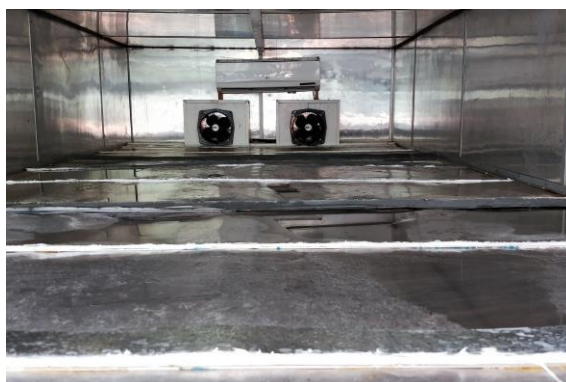
The humidification system of the storage unit consists of a water sprinkler and a water pump controlled by a timer. The sprinkler originally installed had its spray too concentrated in the centre of the container. It was then, replaced by another model that sprays the water more broadly, spreading it over the cover, as shown in Figure 4. In addition, the timer that controls the water pump was replaced by a digital one, allowing more fine control over the pump operation.

Figure 4 Water sprinkler was substituted to spread the water more uniformly over the cover.

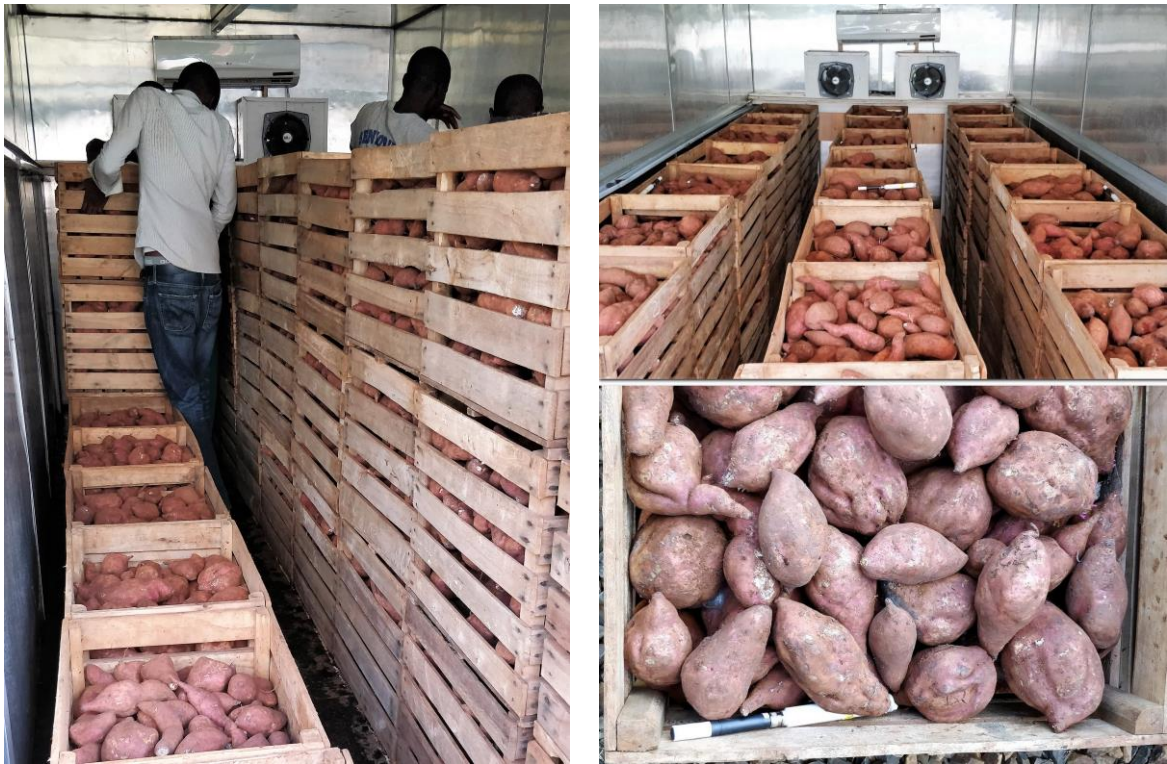
After repairs and improvements were concluded, the store was loaded with approximately 4000 kg of sweetpotatoes (white variety). Twenty temperature-relative humidity sensors (HC2A-S, Rotronic), each connected to wireless data logger (HL-RC-B, Rotronic), were placed within the roots at various locations of the storage unit (Figure 5).

Figure 5 Storage unit loaded with 4000 kg of sweetpotatoes and sensors placed within the roots.

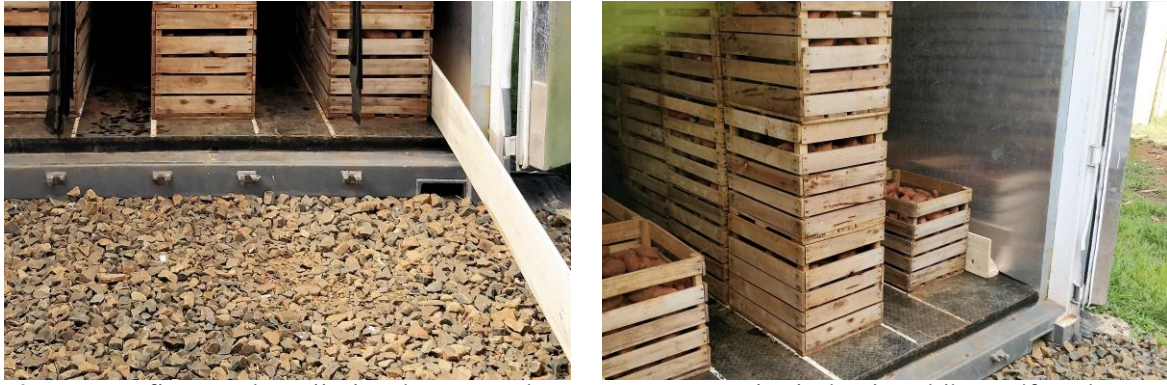
The temperature and humidity maps were used to guide modifications aiming to improve uniformity. An air deflector on both sides of the chamber was installed (Figure 8) and a better distribution of temperature and humidity was achieved as shown in figure 9.

Figure 8 Deflectors installed to improve air temperature and relative humidity uniformity.
