Structural Failure of Silos: Learning Lessons from Failure

Prof Mike Bradley

Director, The Wolfson Centre for Bulk Solids Handling Technology, Univ. of Greenwich,
London, UK M.s.a.bradley@gre.ac.uk www.bulksolids.com

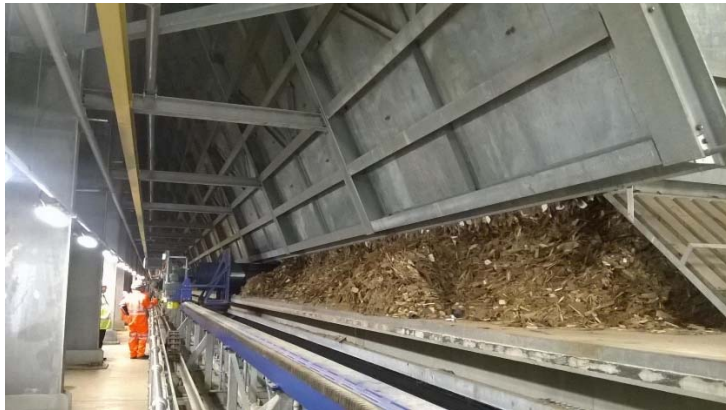
In one case of a large wedge shaped silo of some tens of thousands of cubic metres capacity, the horizontal reinforcing beams running along the sloping flanks were showing some outwards bowing between the supporting struts. Discussions with the structural designer revealed that the actions on these sloping sections had been calculated using the code for retaining walls, the designer being unaware that the code for silo design would have been more appropriate. The retaining wall code does not include for the flow of the material which happens in the silo, which increases the lateral loadings considerably. Experience shows that many structural engineers of even the most senior level that work in general practice, are unaware of the special calculation methods required for the actions on silos.

Figure 3 A Large Wedge-Shaped Linear Silo

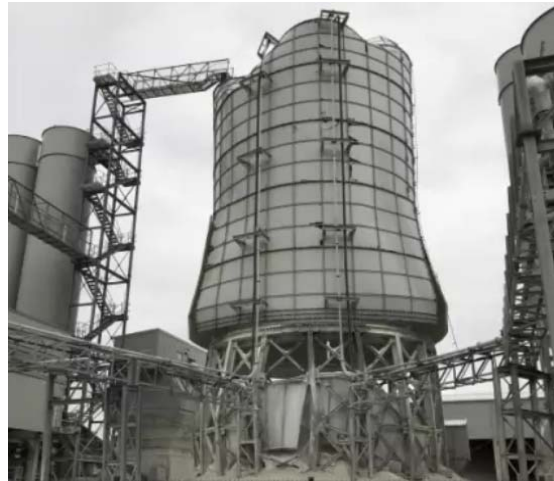
Joints between flanged panels have been seen to present a number of interesting challenges.

Figure 7 Failed Silo Constructed From Flanged Panels

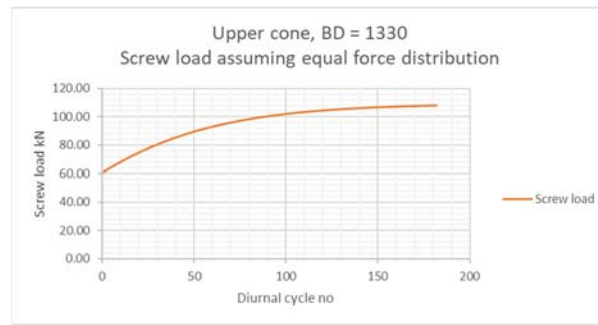
“Thermal racking”, first identified in the 1980s in Australia in the investigation of failures of large grain bins, has been seen in other silo failures. An investigation of a bin holding some thousands of tonnes of a fine powder implicated this as a contributor. The silo collapsed in the early morning, after having held the same quantity of material in static storage for some weeks with no signs of distress. The weather over the previous weeks had hot days and cool nights. This causes the silo to expand during the day, allowing the bulk solid to drop down a little, then when the silo cools and contracts during the night, it compacts the bulk solid, making it stiffer; over multiple cycles, hoop stress increases:-

Figure 9 Model for Increasing Load in Screws Holding the Silo Panels Together, Due to Thermal Racking

In this case it was necessary for the forensic investigation, to devise a model for this effect. However, this could not be validated and the lack of an agreed, validated model for the effect of thermal racking is a serious omission from our ability to predict accurately the actions on large silos.

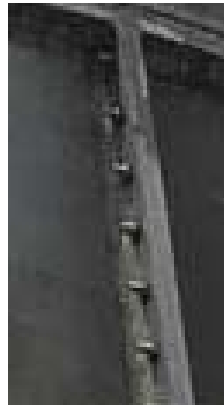
Figure 11 Flanged Vertical Joint in a Bolted Silo

The vertical flange is welded to the shell of the silo which is relatively thin, so the flange can flex under tension. But at the top end, the vertical flange is welded to the adjacent horizontal flange, making it much stiffer. So when the hoop stress tends to pull the flange apart, the top bolt carries much more load than the others.

Again, depending on how stiff the flanges are, this can lead to the top bolt here being loaded over its capacity whilst the ones below share much less load, again initiating progressive failure down the joint.

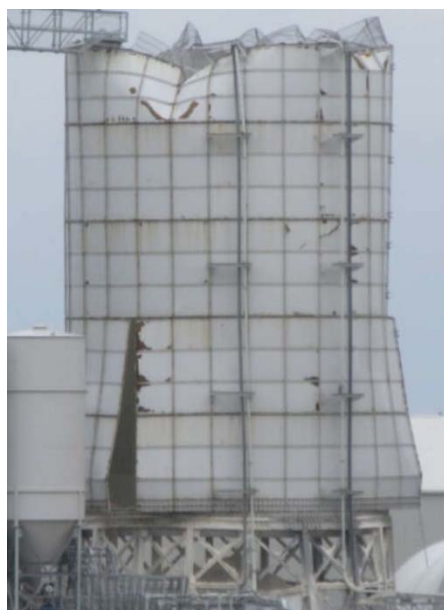
Figure 12 Aligned Vertical Joints Encourage the Spread of a Progressive Failure

As shown in fig. 12 above, the alignment of vertical joints means that if a failure starts in the vertical joint between two panels, it will inevitably continue to progress up and down that joint until the load is removed by release of the silo contents. By contrast, if a failure occurs in a vertical joint in the silos in fig 13, it will spread up and down that individual panel joint but the lateral offsetting of the vertical joints means that the “bridging” effect of the panels above and below the failed joint will prevent the failure from spreading further. The trends for aligned or offset joints appear to be regional; most bolted silos in the UK use offset vertical joints, whereas in mainland Europe, aligned joints seem to be favoured; in other part of the world including the US, it seems to be random between different manufacturers.

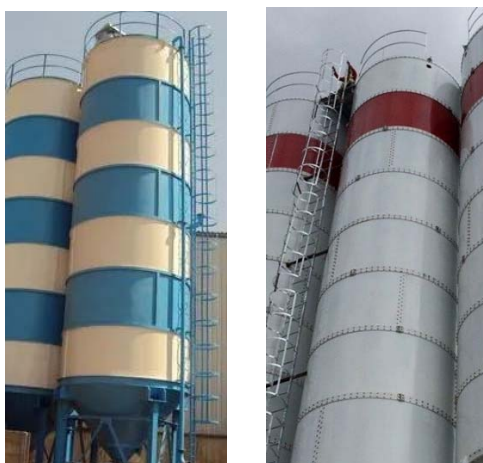
Figure 13 Staggered Joints Will Intercept Progressive Failure

- 6) Build in **robustness** against progressive failure of joints, for example by offsetting the vertical joints in both cone and barrel
- 7) Avoid the use of **unstiffened skirts** on all but the smallest silos

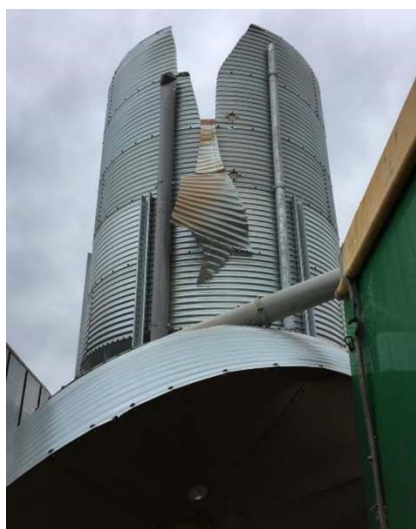
Fig. 14 below shows a silo from which the top cone and the topmost ring of the barrel have been blown off, displaying shear-out failure of the bolted joint to the ring below. The silo top landed right next to the pressure-discharge road wagon operator, who was lucky to avoid serious injury.

Figure 14 Silo With Top Blown Off Due to Over-Pressurisation. The Top Cone and Ring of the Silo Are Lying in the Bottom of the Picture

This occurred just after starting pneumatic discharge of bulk solid into the silo, and resulted from a blocked filter. The filter was crude, a hessian sack tied over the bottom of a vertical pipe down the side of the silo. This had functioned for some time but the dust had gradually built up inside the sack, unseen from the outside, until it blocked the fabric and caused the silo to overpressurise. The over-pressure relief valve, in common with many used on silos, was not large enough to vent the volume of air delivered by the wagon blower.

There is comprehensive guidance available on avoiding such a hazard [iii], however experience shows that this type of occurrence remains quite common because of lack of implementation of the recommendations therein.

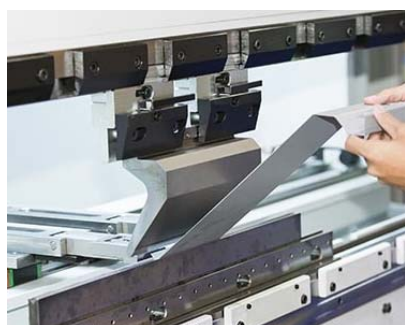
Investigation of the total collapse of a 200 tonne grain bin after 20 years of service revealed a fatigue failure in the sheet along a bend at the top edge of a cone segment, just below the joint to the barrel. The typical signs of metal fatigue were present – a significant part of the fracture area was dirty and corroded where the crack had developed and slowly grown, until the remaining area of sound metal could no longer support the load and failed in direct tension. The inevitable progressive failure occurred, with the cone tearing completely off the silo and the sudden down-movement of the contents sucking in the barrel above.

The cause of the cracking was obvious on the recovered parts – the bend had been made with a sharp-edged tool in the press-brake instead of a radiused tool, leaving a score-line in the surface of the sheet which initiated the crack.

Figure 15 Bending Sheet on a Press-Brake; the Tool Edge Should be Radiused, Not Sharp

This is such a fundamental manufacturing error; the author remembers, as a 15 year-old apprentice being first instructed in the use of the press-brake, always to respect the necessary bend radius by means of a protector over the sharp edge of the tool. This demonstrates graphically how inadequate training of craftspeople, and inadequate inspection of workmanship prior to sign-off of QC in the shop, can lead to small but important detail problems in turn causing major and potentially fatal accidents. Such critical issues need to be identified, and checked in manufacturing QC.

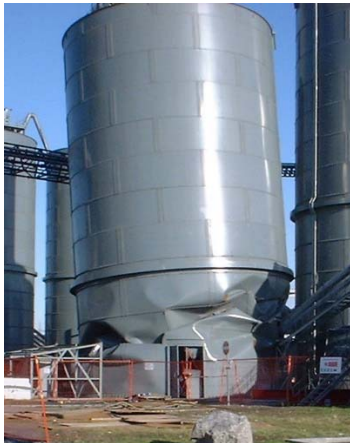
Skirt-supported silos present an interesting challenge to the designer; unlike the silo barrel, the skirt is not held in shape by the radial pressure of the bulk solid, so any small imperfections can greatly increase its susceptibility to buckling. Any uneven support of the skirt also brings great danger, not accounted for in codes, and the inevitable need for access doors to get to equipment under the cone, only makes the problem worse.

Figure 16 Steel silo with buckled unstiffened skirt

The advice of this author is that unstiffened skirts should be avoided on all but small silos, due to the unknowns involved in buckling. Even for small silos, if they stand on load cells, unstiffened skirts are a risk unless they have a very stiff circular beam around the bottom that distributes the load evenly around the skirt. Vertical stiffeners should be used, that should reach at least up to the ring beam at the hip, designed to act as fully

supporting legs in their own right (braced where necessary) so the skirt has no other role than to keep the weather out of the space beneath the silo. Where stiffeners are welded on, they should always be stitch-welded (ie discontinuous welds) so that the shrinkage stresses can dissipate in the spaces between the welds. Sealing against water ingress is required, to avoid corrosion.

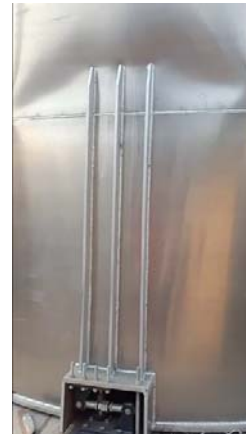
Figure 17 Aluminium silo on load cells, with buckle above stiffeners

Weld distortion can also make the situation worse, not only by introducing critical imperfections in the shape of the skirt, but also building in stresses. In the case of the aluminium silo in fig. 17, it was standing on three load cells so the designer was aware of the uneven load distribution that could cause problems with the skirt. His solution was to weld vertical stiffeners to the skirt above the load cell positions to distribute the load up the skirt. However, there were a number of problems with these. First, the stiffeners were continuously welded, meaning that shrinkage introduced a very high vertical compression in the skirt locally, thereby concentrating the vertical load into areas around the top of the stiffeners. Secondly, the stiffeners did not reach up to the hip but stopped at an unstiffened position part way up the skirt, where the sheet of the skirt could easily distort inwards or outwards with little restraint.
