Effect of water temperature and induced acoustic pressure on cavitation erosion behaviour of aluminium alloys

To appear in: *Tribology International*

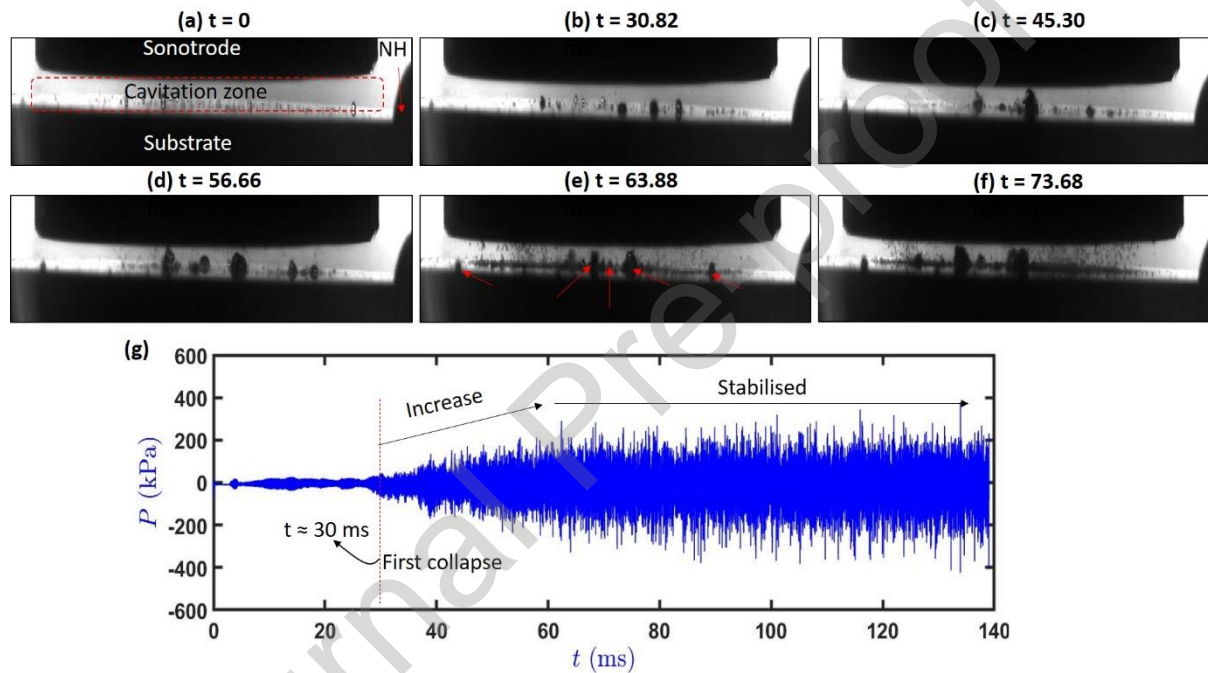
Fig. 5 Sequence of high-speed images (a-f) of the cavitation activity occurring between the horn and the specimen separated at 30°C. The synchronised acoustic pressure (g) is obtained from the generated cavitation emissions measured using NH.

explained in Fig. 5(a-f) with microbubble clusters pulsating and imploding repeatedly at specific (favourable) locations, for example, regions exhibiting high porosity in A356.2 (Fig. 2b) thus weakening those regions and eventually initiating damage.

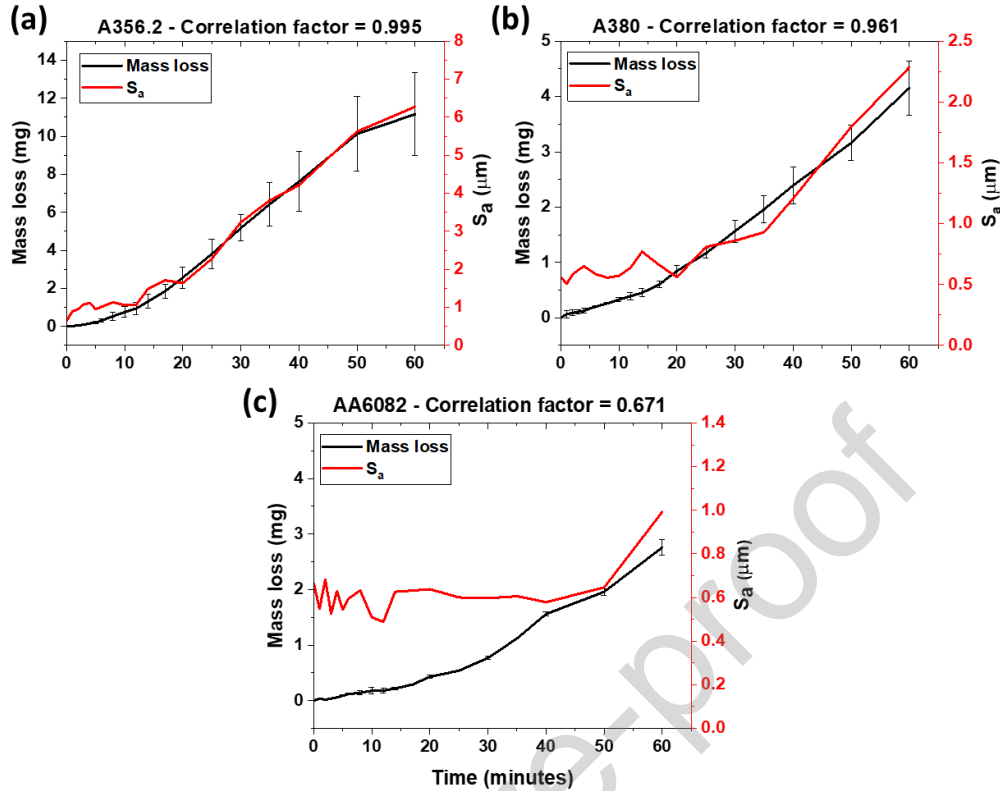
Fig. 6 Results of cavitation exposure at 30°C on the variation of mass loss and its correlation with surface roughness measurements (S_a) with respect to exposure time for different Al alloys.

After identifying the temperature response to erosion and noting that bulk temperature close to 30°C contributes to maximum erosion for as-cast alloy specimens, we now compare their mass loss and surface roughness profile measured in terms of S_a with an extruded AA6082 alloy at this temperature. This alloy represents an alternative way of manufacturing through deformation and machining. Fig. 6(a-c) shows the cumulative mass loss and change in S_a against different exposure time for each tested Al alloy. As expected, after 1 hr of cavitation exposure, the surface roughness of all specimens tends to increase along with the mass loss. Interestingly, for the as-cast A356.2 (Fig. 6a), the mass loss showed a strong correlation with

S_a curve with short incubation period interval having correlation coefficient of 0.995, demonstrating its poor erosion resistance as compared to the A380 alloy (Fig. 6b), which seemed to show a relatively longer incubation period of approximately 20 minutes in terms of S_a value in comparison to the mass loss, with the correlation coefficient of 0.961. It is interesting to note that after 1-hr exposure, the eroded mass for the extruded AA6082 alloy was almost 4 times lower compared to the worst performing alloy, i.e. A356.2. The extruded AA6082 alloy (Fig. 6c) also showed an almost negligible correlation of S_a with mass loss with the longest incubation period of almost 40 minutes signifying its strong erosion resistance. It can be seen that after 40 min of cavitation exposure, the trend for mass loss and S_a are pretty much similar in all Al alloys meaning an extended cavitation exposure would result in even higher correlation coefficient, almost tending towards unity.

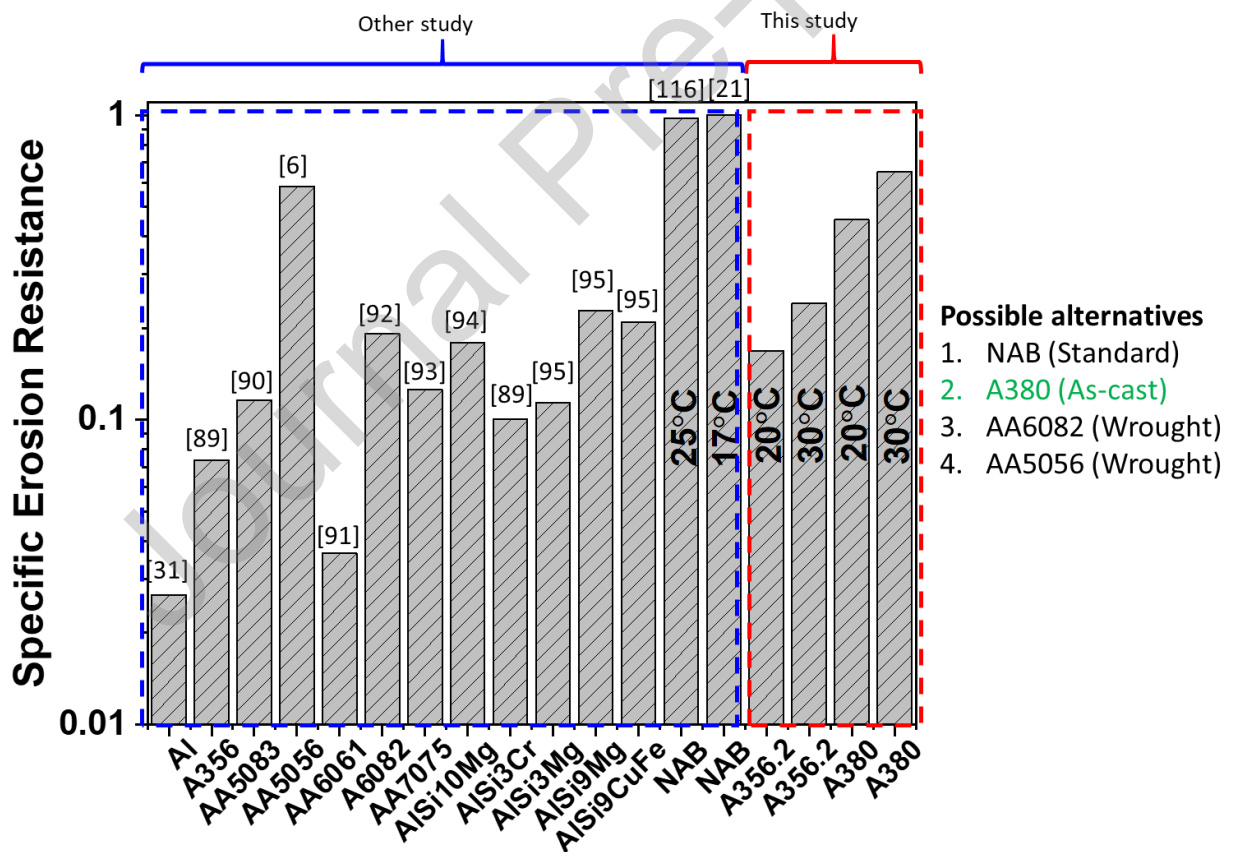
Fig. 8 Comparison of specific erosion resistance of Al alloys with extruded AA6082 and standard NAB obtained after 1 h of exposure.

cast alloys used in our study was estimated based on the least and most aggressive erosion environments near 20°C and 30°C, respectively. In contrast, erosion resistance for alloys not included in our study was estimated solely at ambient temperature conditions (refer to Table A in appendix). Therefore, the comparison in such cases can only be made in terms of exposure time and not temperature. For instance, the erosion response of AA5056 was assessed at 22°C, while for NAB it was $17 \pm 0.5^\circ\text{C}$. Thus, it is highly likely that both these alloys will exhibit significantly lower resistance under aggressive erosion conditions near 30°C. There is even a possibility that A380 and extruded AA6082 may outperform AA5056 and NAB under such conditions making it a more suitable candidate for use in manufacturing critical marine components. It should be noted that this ranking is made solely based on the erosion characteristics (which is the focus of this paper), while other properties such as corrosion resistance should be also taken into account in the materials selection (but this is outside the scope of this study).

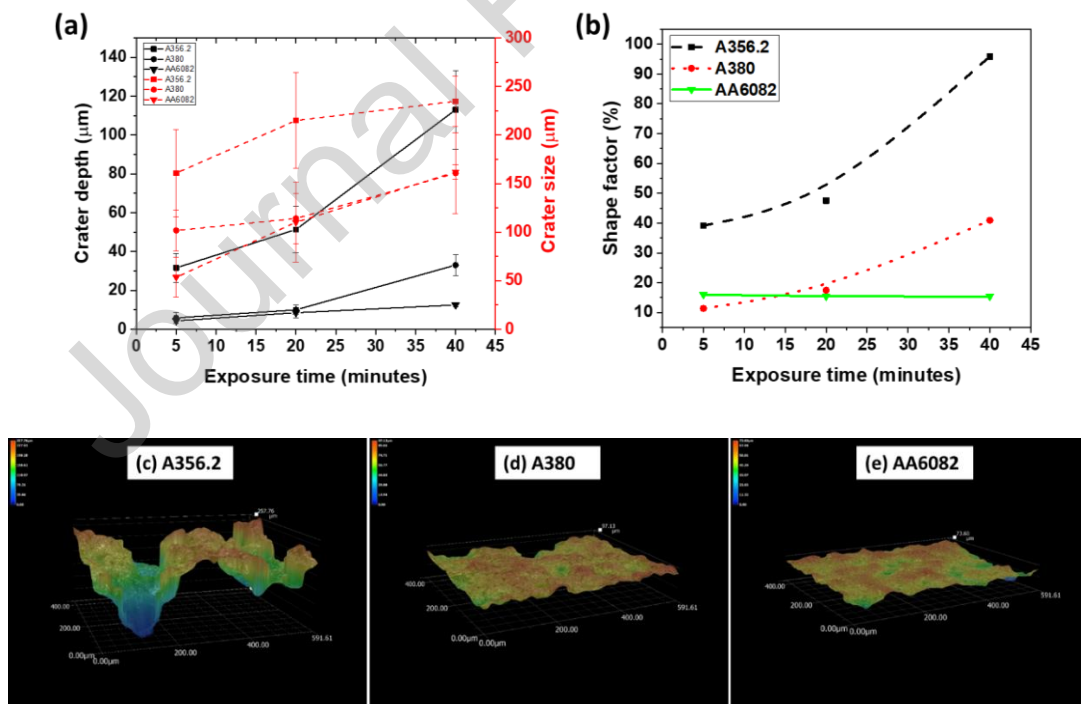
Fig. 10 (a) Evolution of crater showing its mean depth and size of the damaged surface after erosion tests; (b) Normalised shape factor (ratio of crater depth to diameter) as a function of cavitation exposure time for different Al alloys; (c-e) An indicative example showing 3D scan micrographs of the studied Al alloys obtained after 60 minutes of exposure.

The severity of erosion sustained at this aggressive temperature regime was also quantified based on the average crater depth and size obtained from the 3D scan microscopic images. Figure 10a shows the plot of depths and size (in microns) of formed craters for each alloy at different cavitation exposure period. As it can be seen, for all alloys the crater depth and size increases with the cavitation exposure time. The evolution of crater depth was rather rapid for the A356.2 alloy until 20 minutes of exposure; in contrast to the A380 and extruded AA6082 alloys where the cavitation was still in its incubation stage. The evolution rate of crater size (equivalent diameter, see double sided arrow in Fig. 9a) was comparatively similar and independent of the cavitation incubation or acceleration stage for all alloys. Overall, the crater depth and size for each alloy increased by approximately 3 to 6 times and 1 to 3 times, respectively, after 40 minutes. In order to find the influence of cavitation on the relative surface damage, we plotted shape factor (defined as the normalised ratio of crater depth to diameter) against cavitation exposure time as shown in Fig. 10b. During initial stages of exposure, the A356.2 alloy exhibited shape factor of almost 40%, about 2-3 times higher than other alloys. Among cast alloys, A380 showed best resistance to surface degradation. It is interesting to see that shape factor increases with erosion time for all alloys except extruded AA6082, for which

it showed a decreasing trend. This unique behaviour can be ascribed to the specific combination of mechanical and microstructural properties inherent to AA6082. These inherent characteristics likely played a pivotal role in shaping the erosion pattern evolution over time. While the craters did undergo deepening and expansion, the alloy's inherent mechanical robustness could have induced a distinct alteration in the progression of crater morphology, ultimately leading to the observed decrease in the shape factor. Figure 10(c-e) shows the representative 3D scan microscopic images of the all the studied alloys, obtained after 60 minutes of exposure. The large crater dimension observed in case of as-cast A356.2 alloy maybe related to the presence of shrinkage porosity and large equiaxed grains (see Fig. 2b), which provided locations of weakness and vulnerability for erosion initiation. In addition, the heterogeneous distribution of phases and the presence of non-equilibrium eutectics at the dendrite boundaries acted as preferential sites for the formation and violent collapse of cavitation bubbles. With prolonged cavitation exposure, removal of secondary and eutectic phases such as hard and brittle Si particles occurred through rim necking and dislodgment, thereby contributing to the formation of large craters and undulations on the surface [36,99,100].
