# **THATCHING IN CAMBRIDGESHIRE**

**CHRISTOPHER PAUL STANFORD**

A thesis submitted in partial fulfillment of the  
requirements of the University of Greenwich  
for the Degree of Doctor of Philosophy

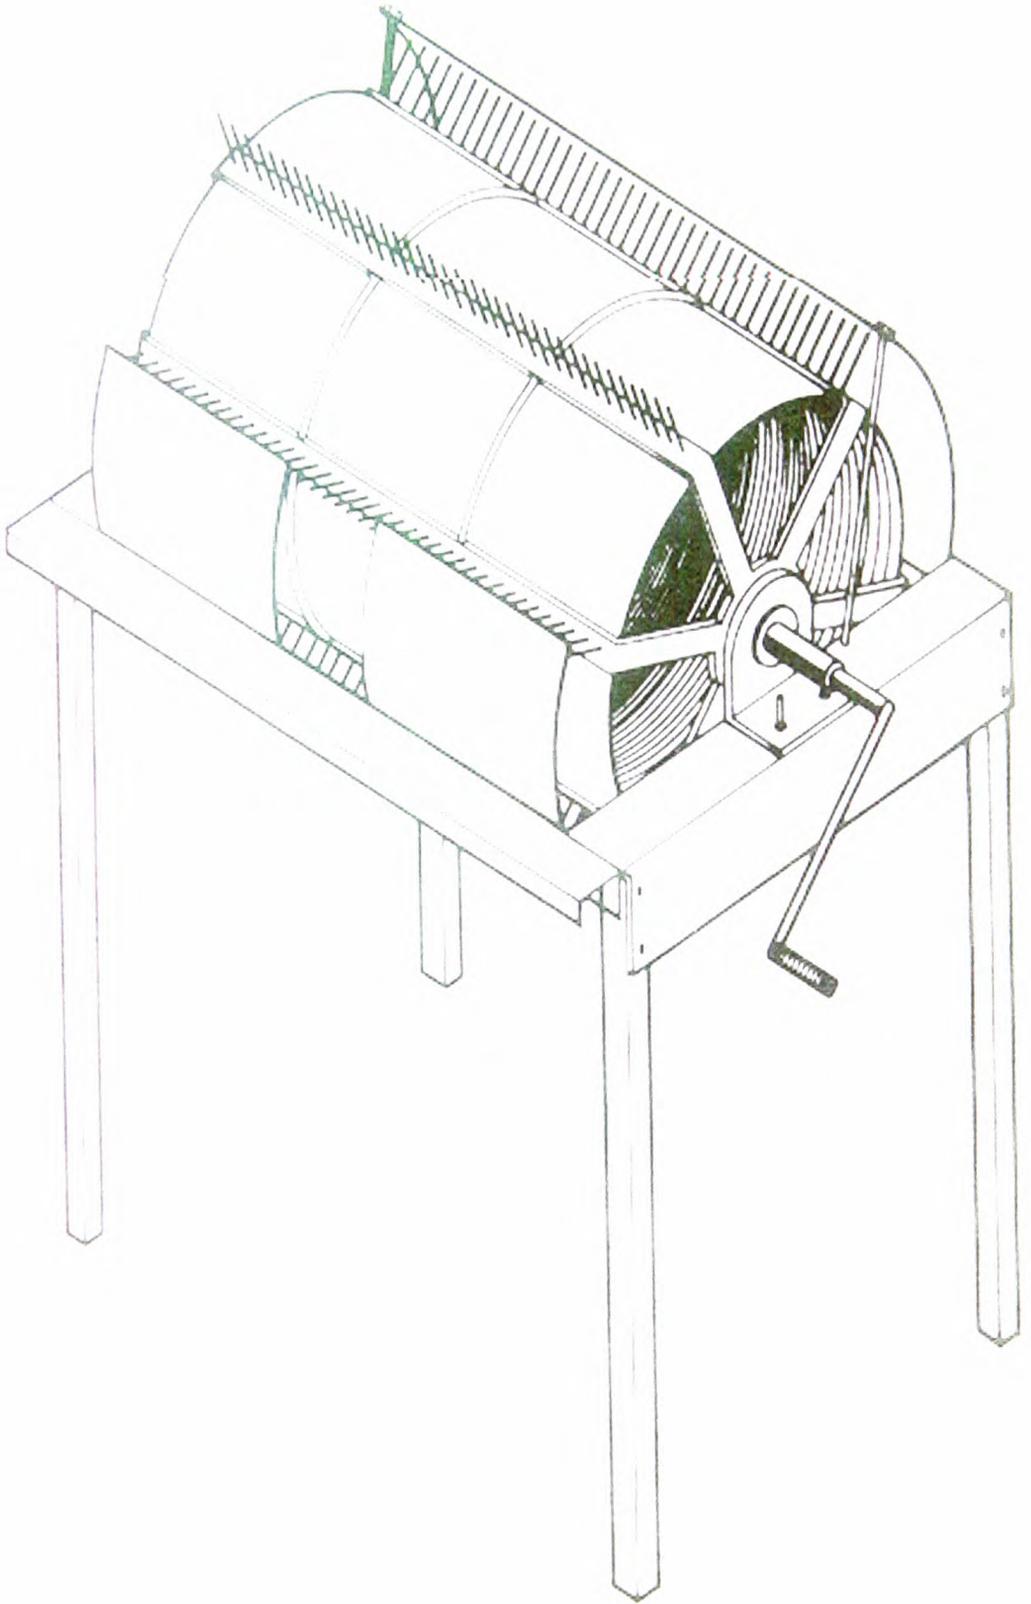
Illustration 1 – Combing drum, showing rows of iron teeth.

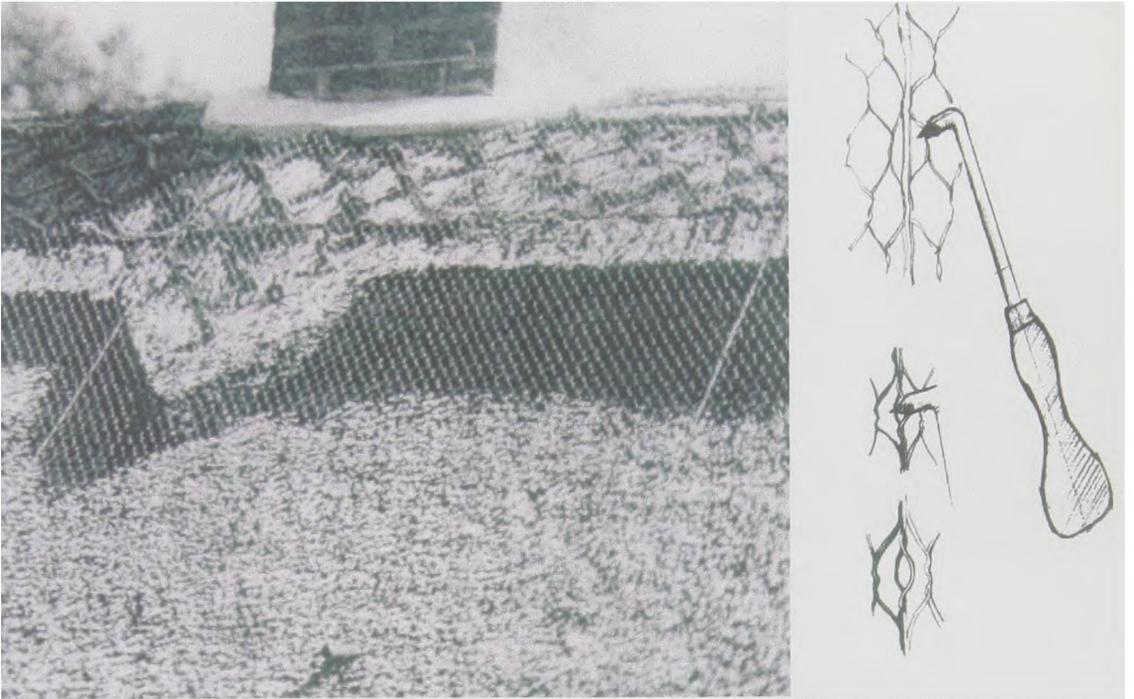
**Illustration 5 - Wire mesh and (insert) tool used to apply it**

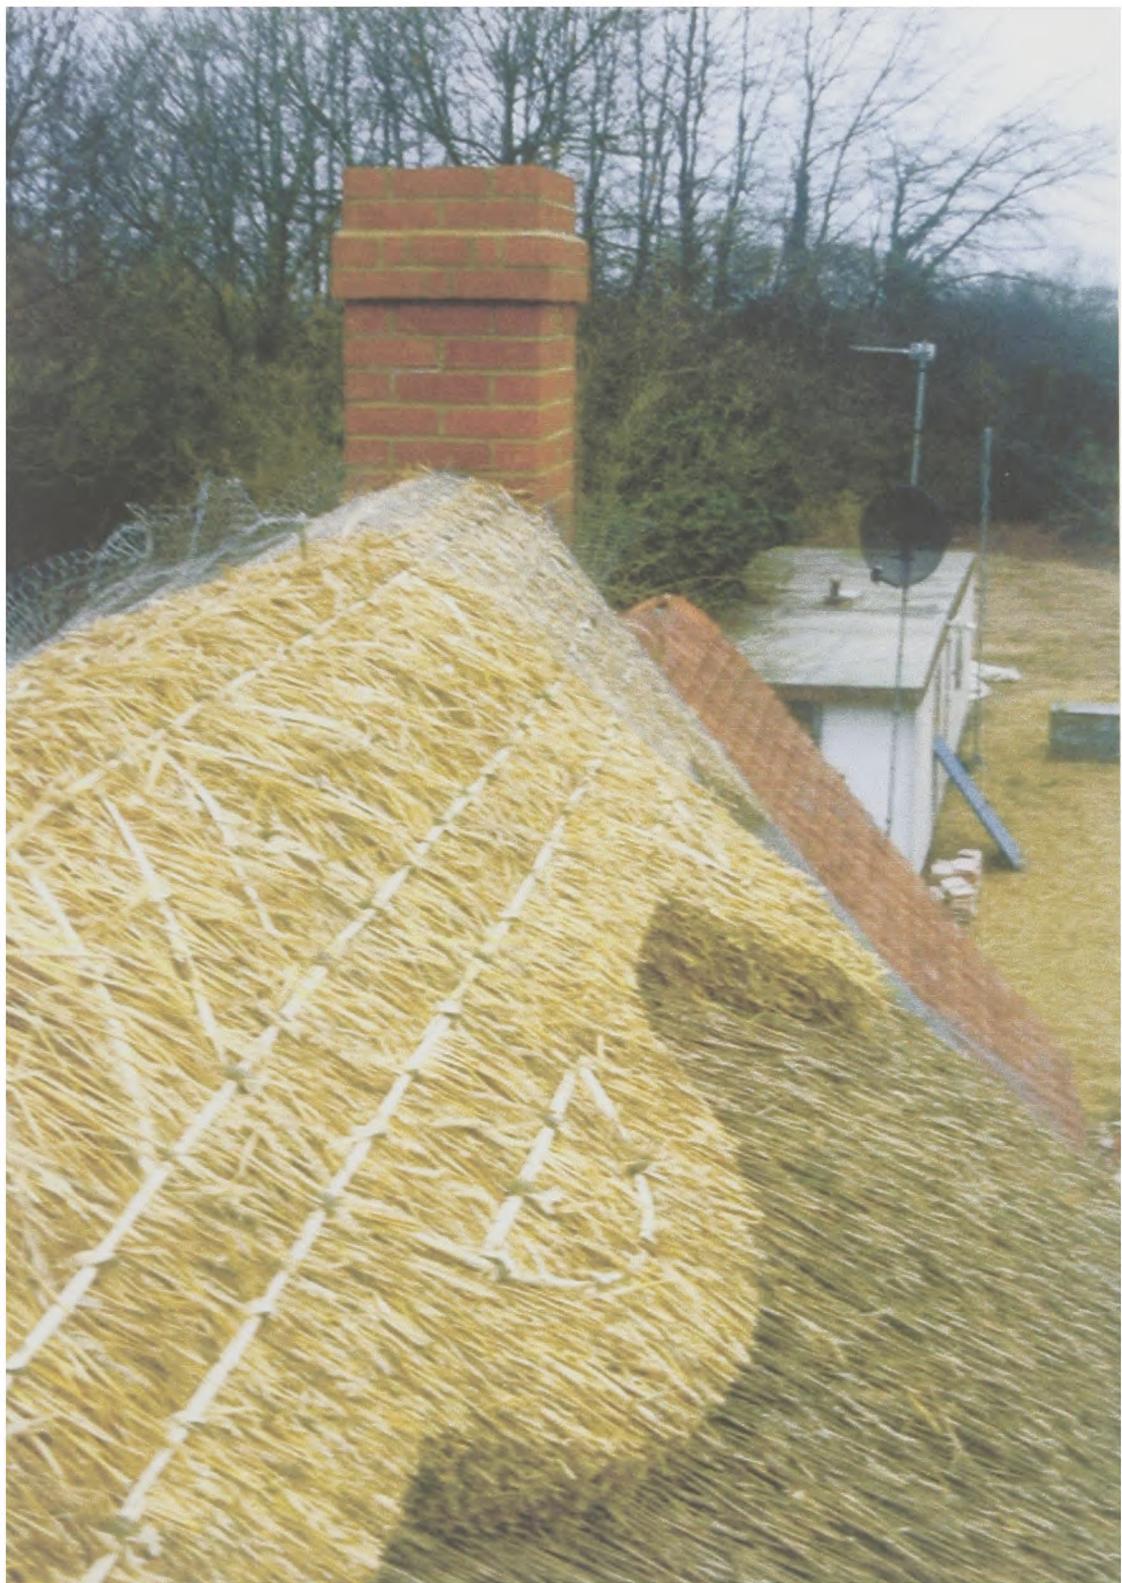
**Illustration 7 - Block cut ridge in long wheat straw at 41 Whitecroft Road, Meldreth (Me 02)**

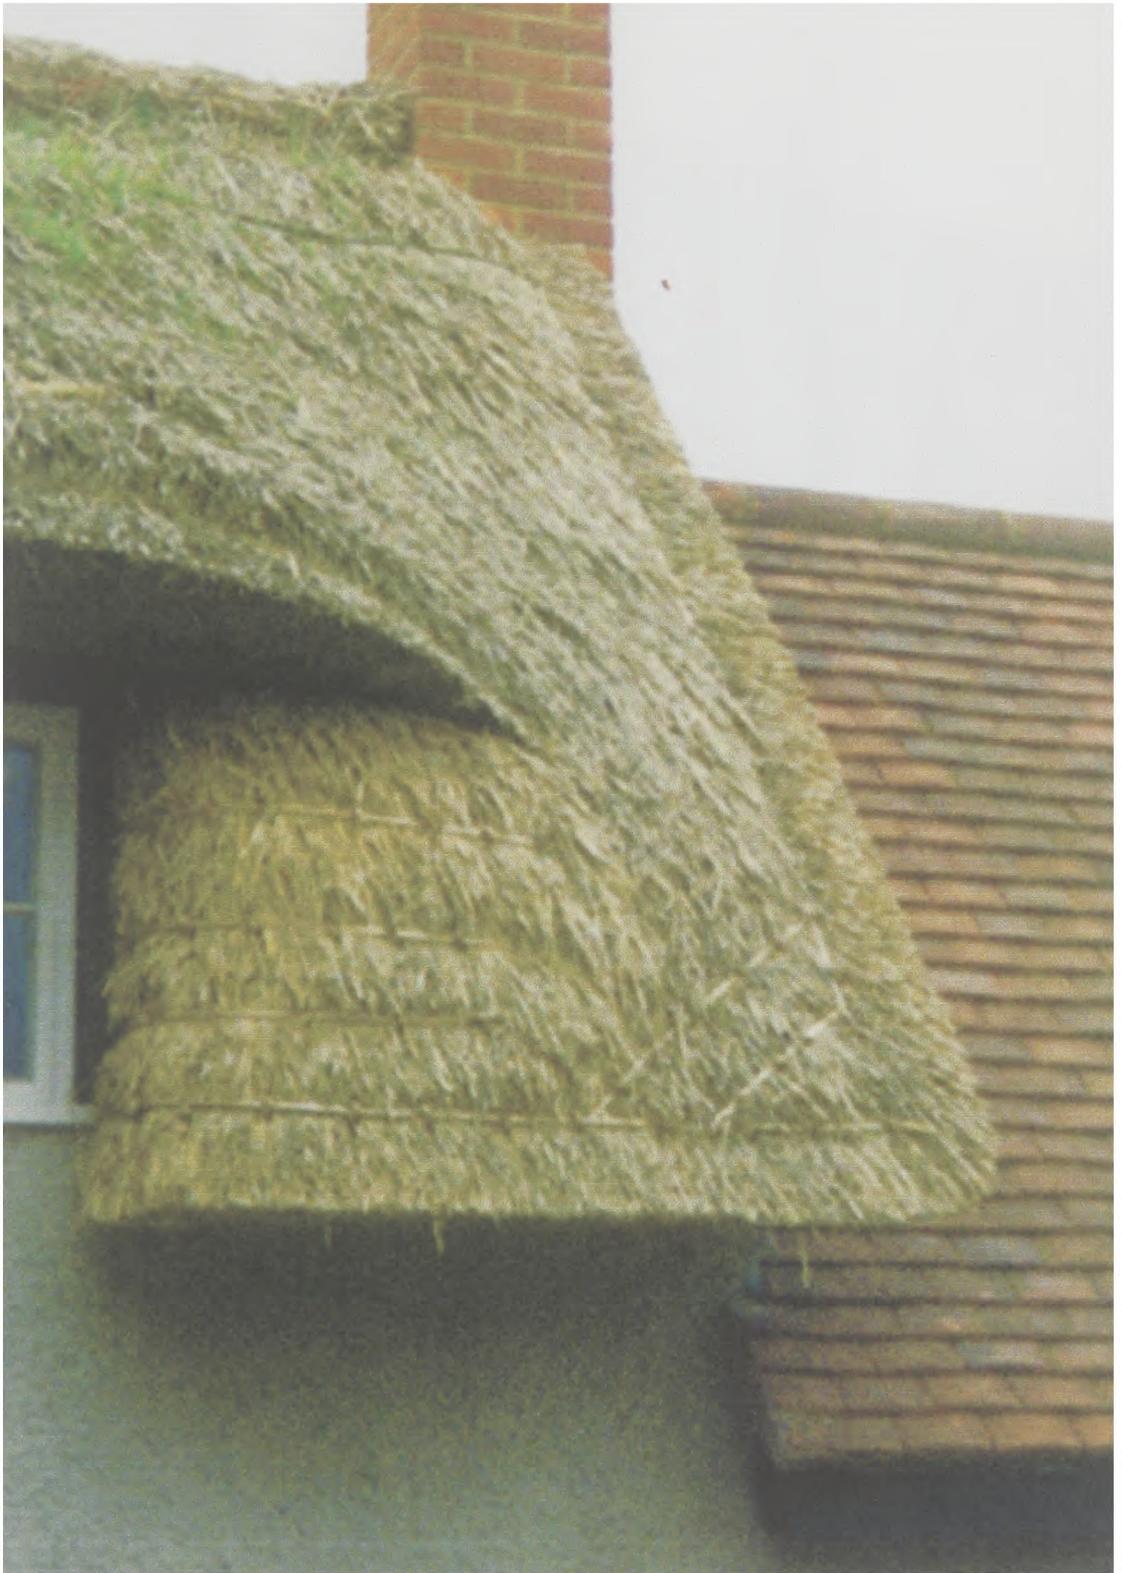
**Illustration 8 - Exposed liggers to the eaves and cheek of the eyebrow window at  
41 Whitecroft Road, Meldreth (Me 02)**

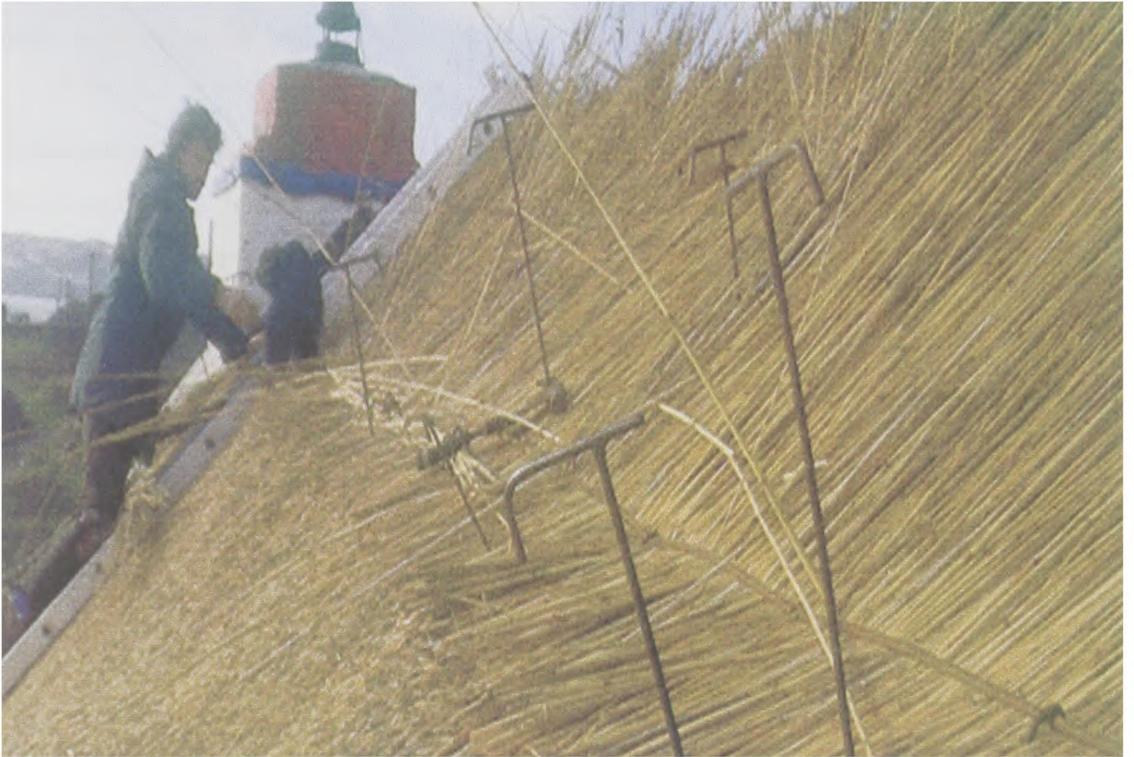
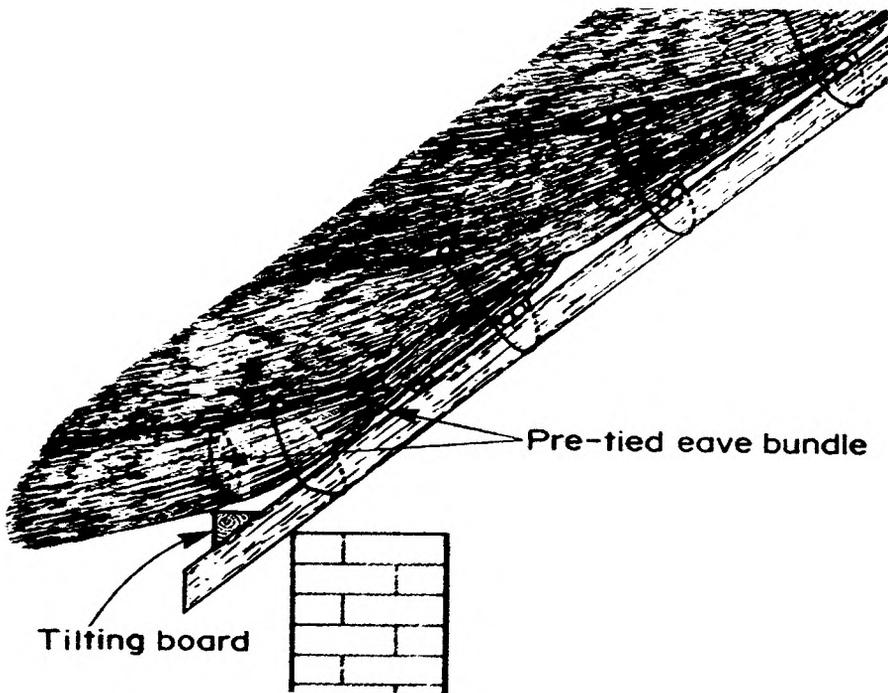
Illustration 15 - Water reed thatch being laid, and (below) diagram of how bundles of water reed relate to pitch of rafters

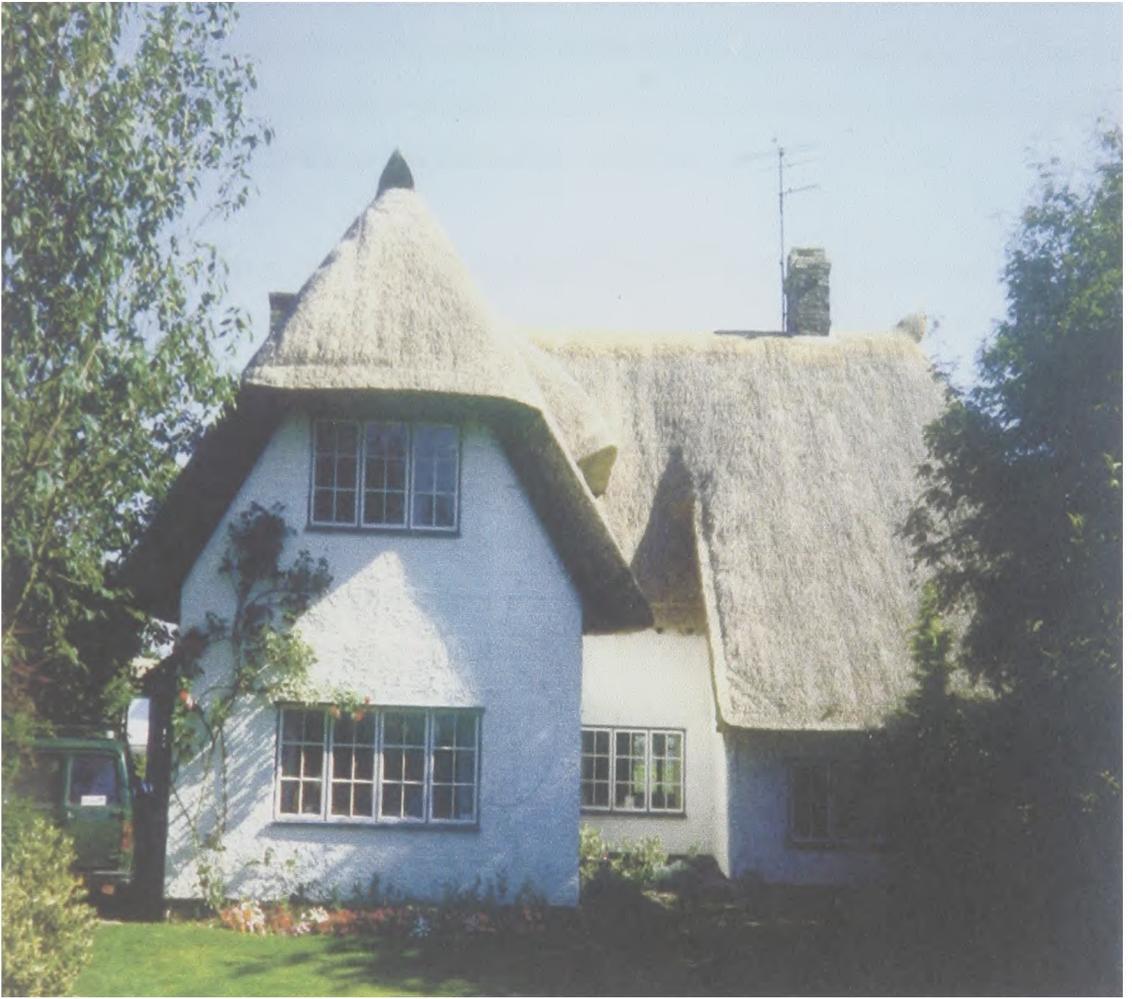
**Illustration 16 - A newly thatched long wheat straw roof at The West Green, High Street, Barrington (Ba 03), showing how the straw seems to have been poured over the bones of the structure**

The technique of thatching in long wheat straw has characteristics that can readily be distinguished from those of other thatching techniques. For instance, a roof thatched in long straw may be easily recognized from a considerable distance by the way in which the eaves and barges are invariably decorated with a pattern of liggers and cross rods. This distinctive feature is not shared by either of the thatching techniques used for combed wheat reed or water reed. A closer approach heightens the impression that the roof covering as a whole has simply been poured over the underlying structure, causing the angles to be rounded, as opposed to the more tailored, angular appearance of a roof thatched in combed wheat reed or water reed (see Ill. 16).

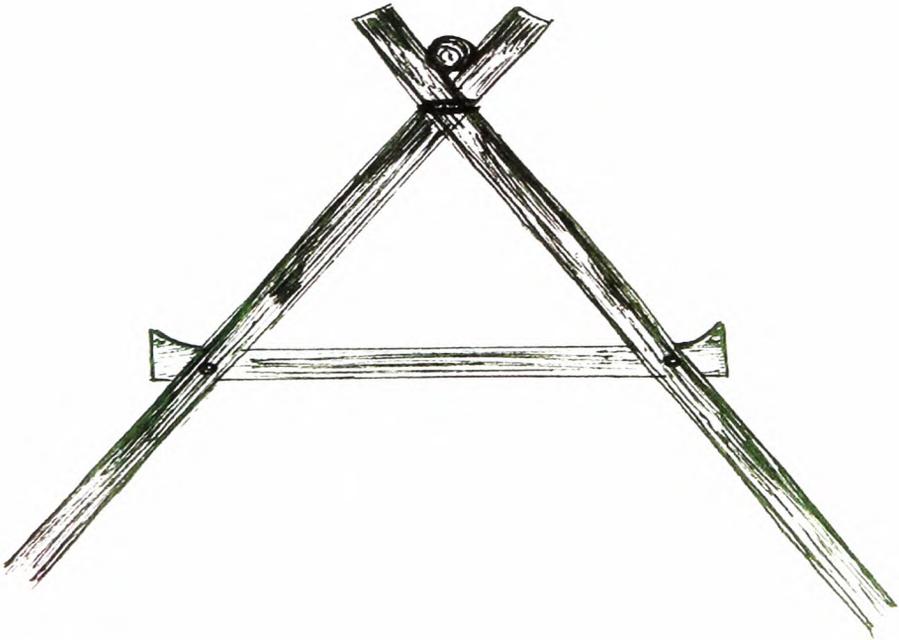
Illustration 18 - Diagram showing the crude hook-shaped collar found on some former peasant cottages

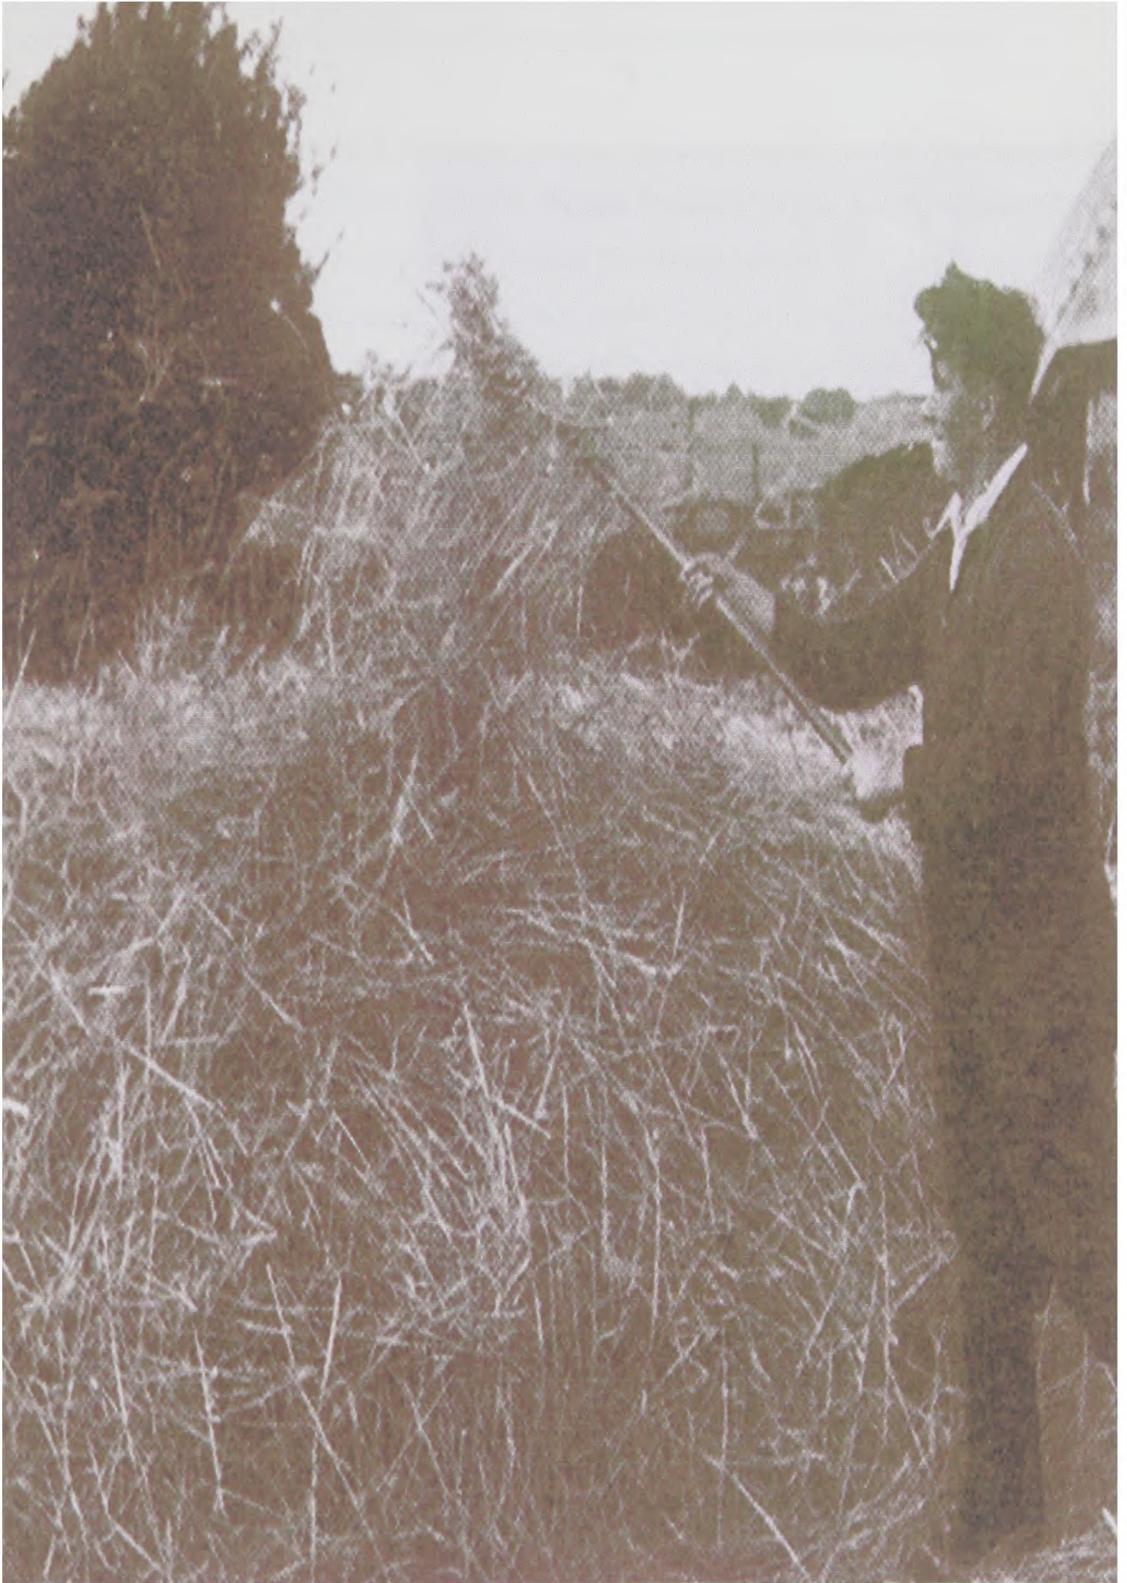
**Illustration 19 - Straw shaken into a heap forming a bed from which the yealms are drawn**

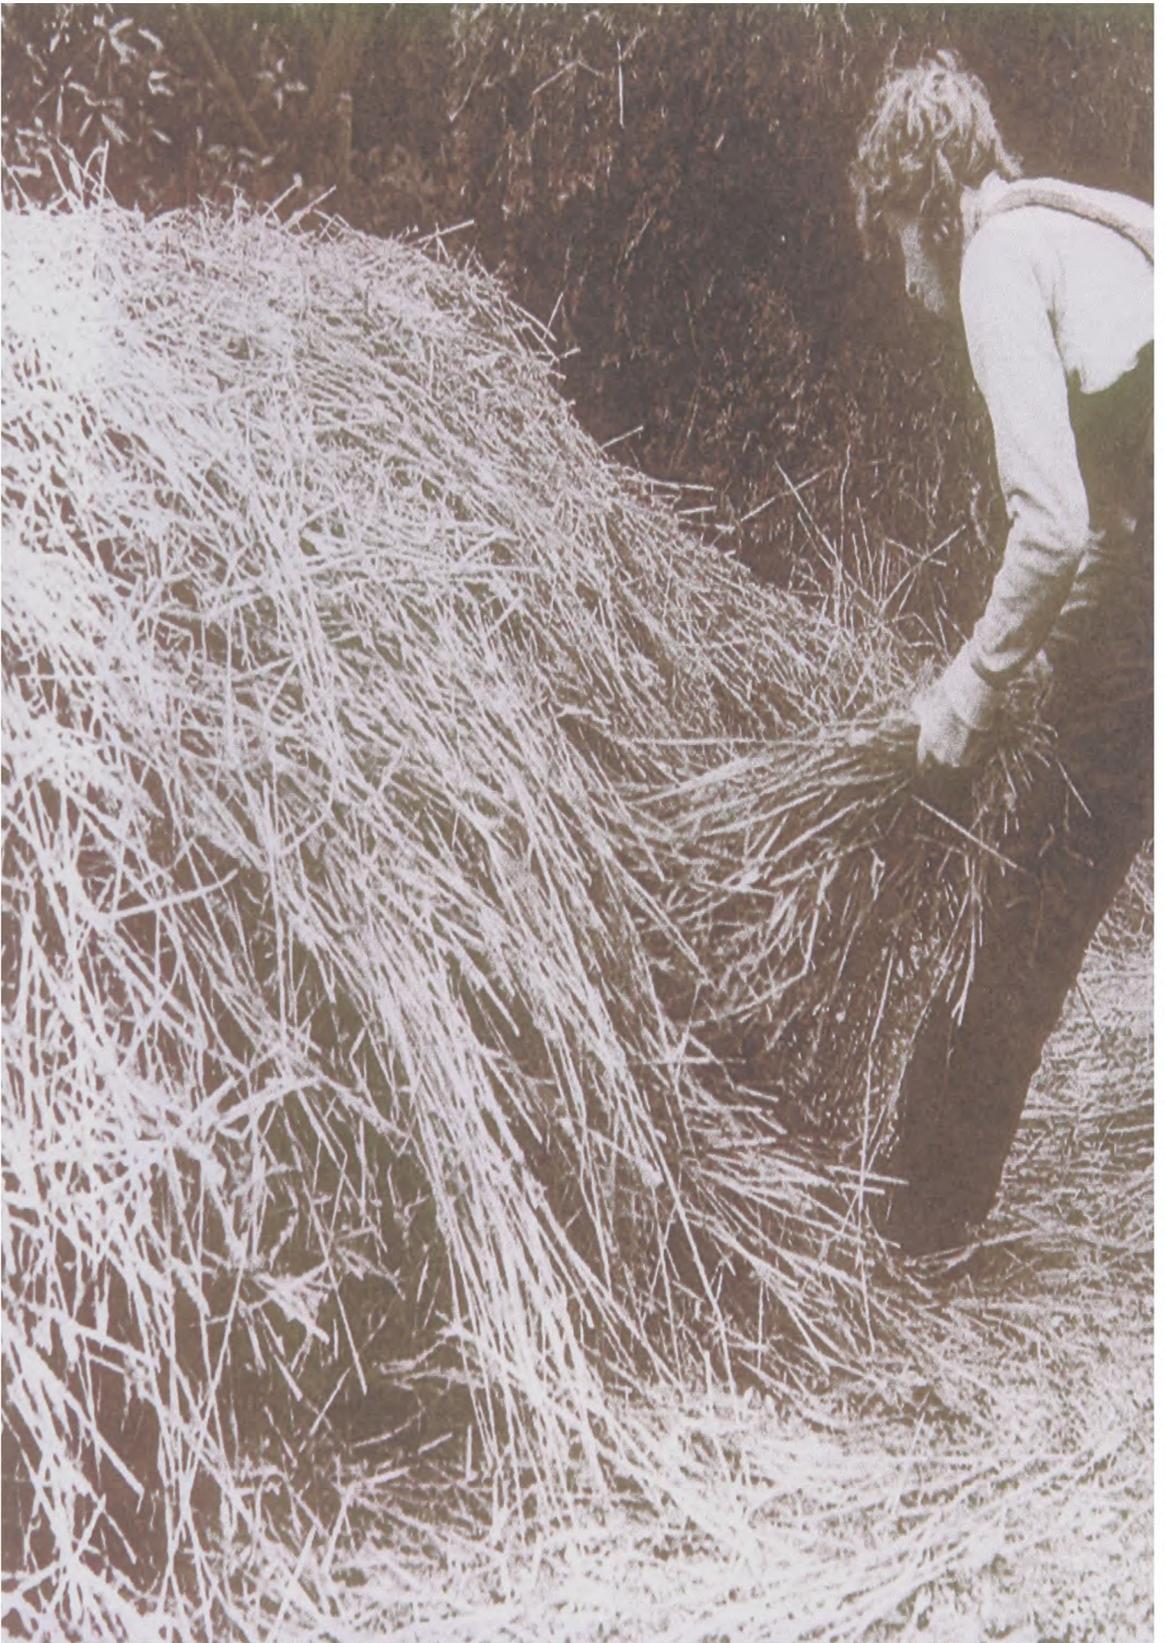
**Illustration 20 - A master thatcher drawing straw from a bed to form a yealm**

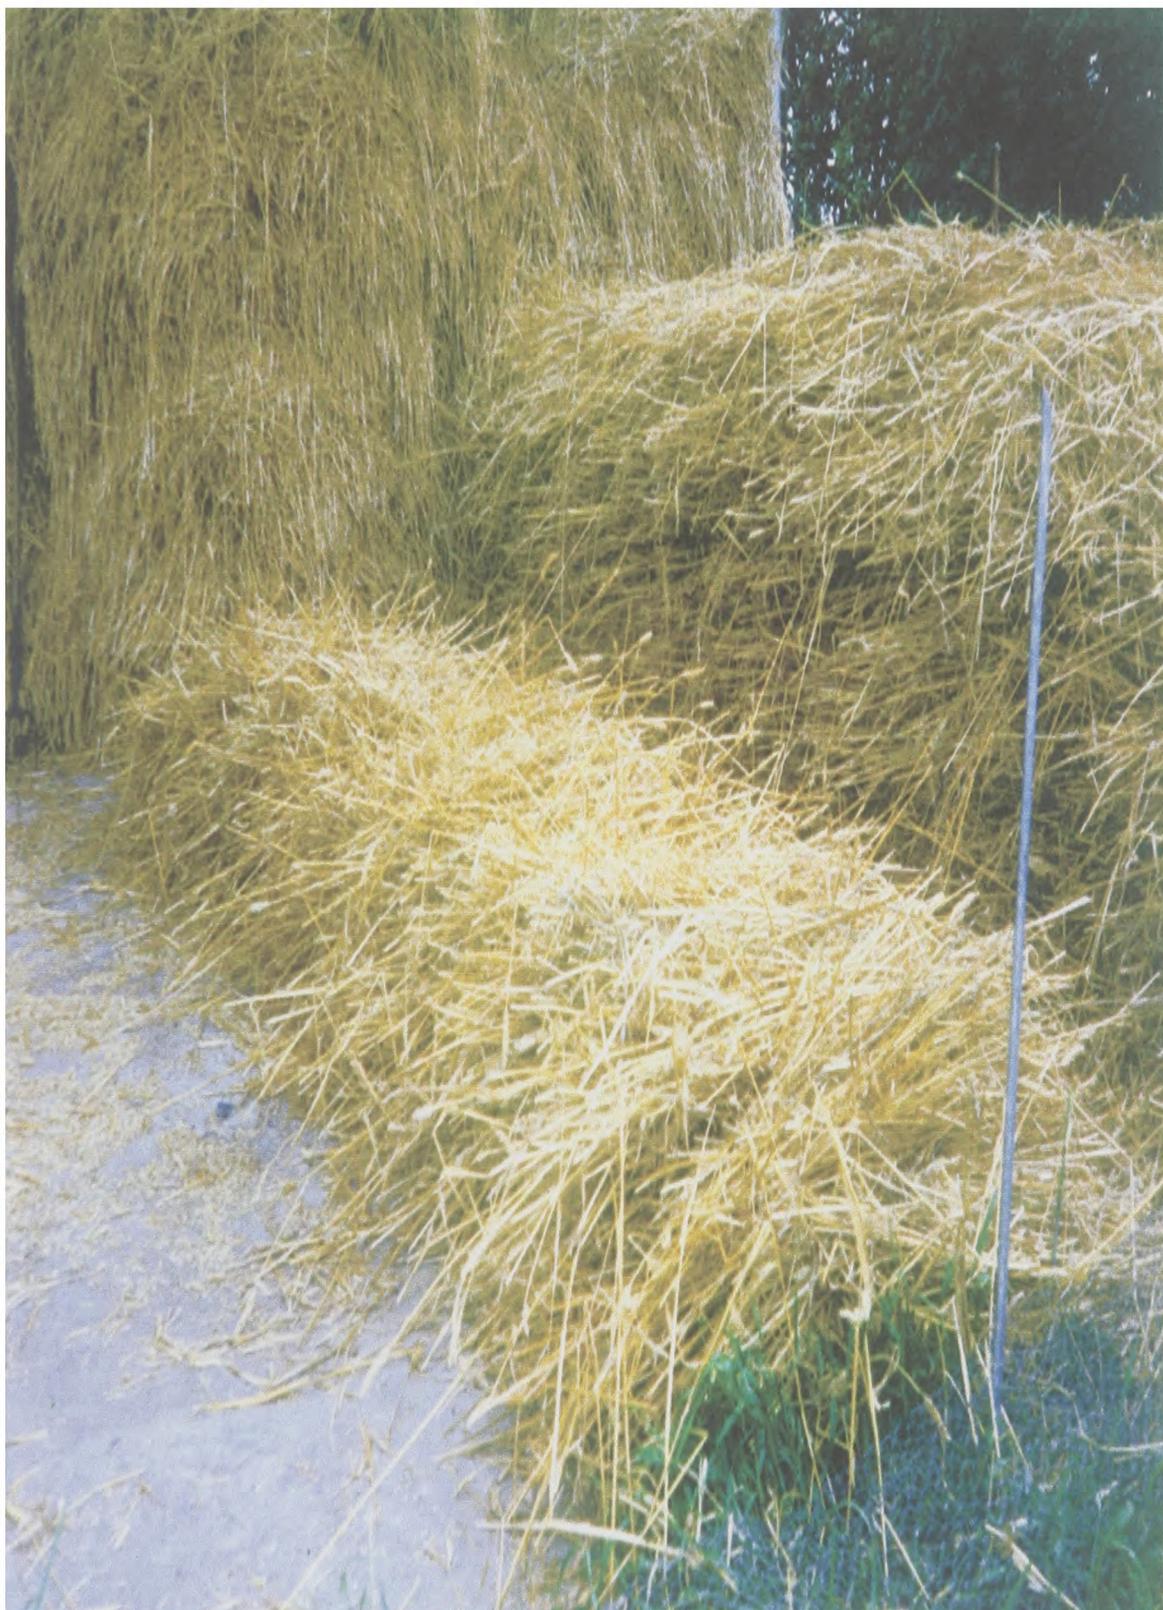
**Illustration 21 - A layer of straw, known as a yealm, after it has been drawn from the bed**

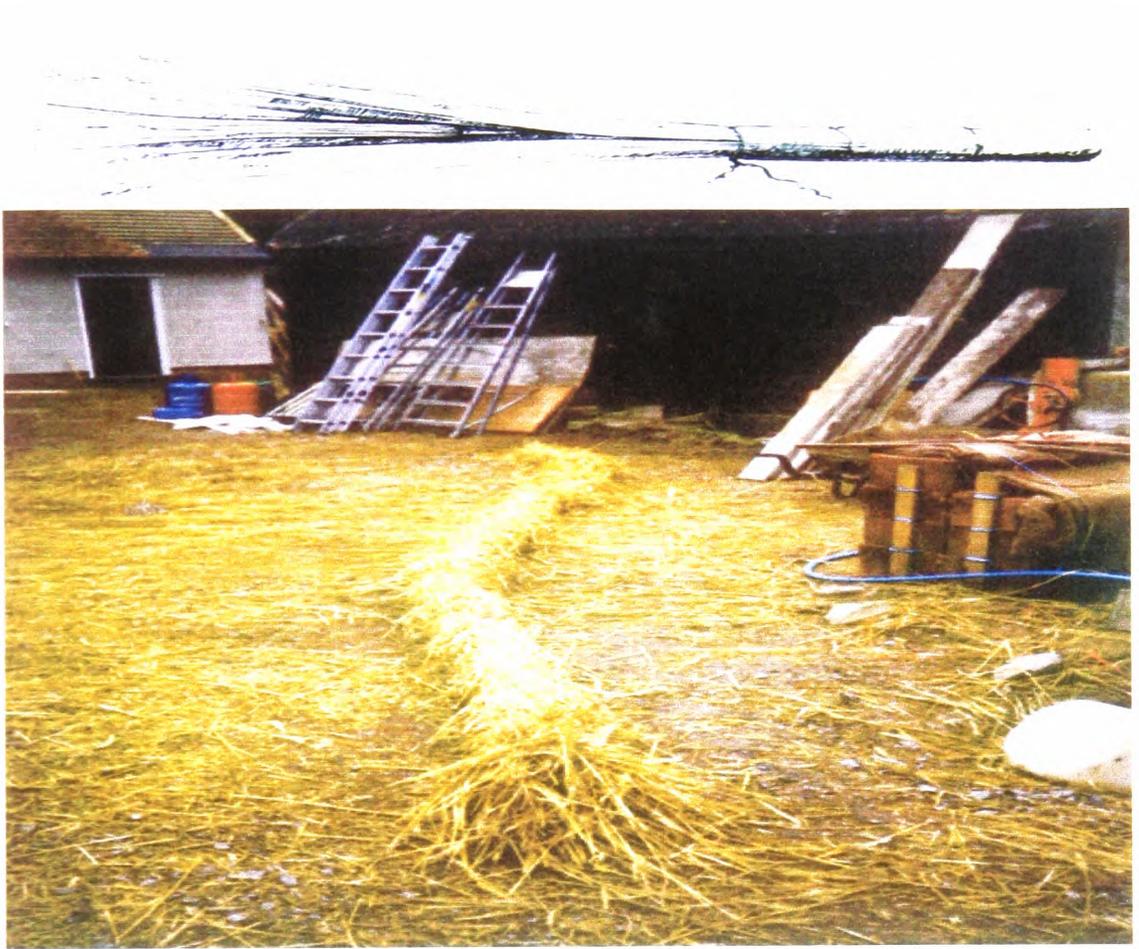
**Illustration 23 - Diagram (above) showing how a ridge roll is formed, and (below) a ridge roll before being secured to the roof**

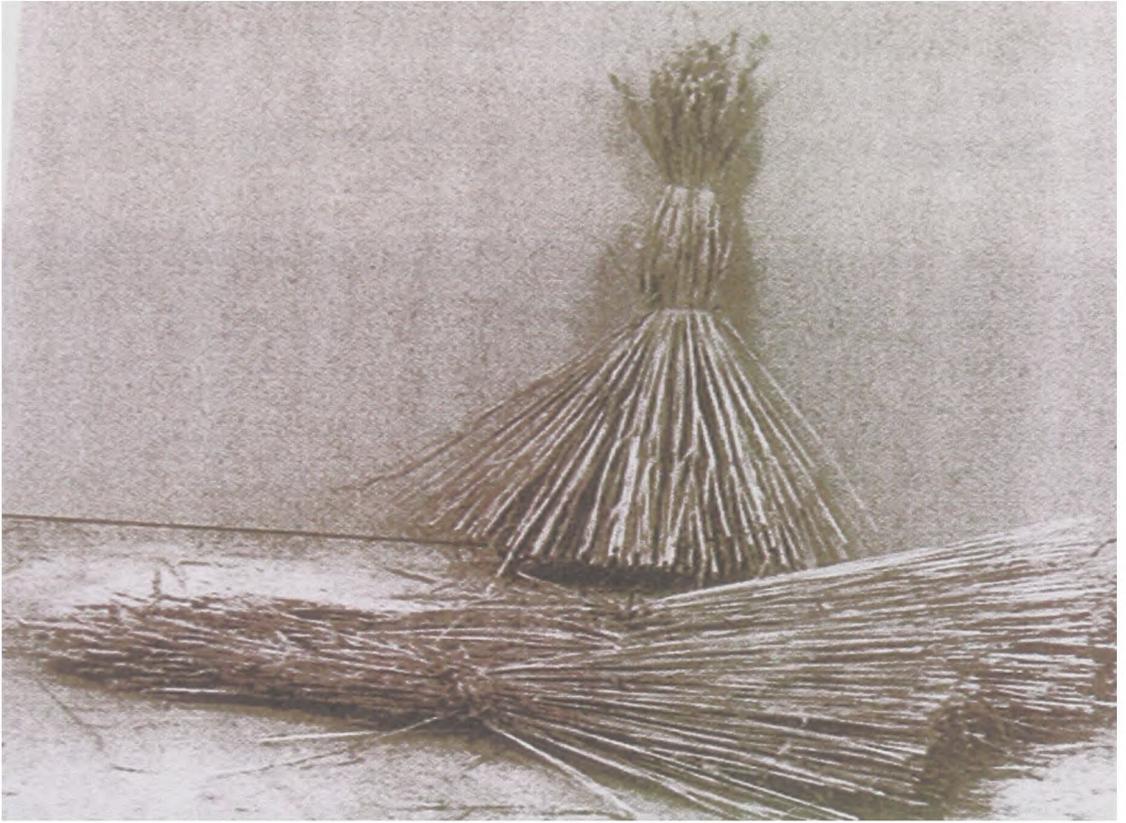
**Illustration 25 - Two bottles showing their exaggerated large ends**

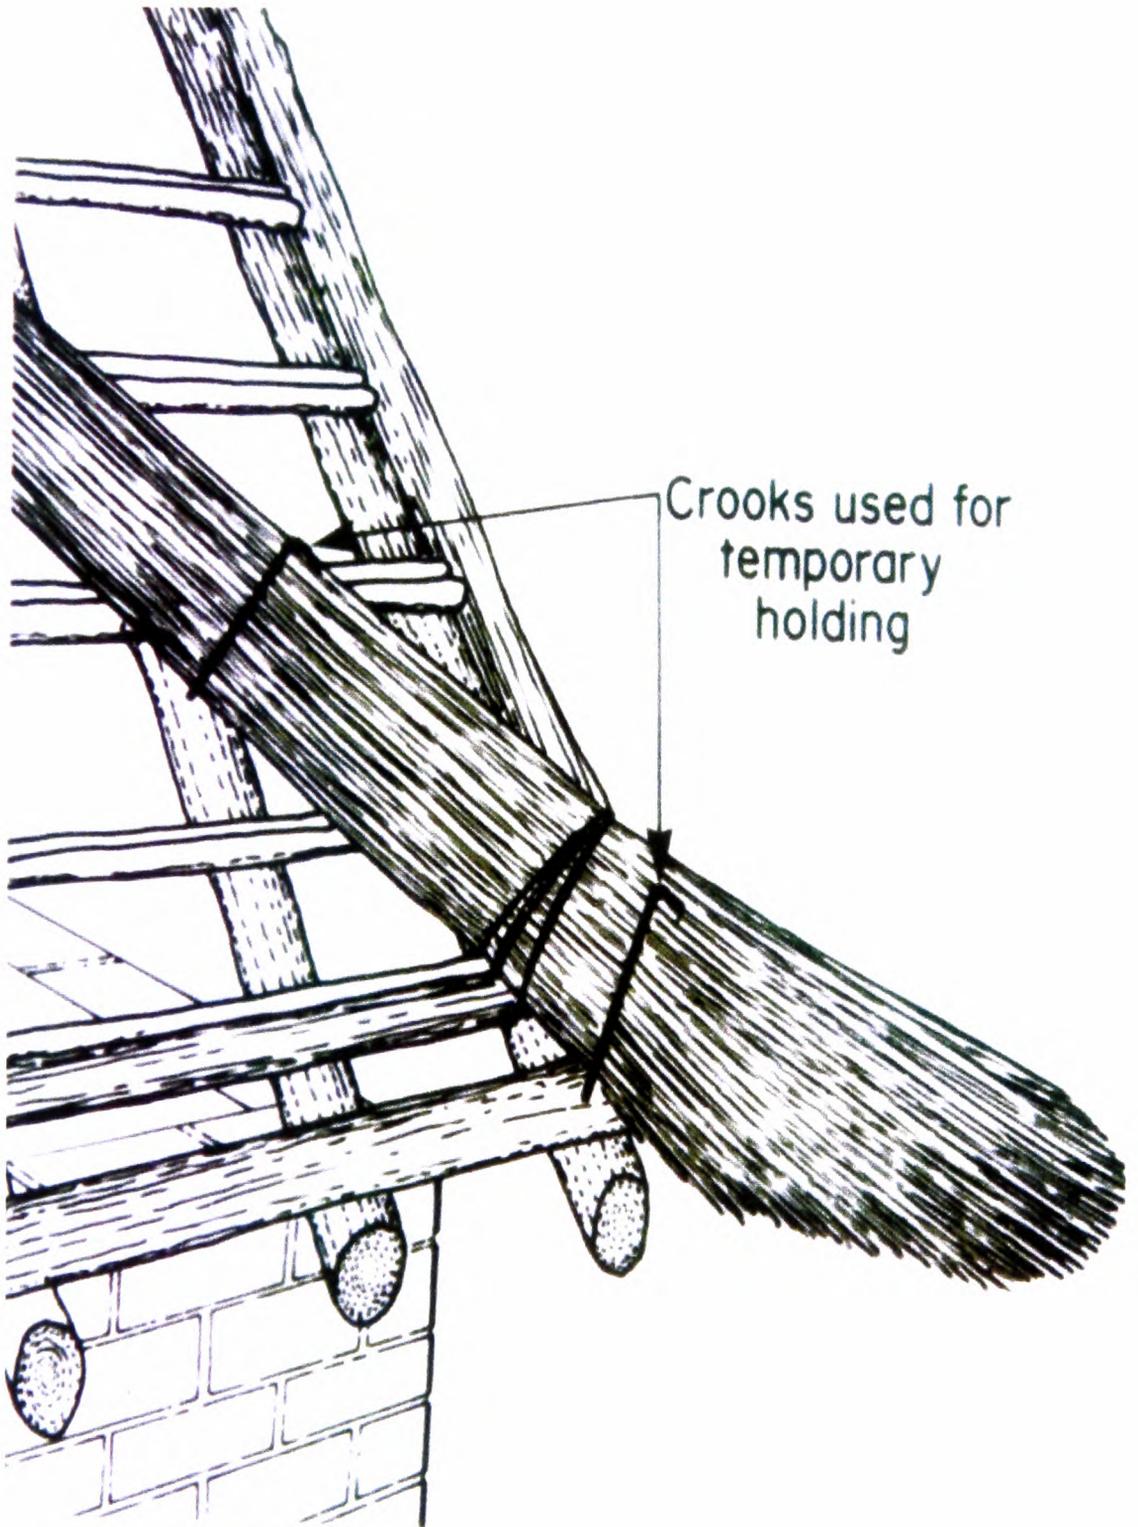
Illustration 27 - Diagram showing how a bottle is placed at 45 degrees to the eaves and barge

The main work on the roof starts at the eaves and progresses upwards. It begins by positioning a bottle at 45 degrees at the intersection of the eaves and the gable (see III. 27). A bottle is needed at eaves level, at every corner of the roof. Its purpose is to act as a kind of corner stone, setting the all-important angle at which the thatch will lie at the corner, both along the eaves and along the edge of the gable. Further bottles are then laid beside it along the first section of the eaves, their angle being decreased until they are vertical. A bottle is also needed on a hipped roof, in

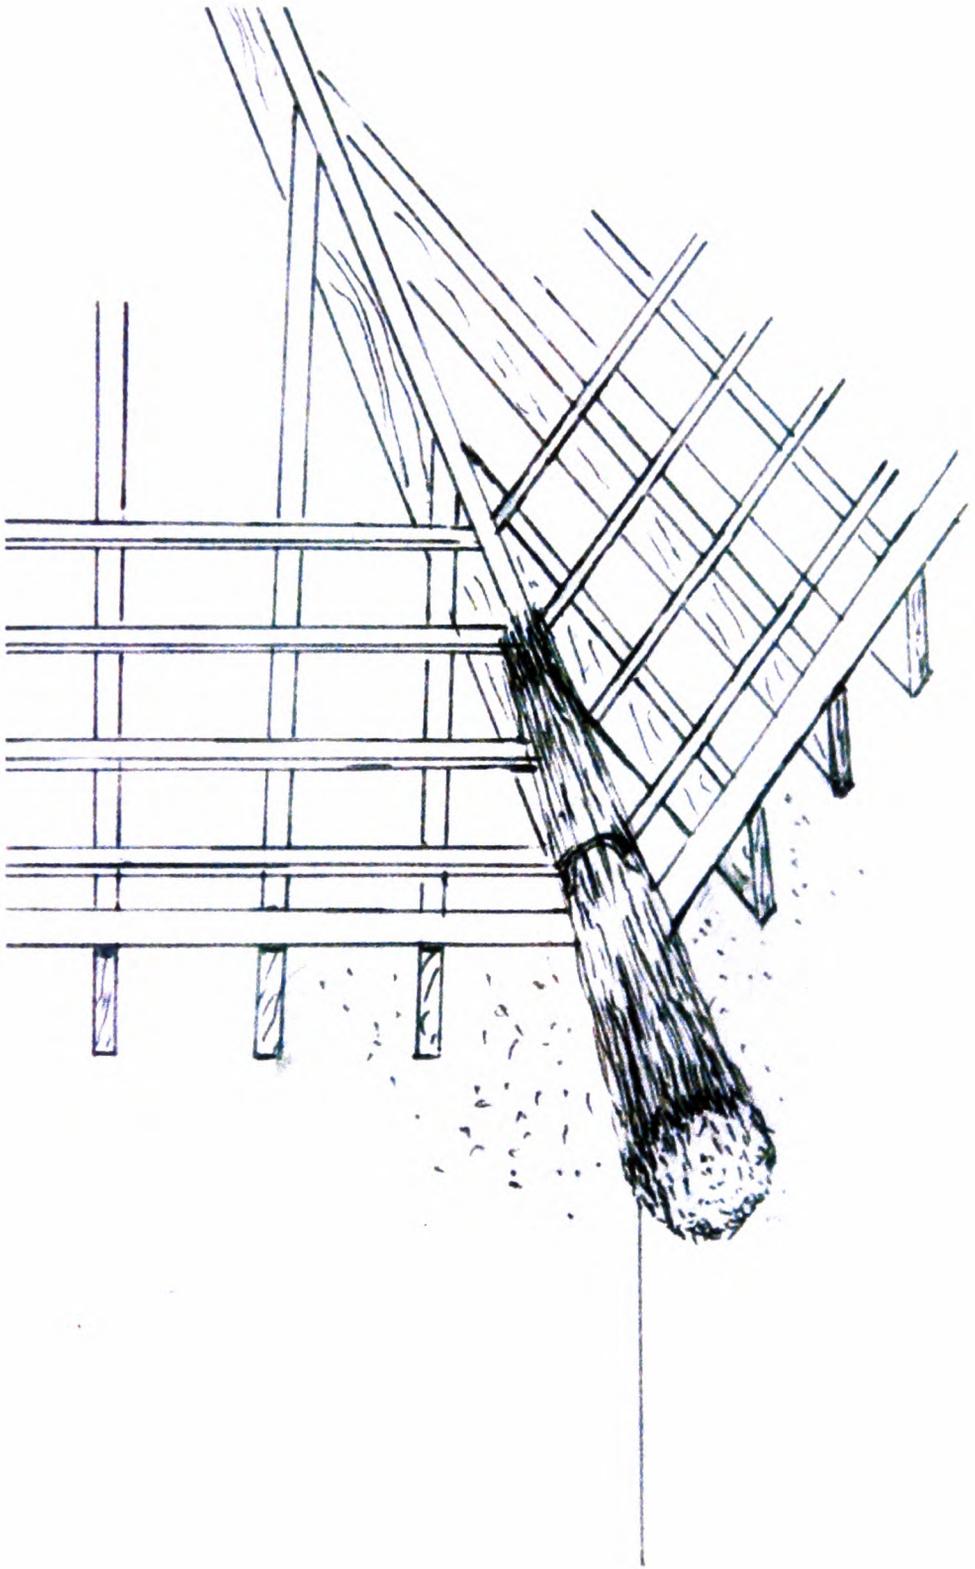
Illustration 28 - Diagram of how a bottle is placed on a hip rafter

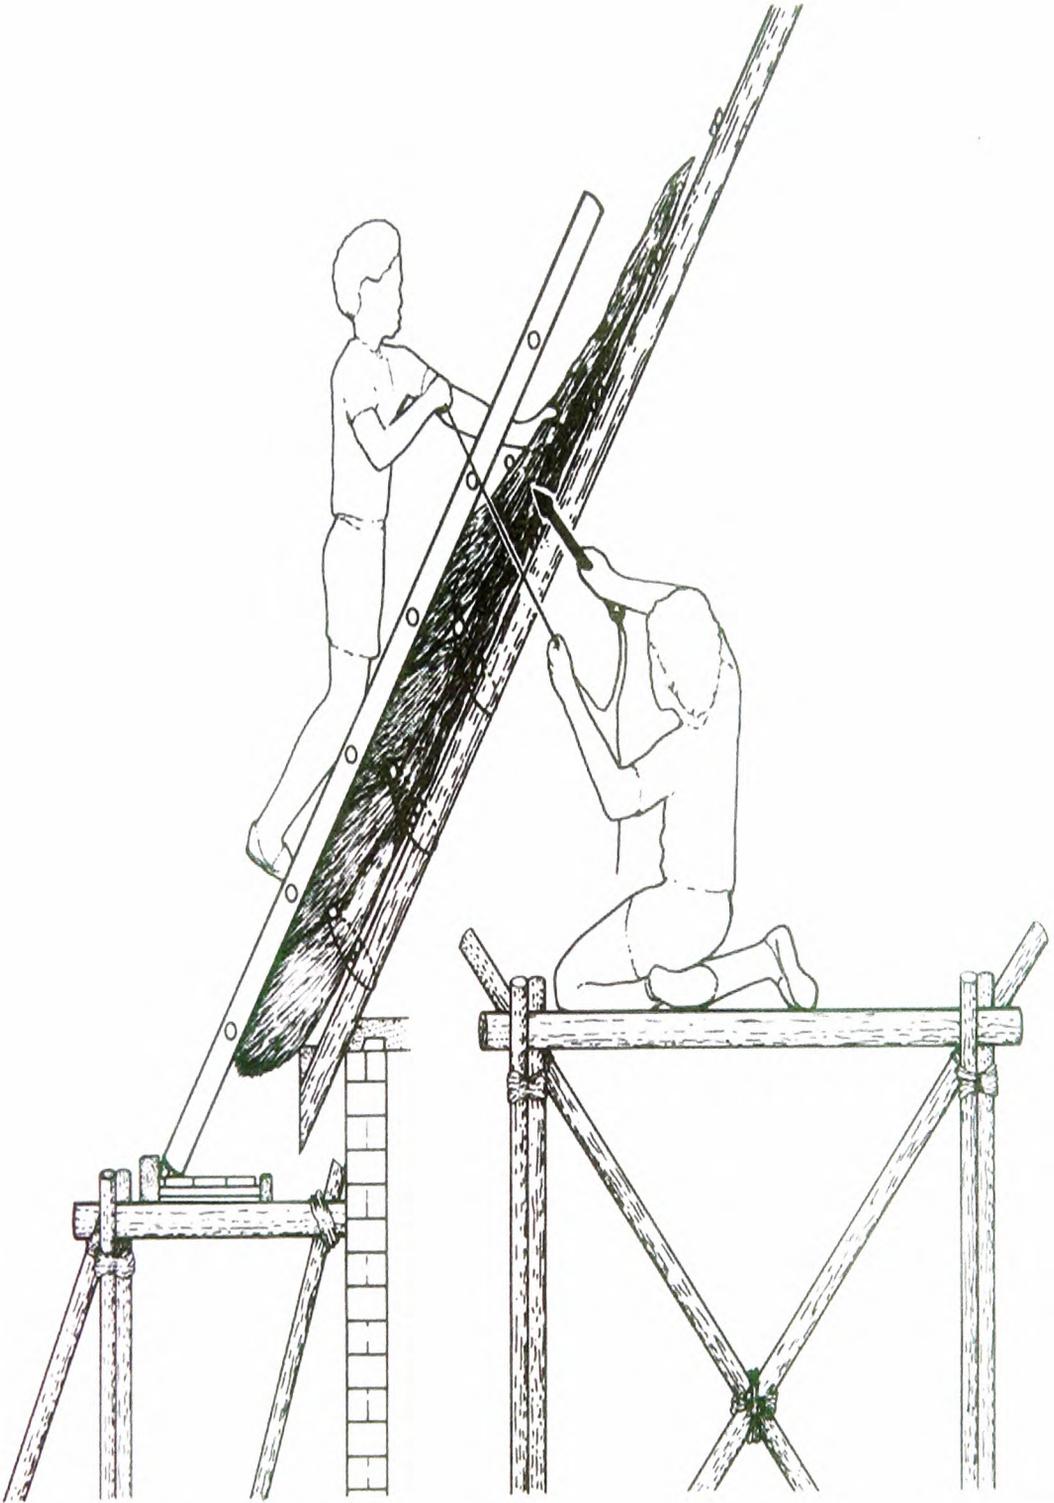
**Illustration 30 - Diagram showing how the thatching material was traditionally stitched to the roof with a straight needle**
