# **THATCHING IN CAMBRIDGESHIRE**

**CHRISTOPHER PAUL STANFORD**

A thesis submitted in partial fulfillment of the  
requirements of the University of Greenwich  
for the Degree of Doctor of Philosophy

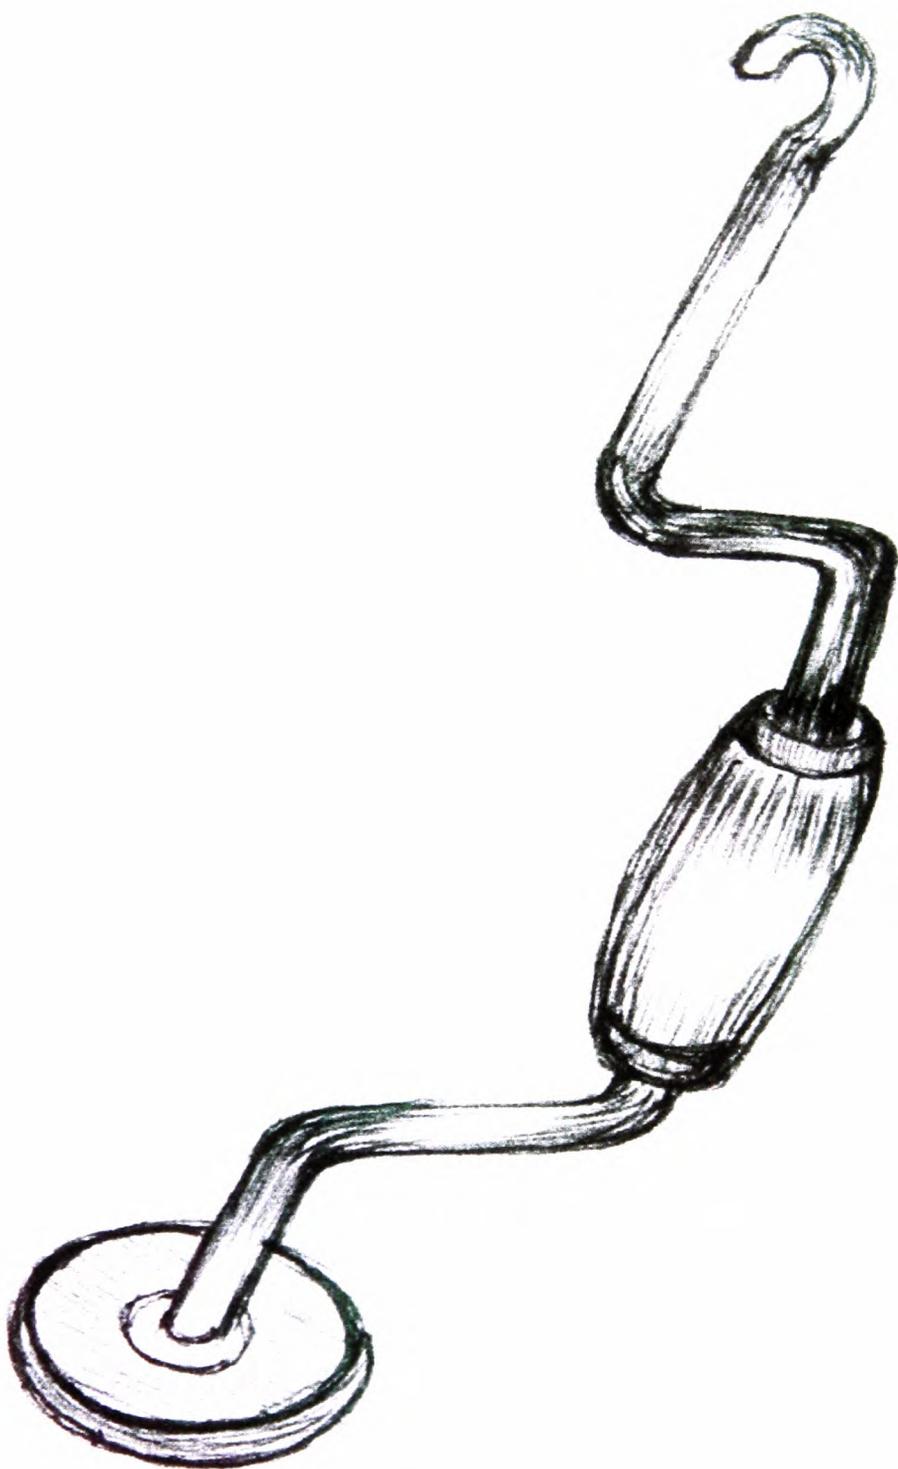
Illustration 31 - A winding tool

Before tarred cord was commercially available, home-made twine was used instead. This was made with a winding tool. The research found only one person who owns a winding tool and knows how to use it. The tool in question resembles a carpenter's brace (see Ill. 31). In place of

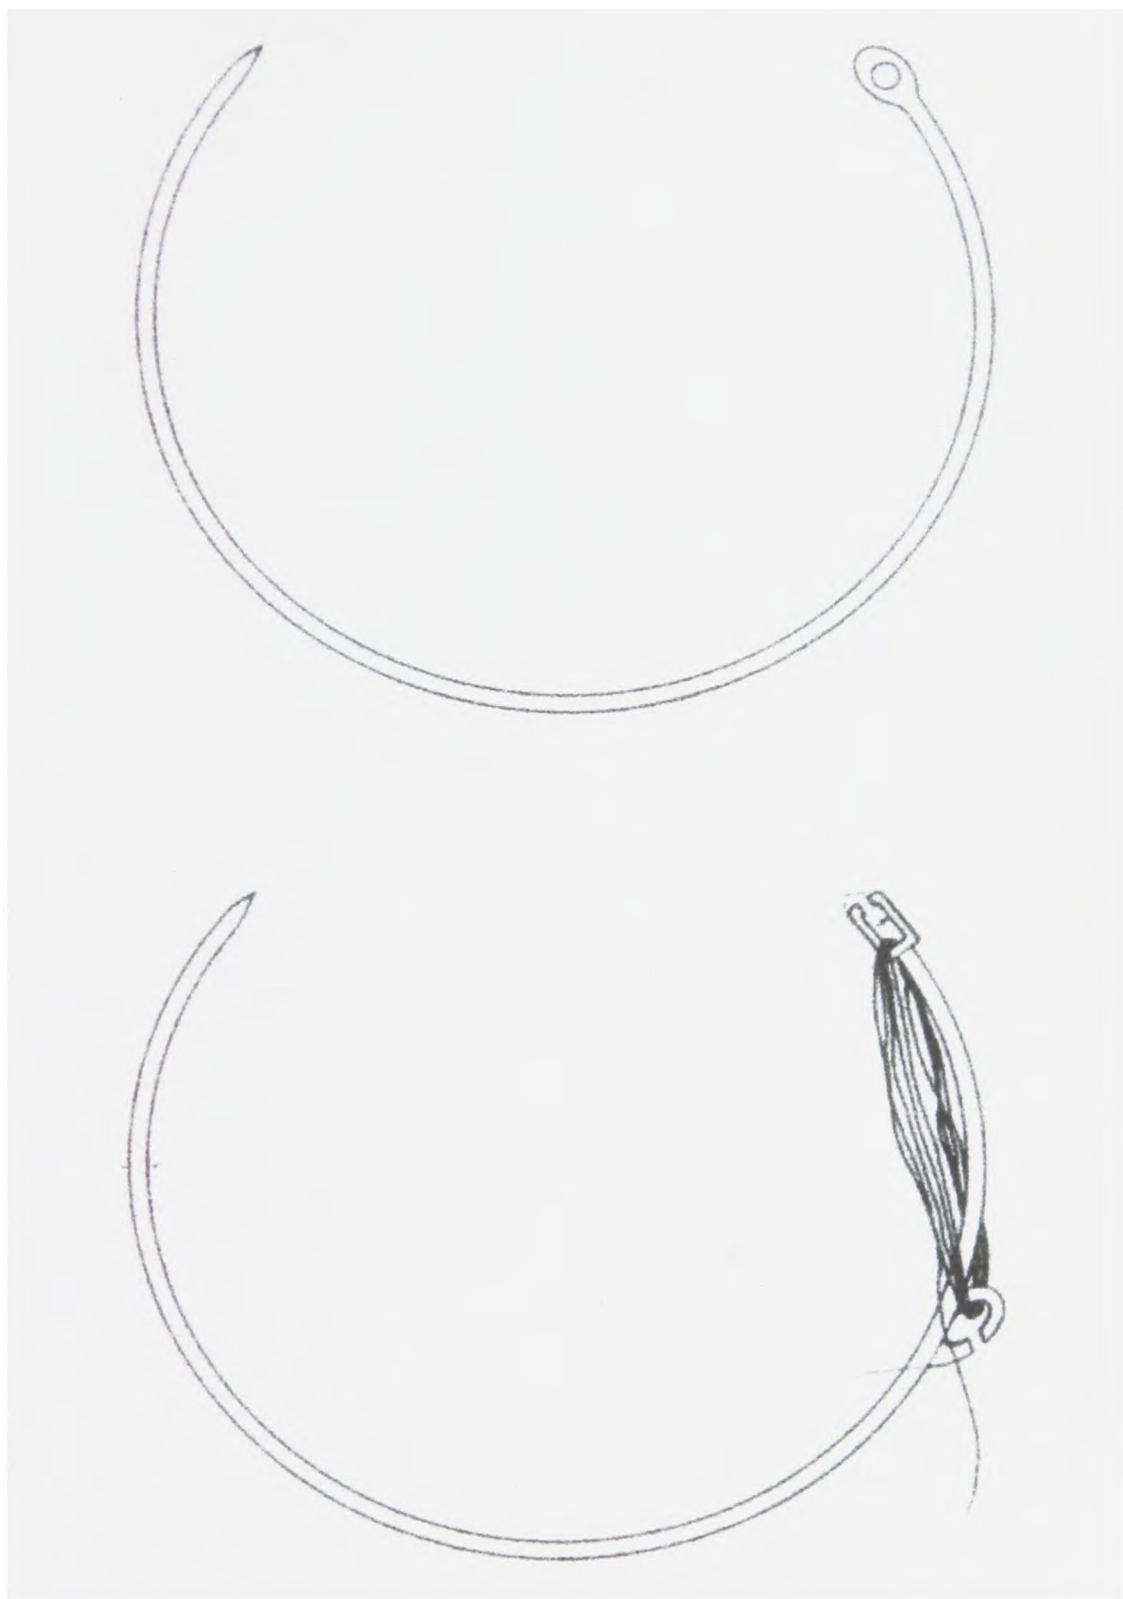
**Illustration 32 - Two types of curved thatching needle, the lower one enabling a length of cord to be used several times without re-threading**

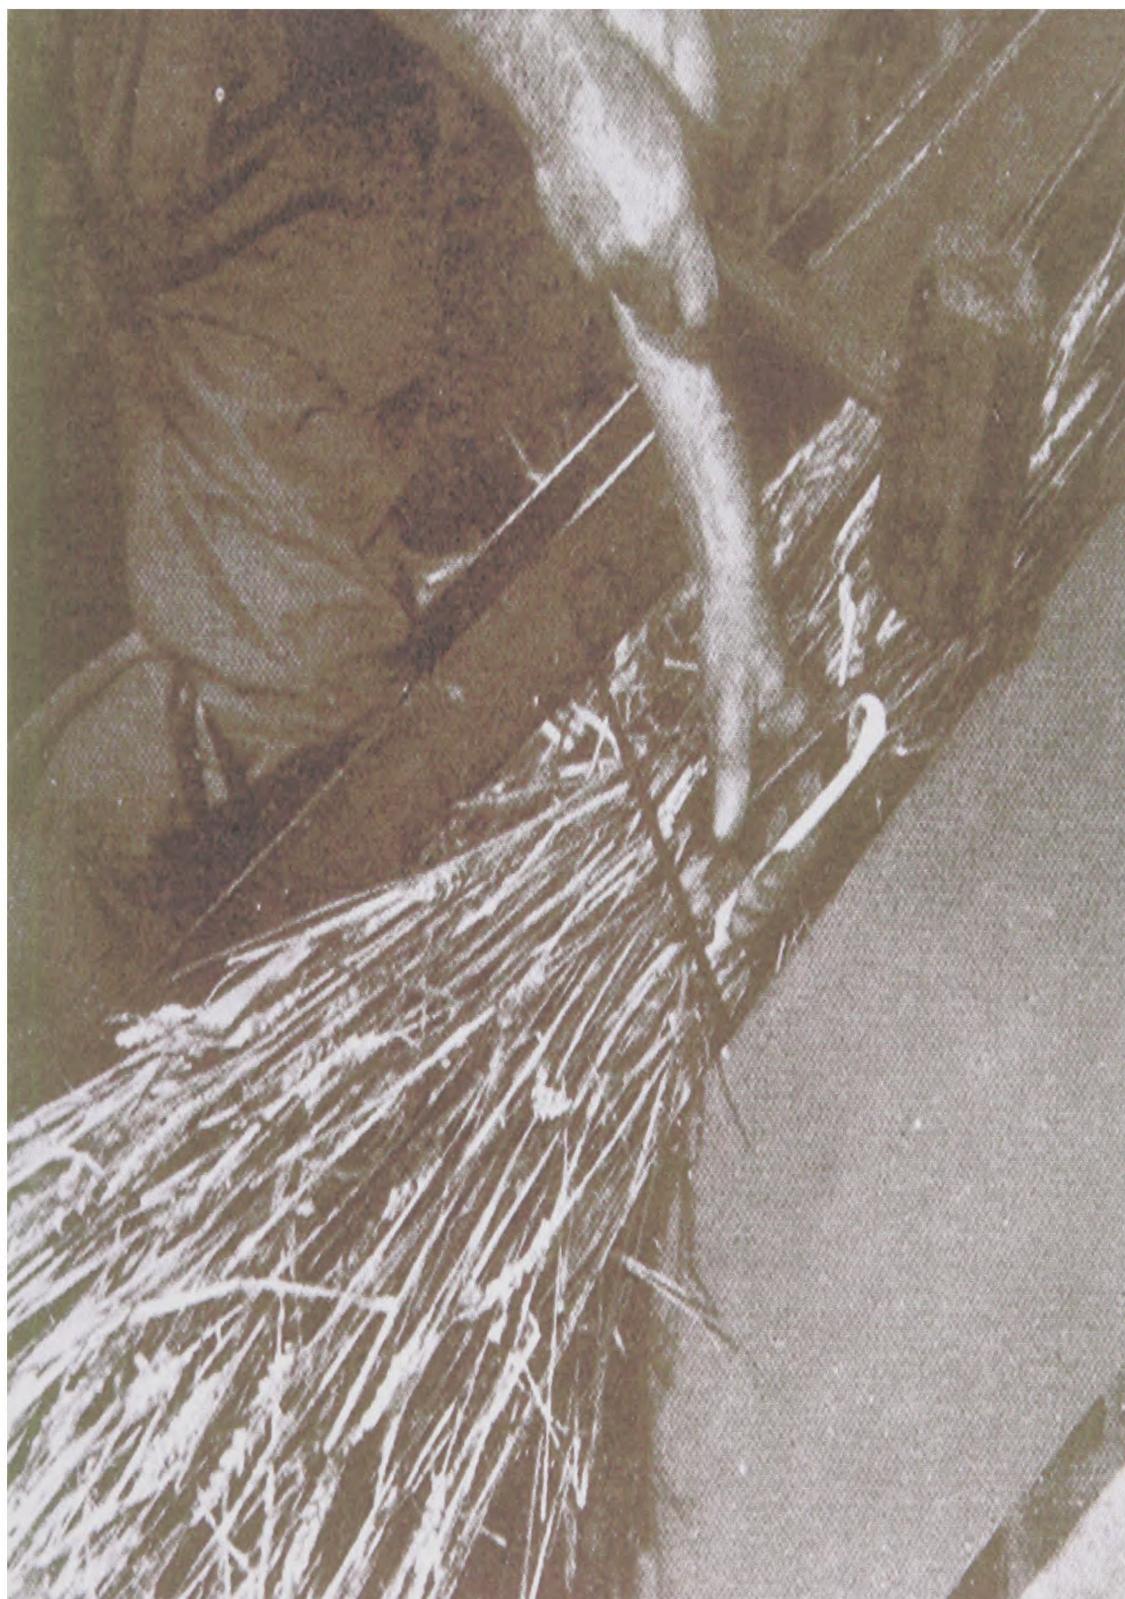
**Illustration 33 – An additional spar fixing to the barge bottle**

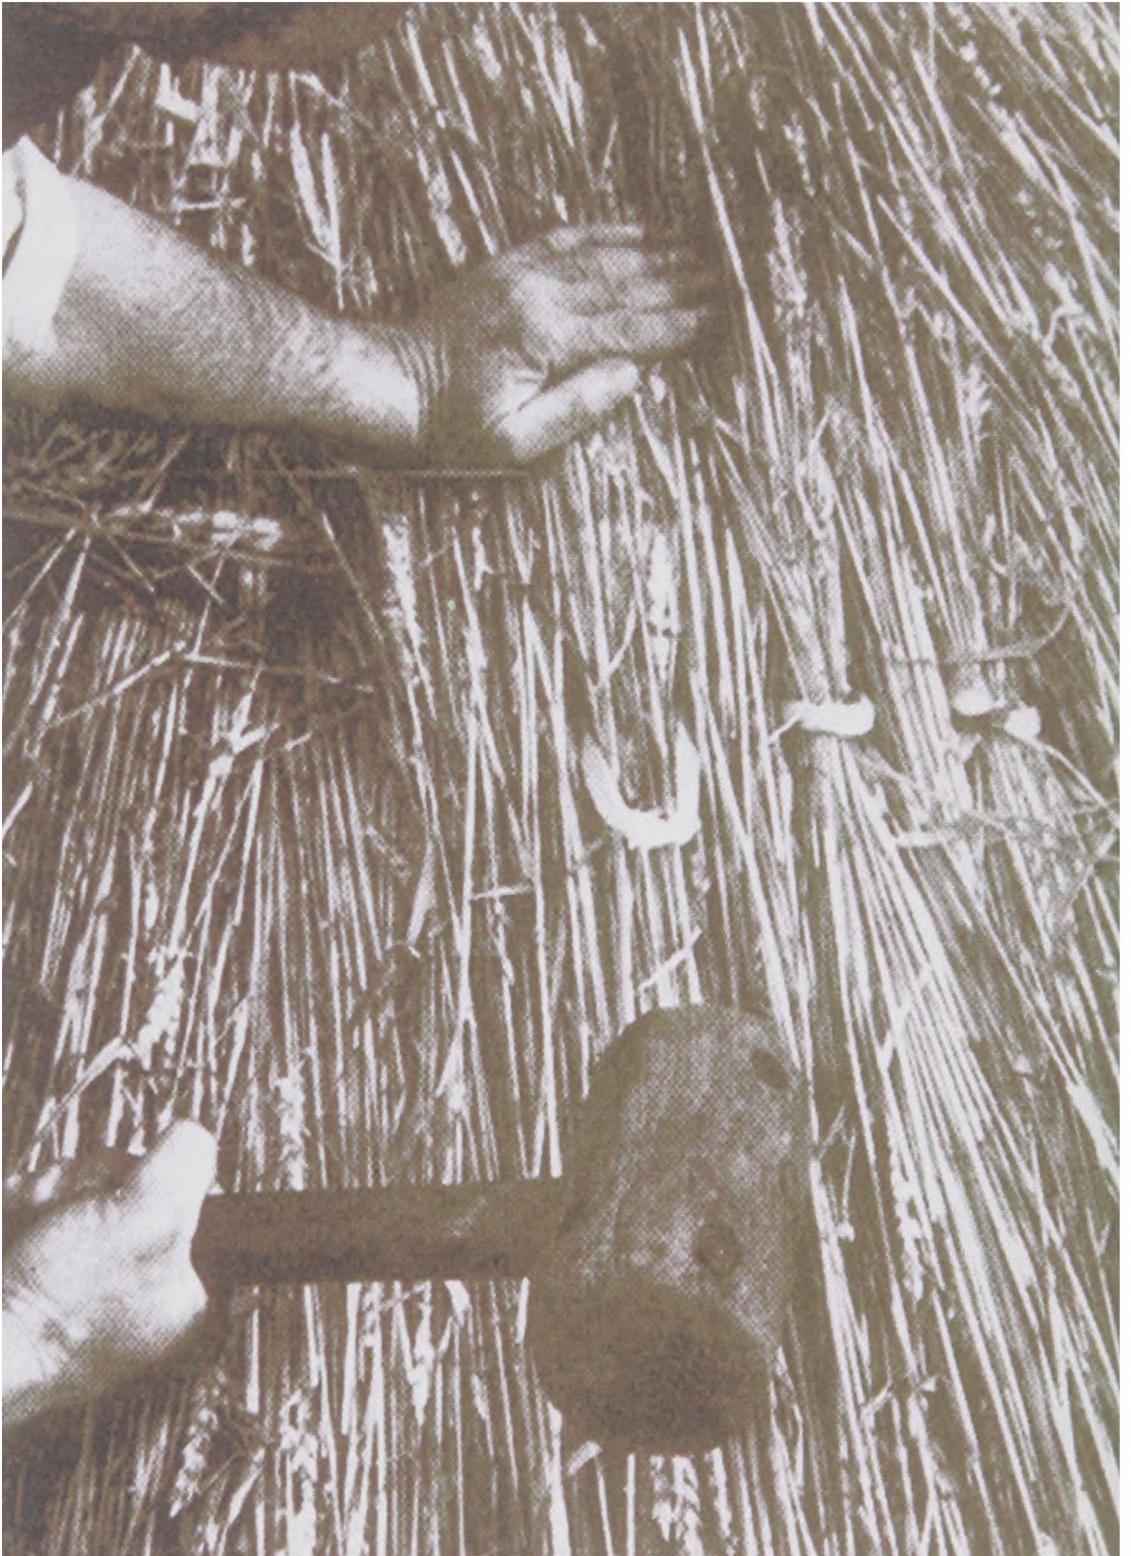
**Illustration 34 - An extra yealm laid to a corner, showing the row of spars halfway between the hammer and the thatcher's left hand, and the tarred cord immediately below his left hand**

An extra yealm is laid on the corner of the roof (see Ill. 34) to give added strength and thickness. This extra yealm is fixed by means of a row of short spars driven into the firm portion immediately below the tarred cord or rod, depending on the method employed. These spars are not driven in at right angles to the slope of the roof, but with sufficient slope to

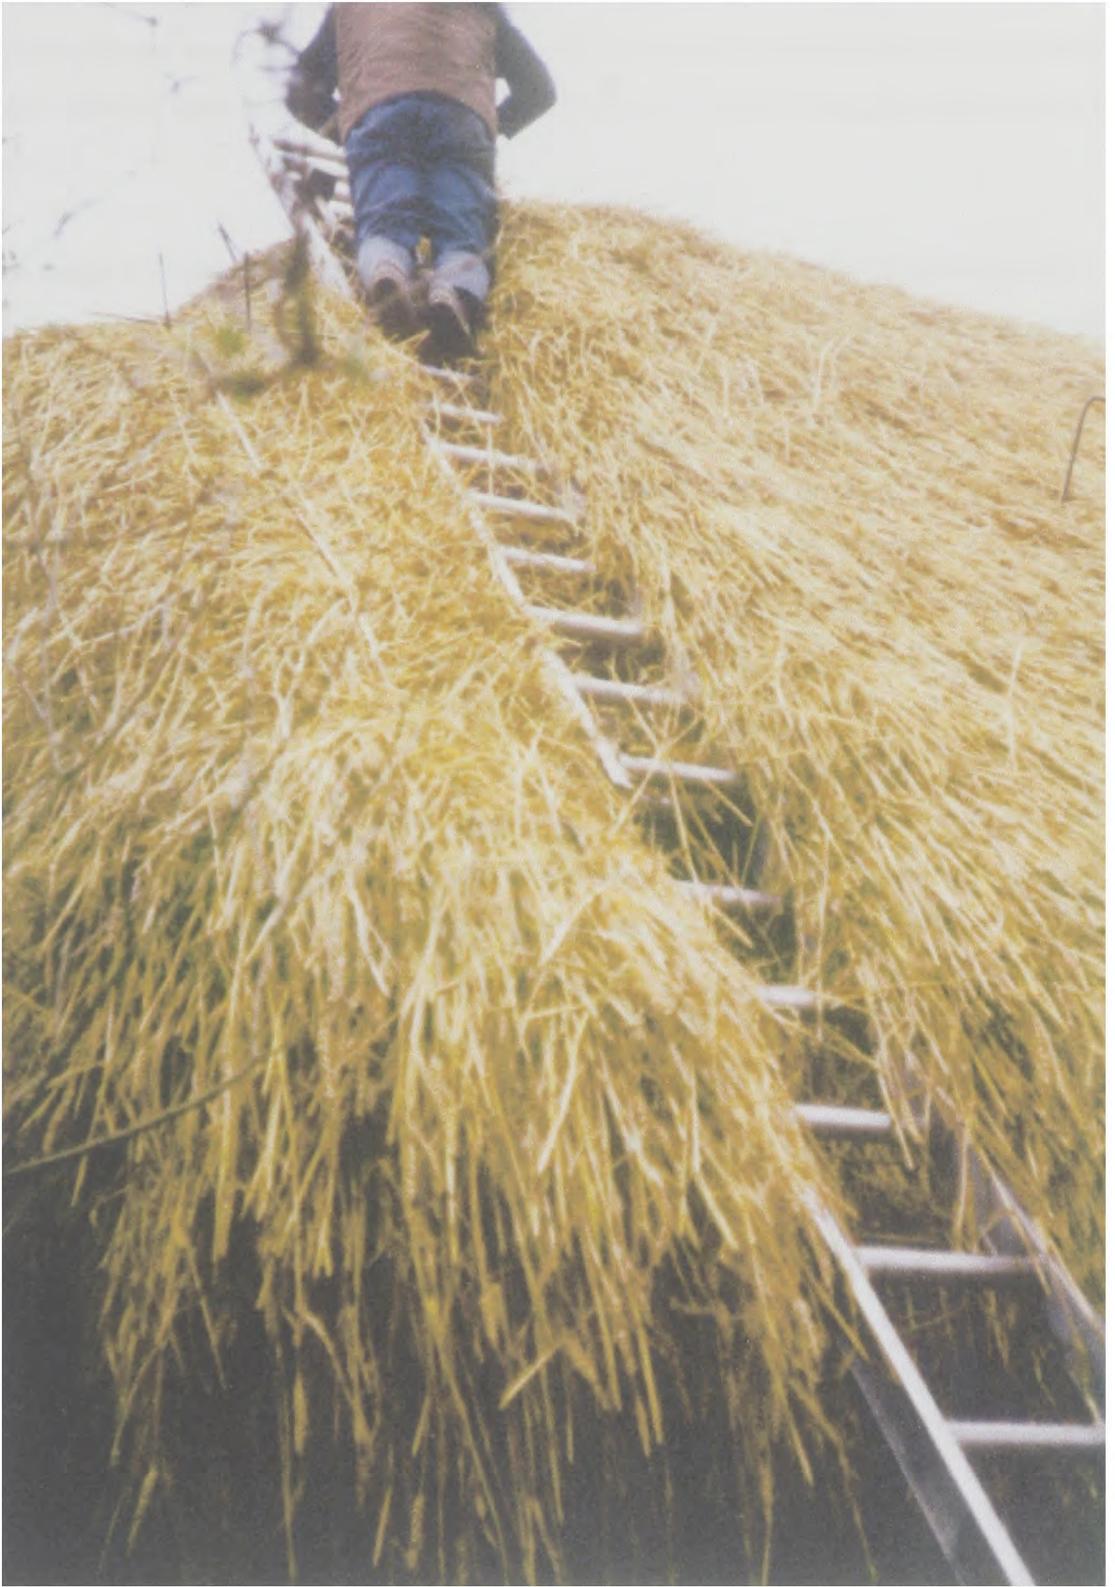
**Illustration 37 - Completed left barge course, with the ladder course still to be completed**

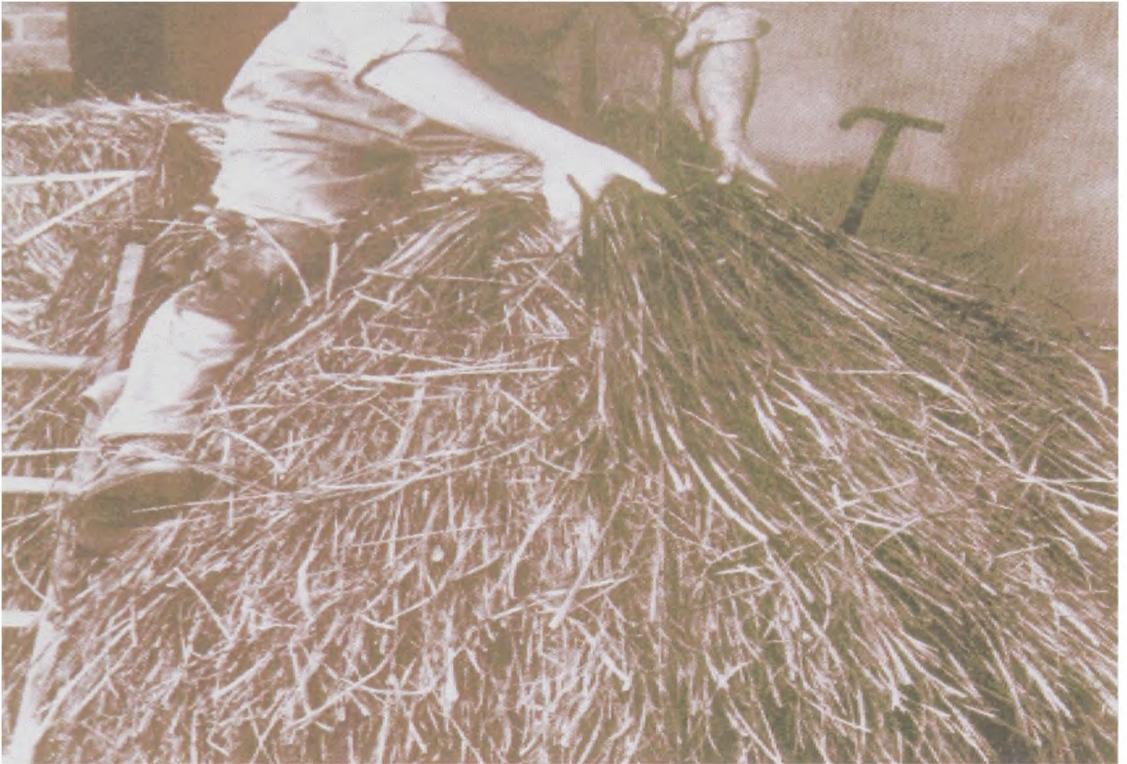
**Illustration 43 – A yealm bent round the needle to form a cap end, before it is secured with spars**

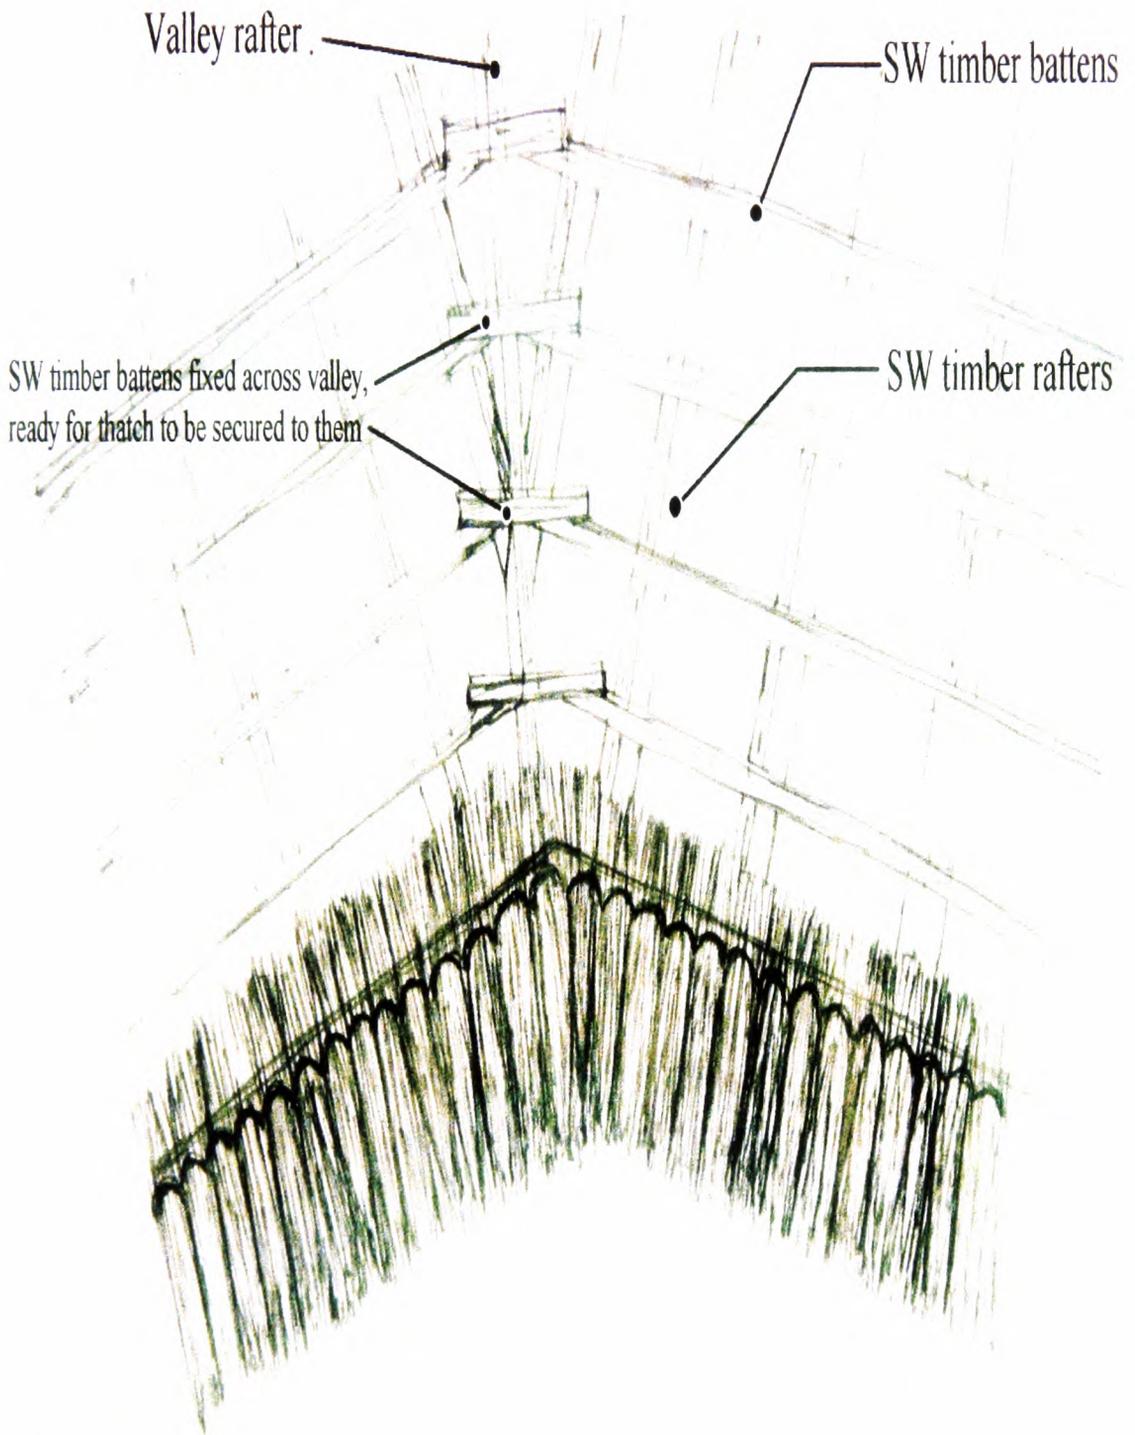
**Illustration 46 - Diagram showing an alternative method of fixing thatch to the valley using soft wood timber battens in a ladder type fashion to which the thatch is secured**

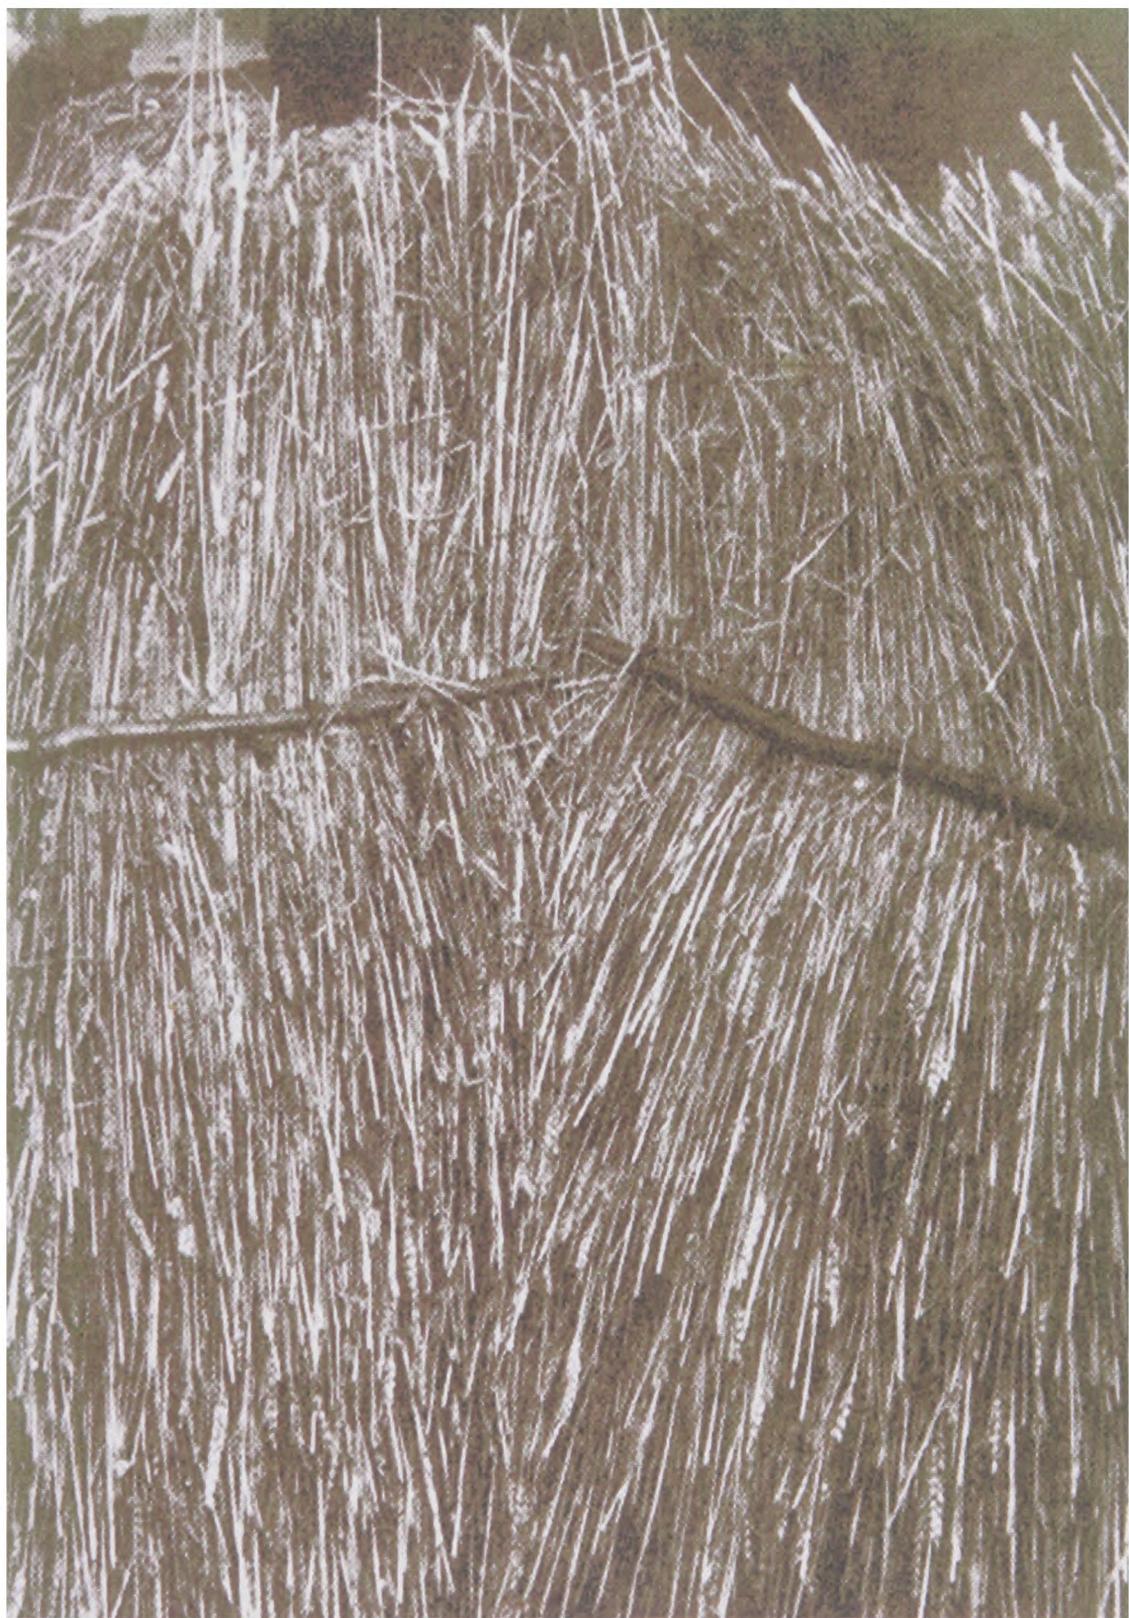
**Illustration 47 - A valley showing the junction of the yealms**

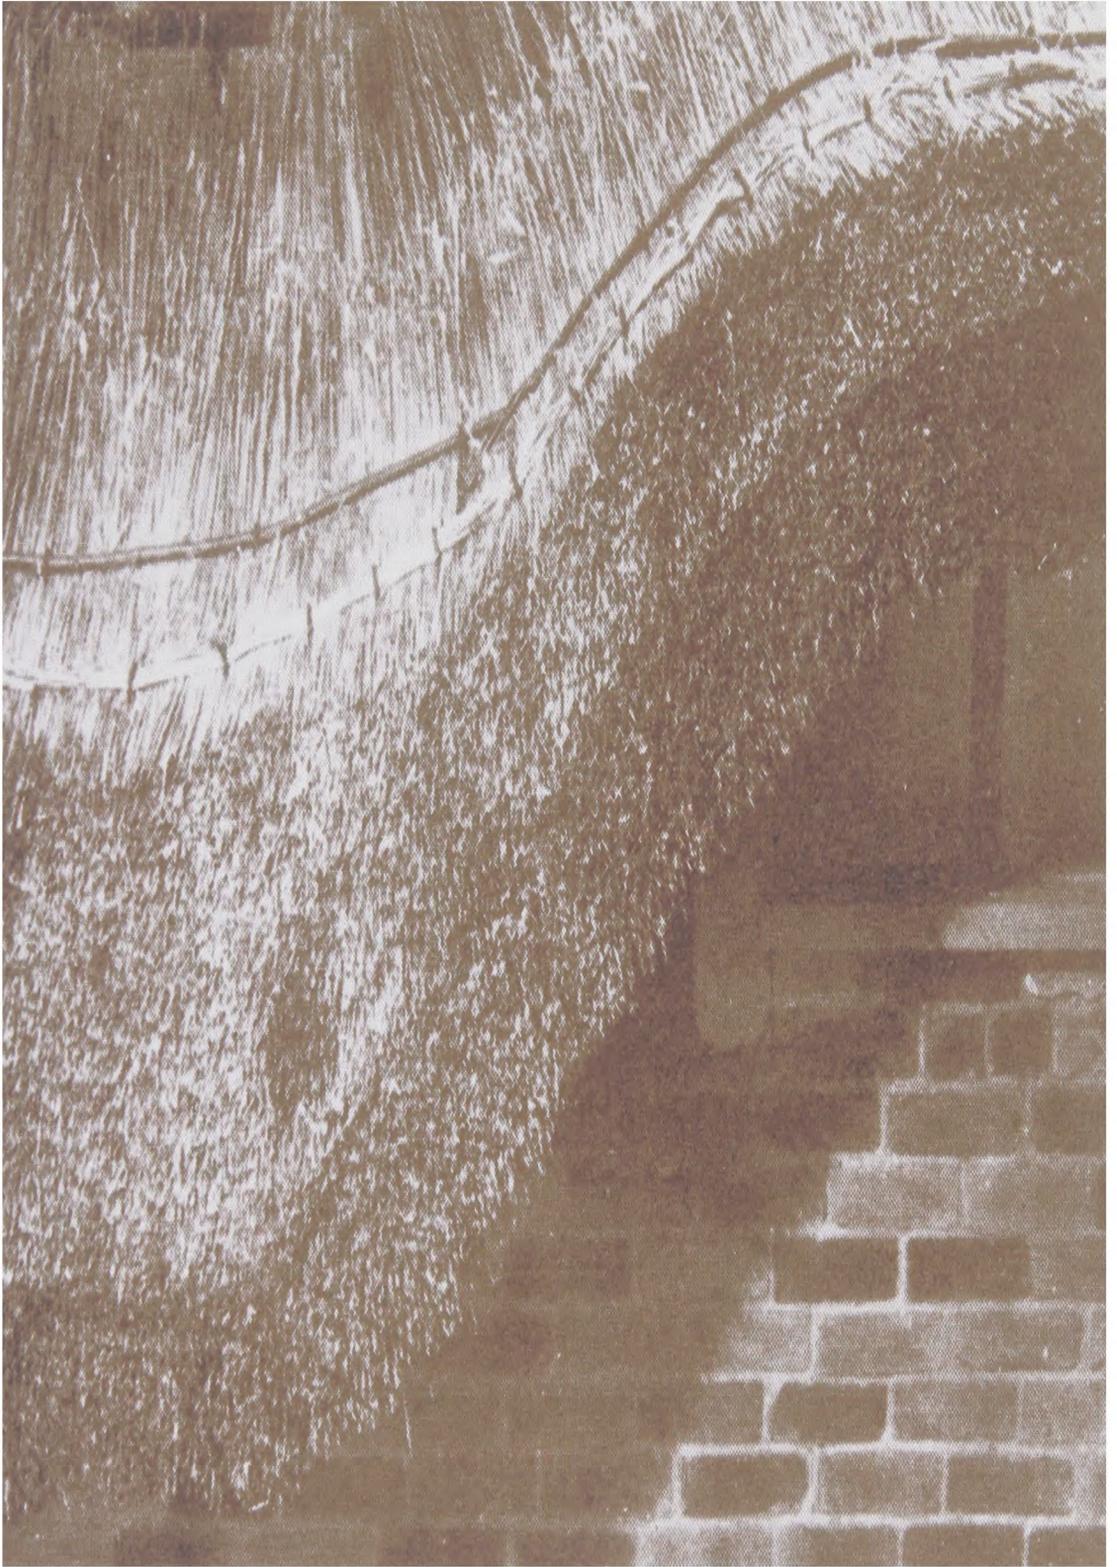
**Illustration 48 – The relationship of the sways to an eyebrow (with a temporary straw sway still in position just beneath)**

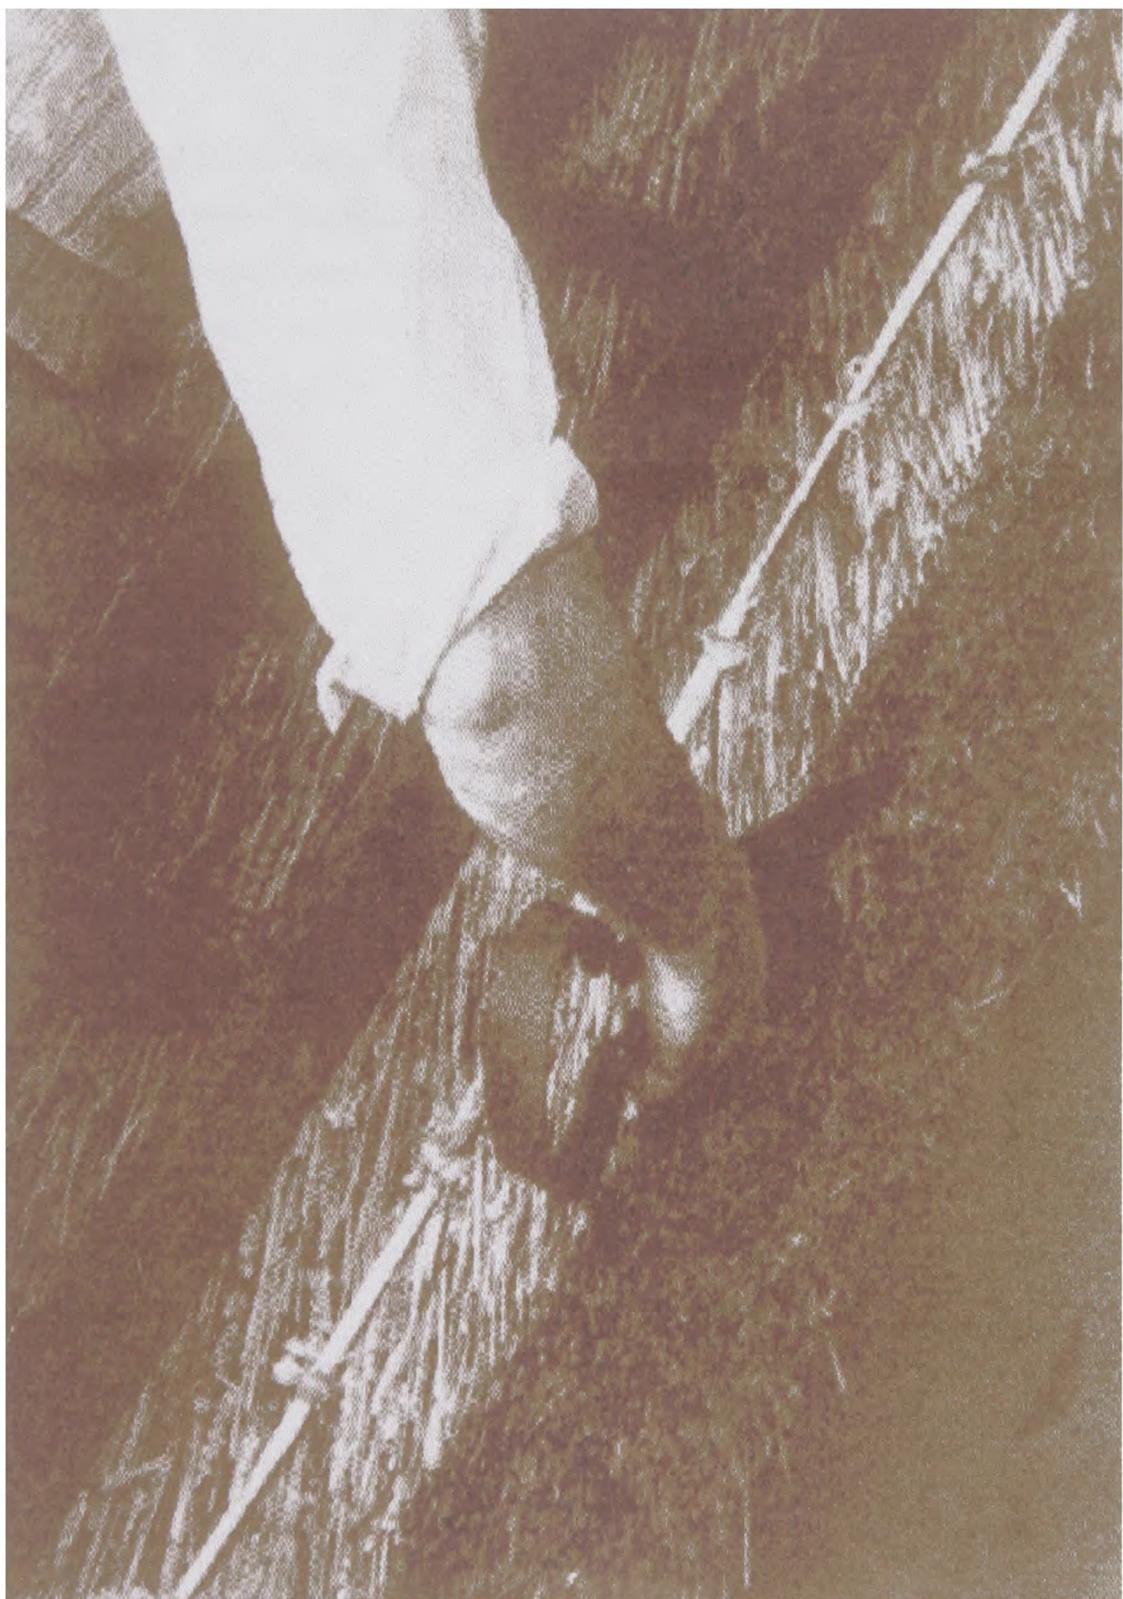
**Illustration 49 – The clean-cut lines of a gable**

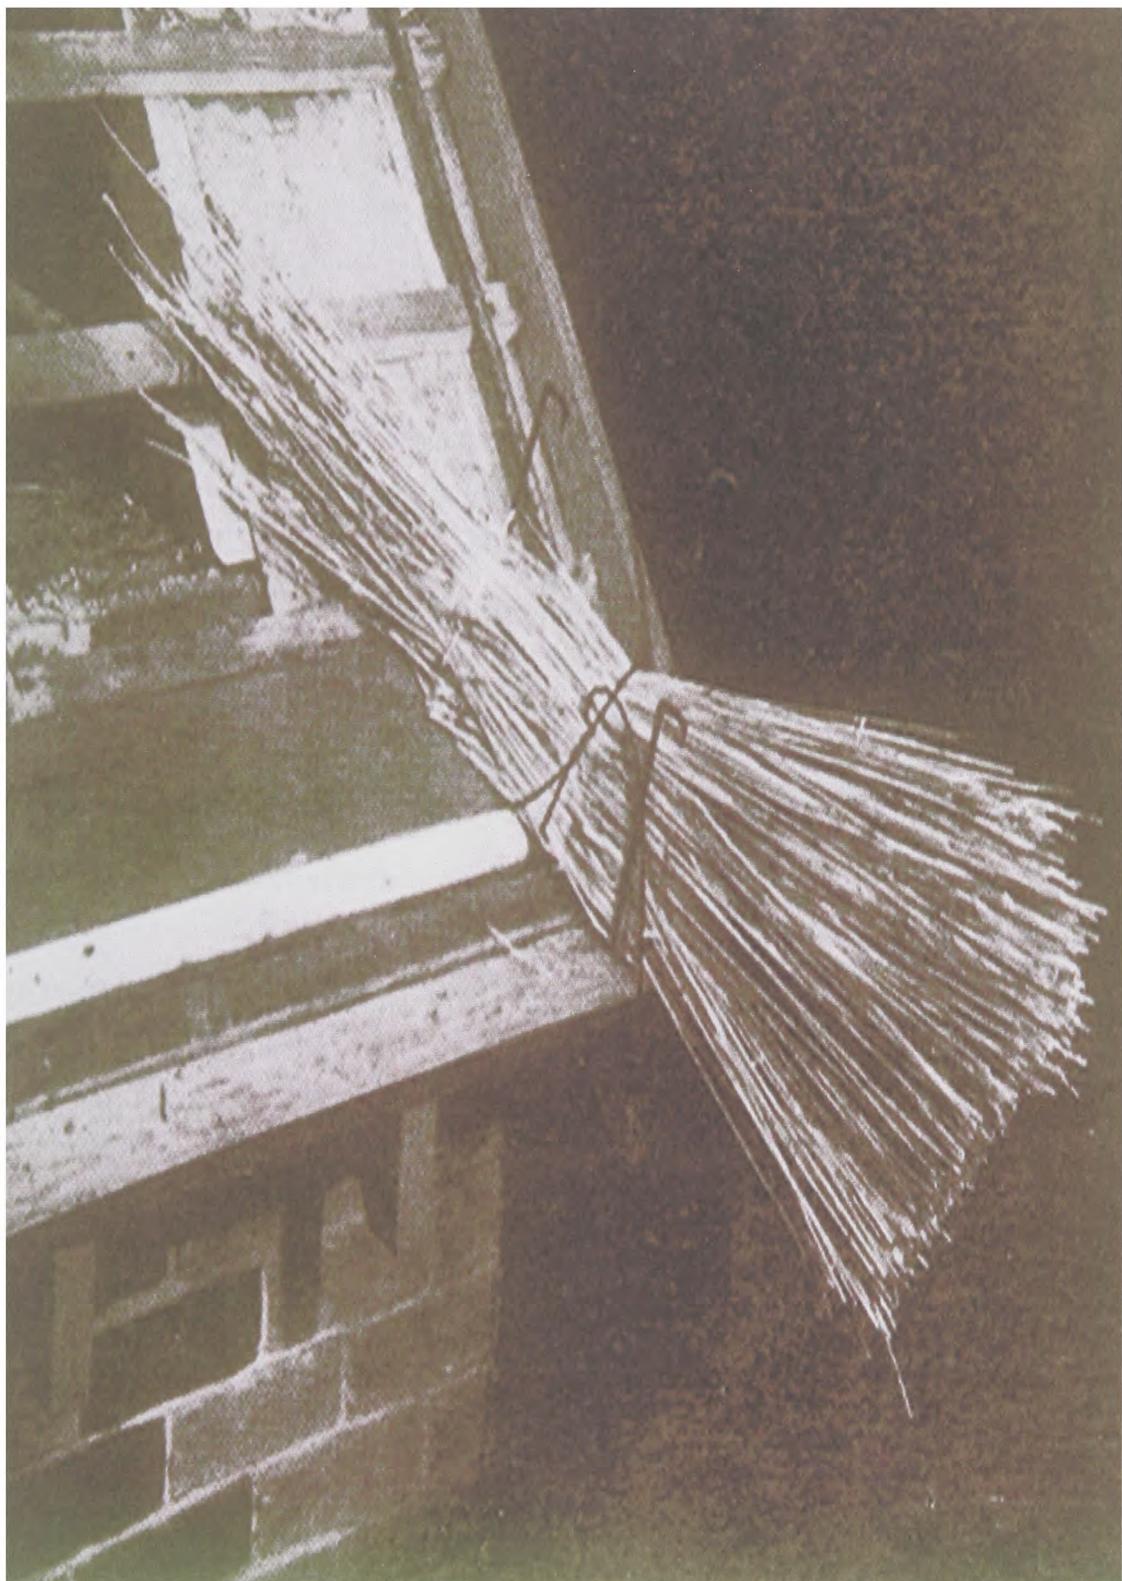
**Illustration 50 - A corner wadd fixed in place, the lower end being pushed upwards by the tilting fillet which lies along the length of the eaves**

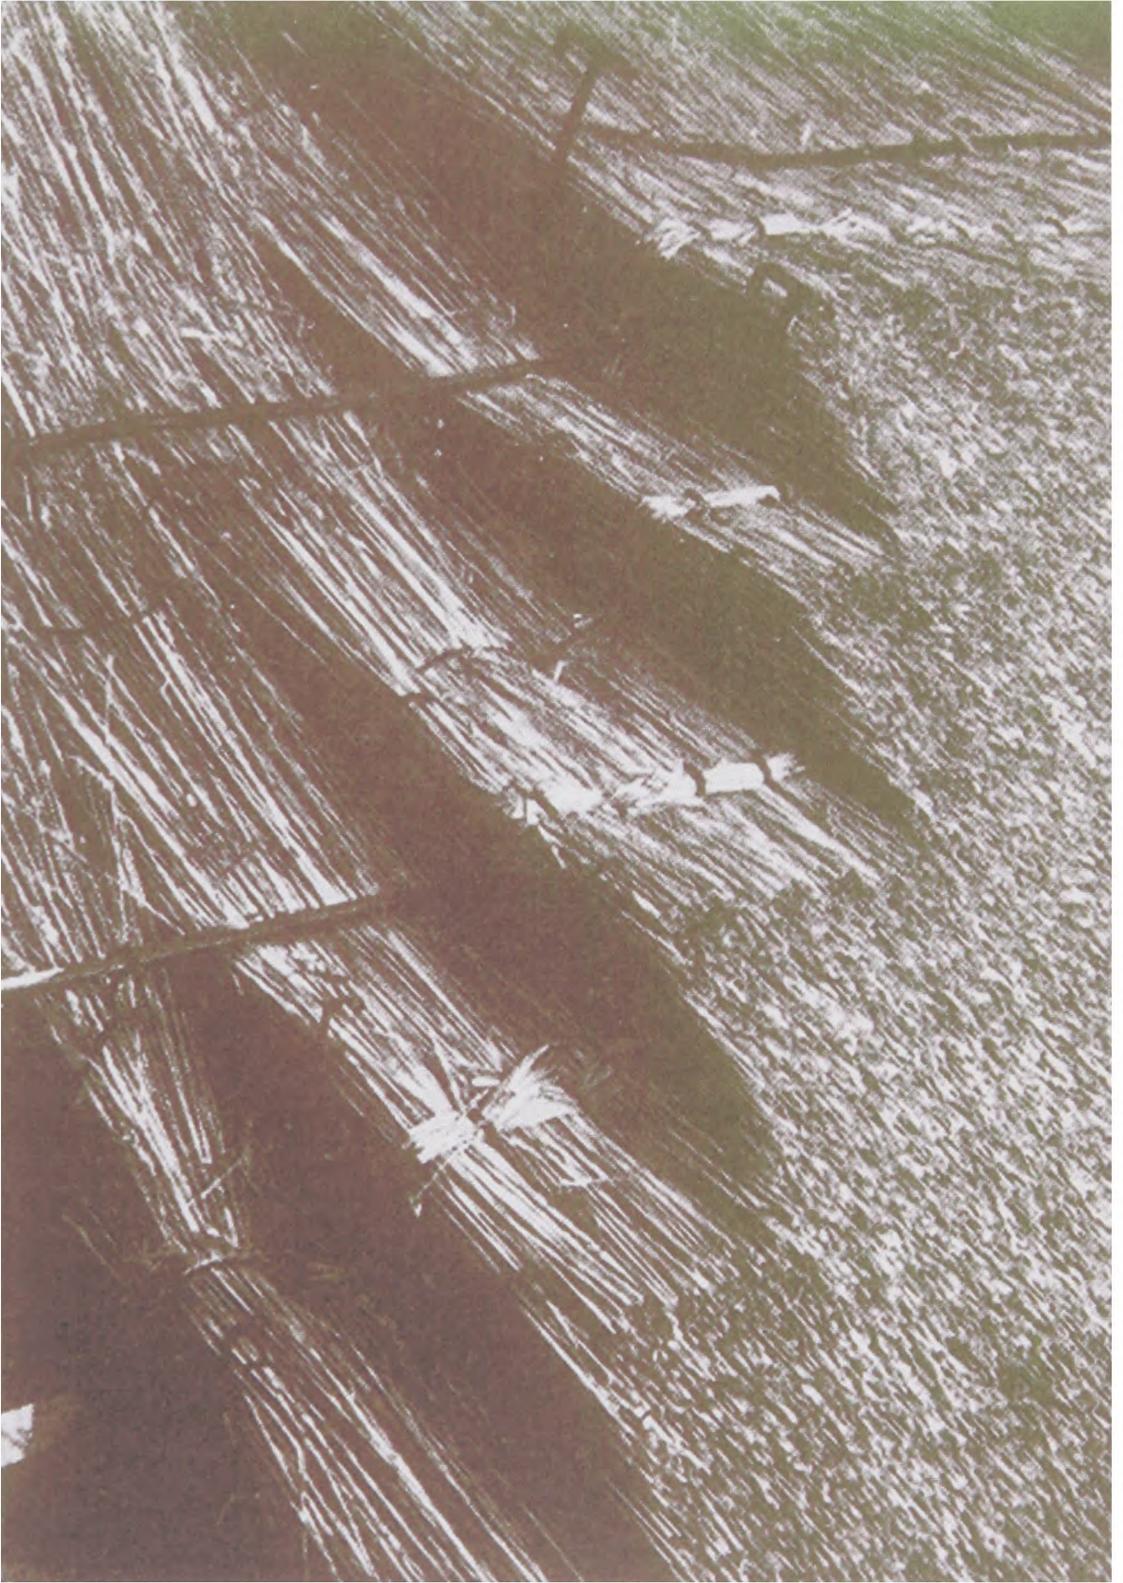
**Illustration 53 - Courses or setts, showing how they are staggered**

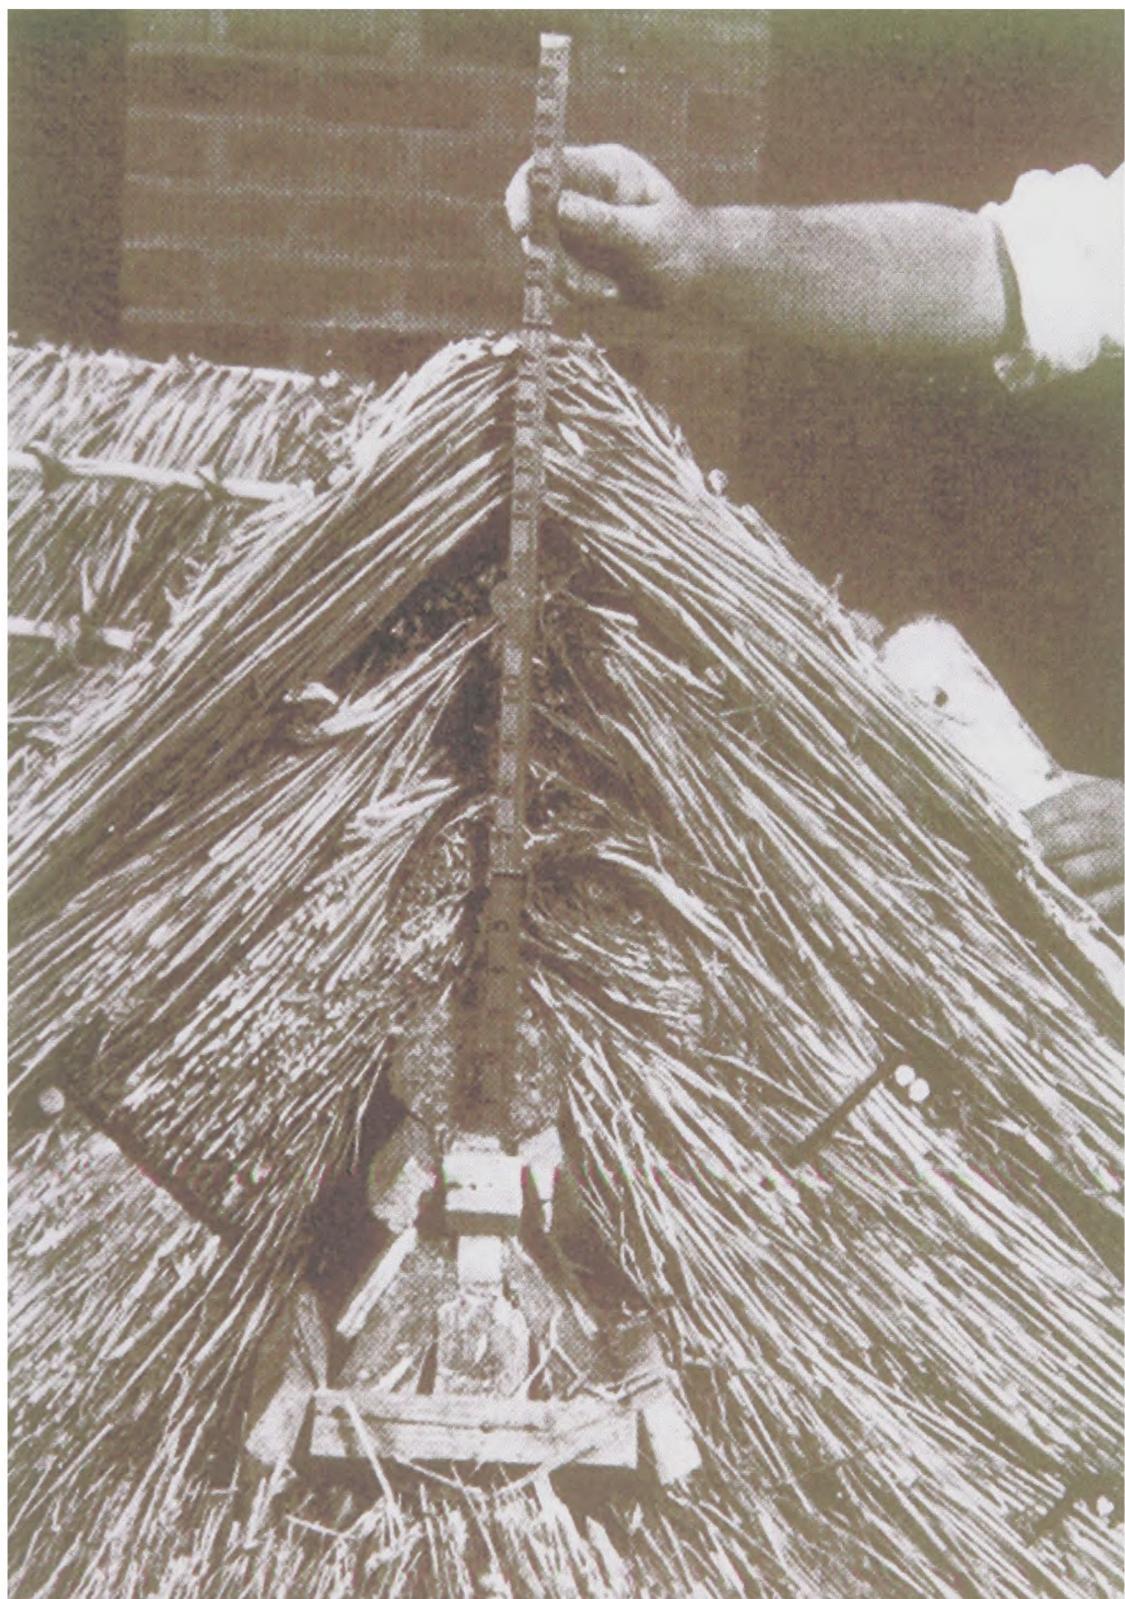
Illustration 54 - The formation of a ridge
