# **THATCHING IN CAMBRIDGESHIRE**

**CHRISTOPHER PAUL STANFORD**

A thesis submitted in partial fulfillment of the  
requirements of the University of Greenwich  
for the Degree of Doctor of Philosophy

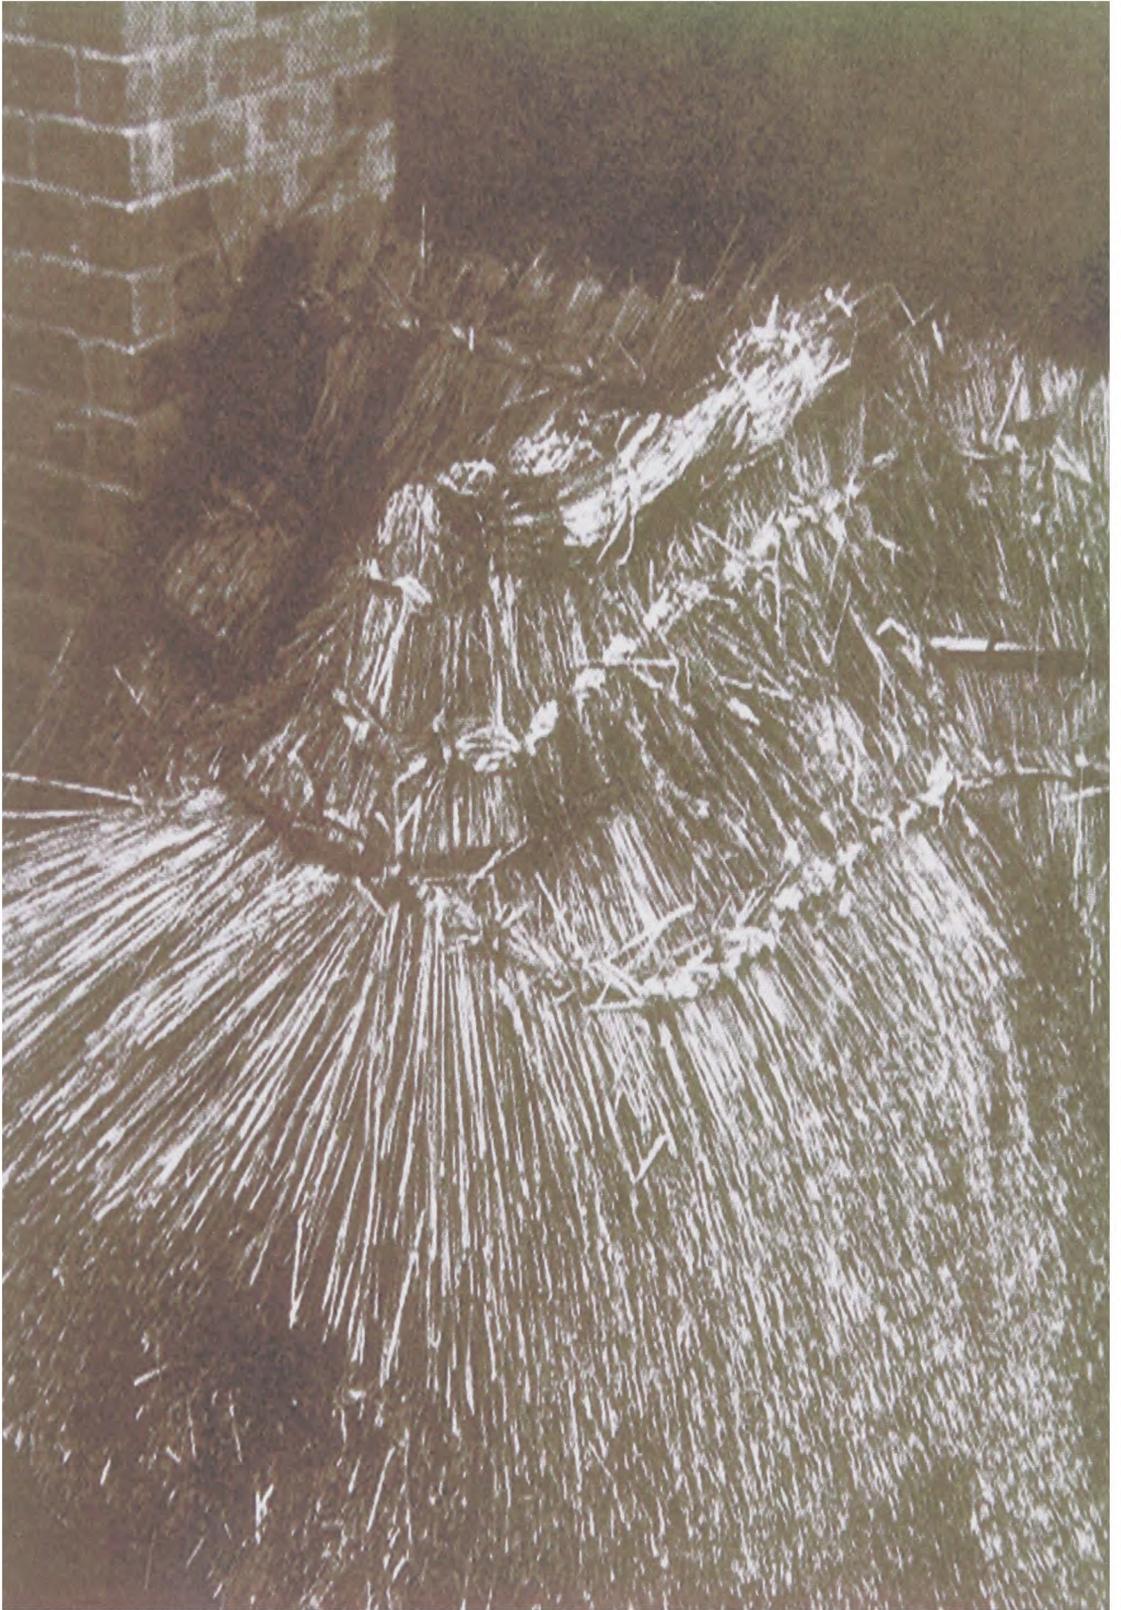
Illustration 55 - A waistcoat layer

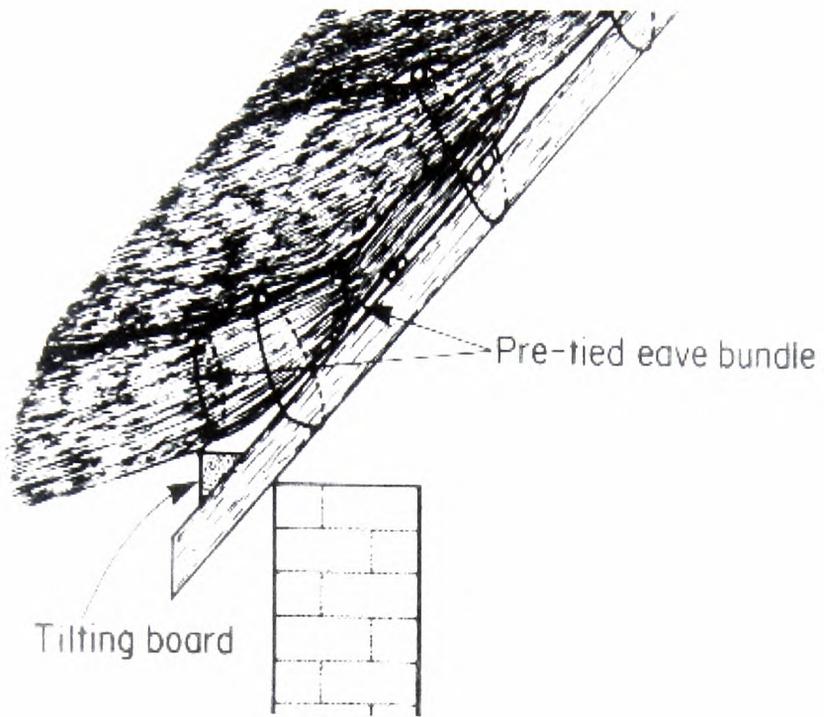
Illustration 59 - Diagram showing how a tilting fillet creates tension

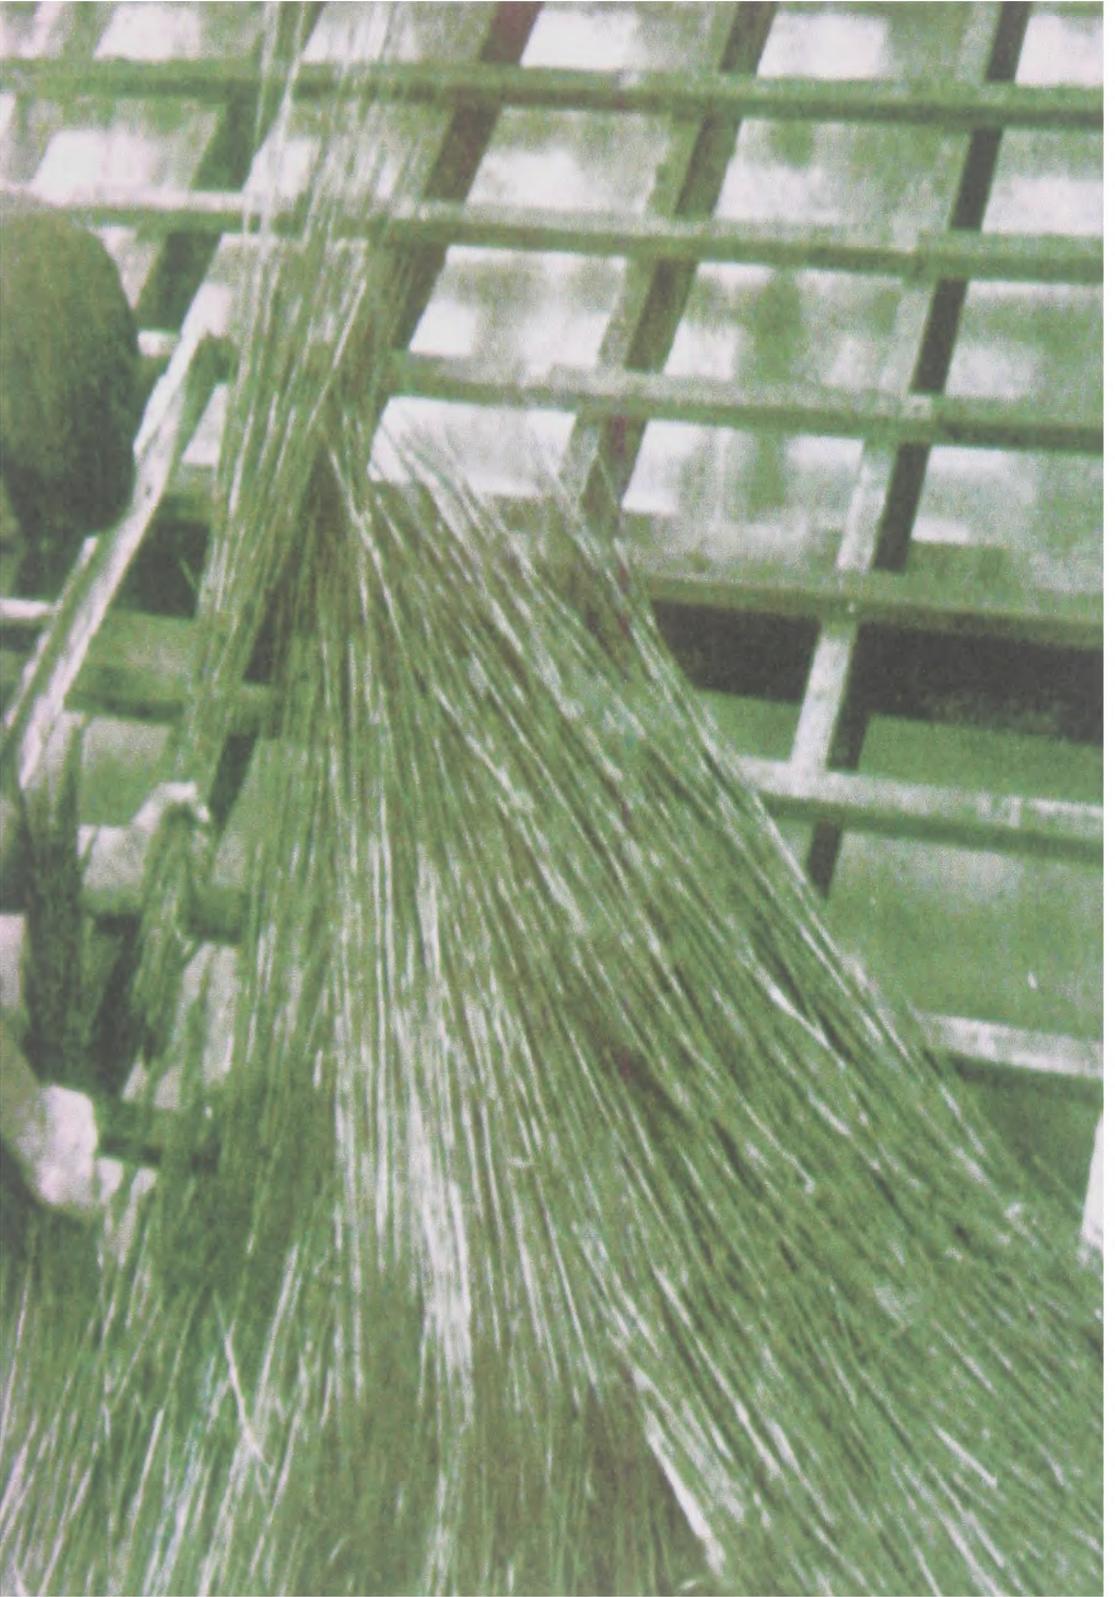
**Illustration 61 - The back-filling method**

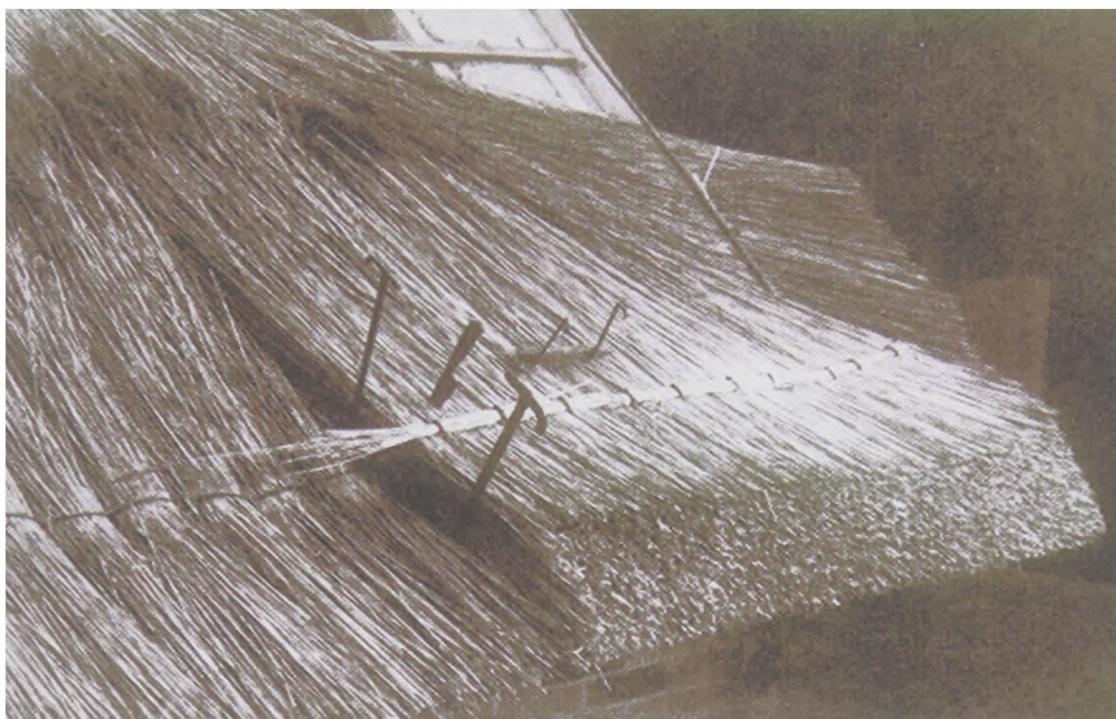
**Illustration 62 - A brow course fixed with temporary sways and hooks**

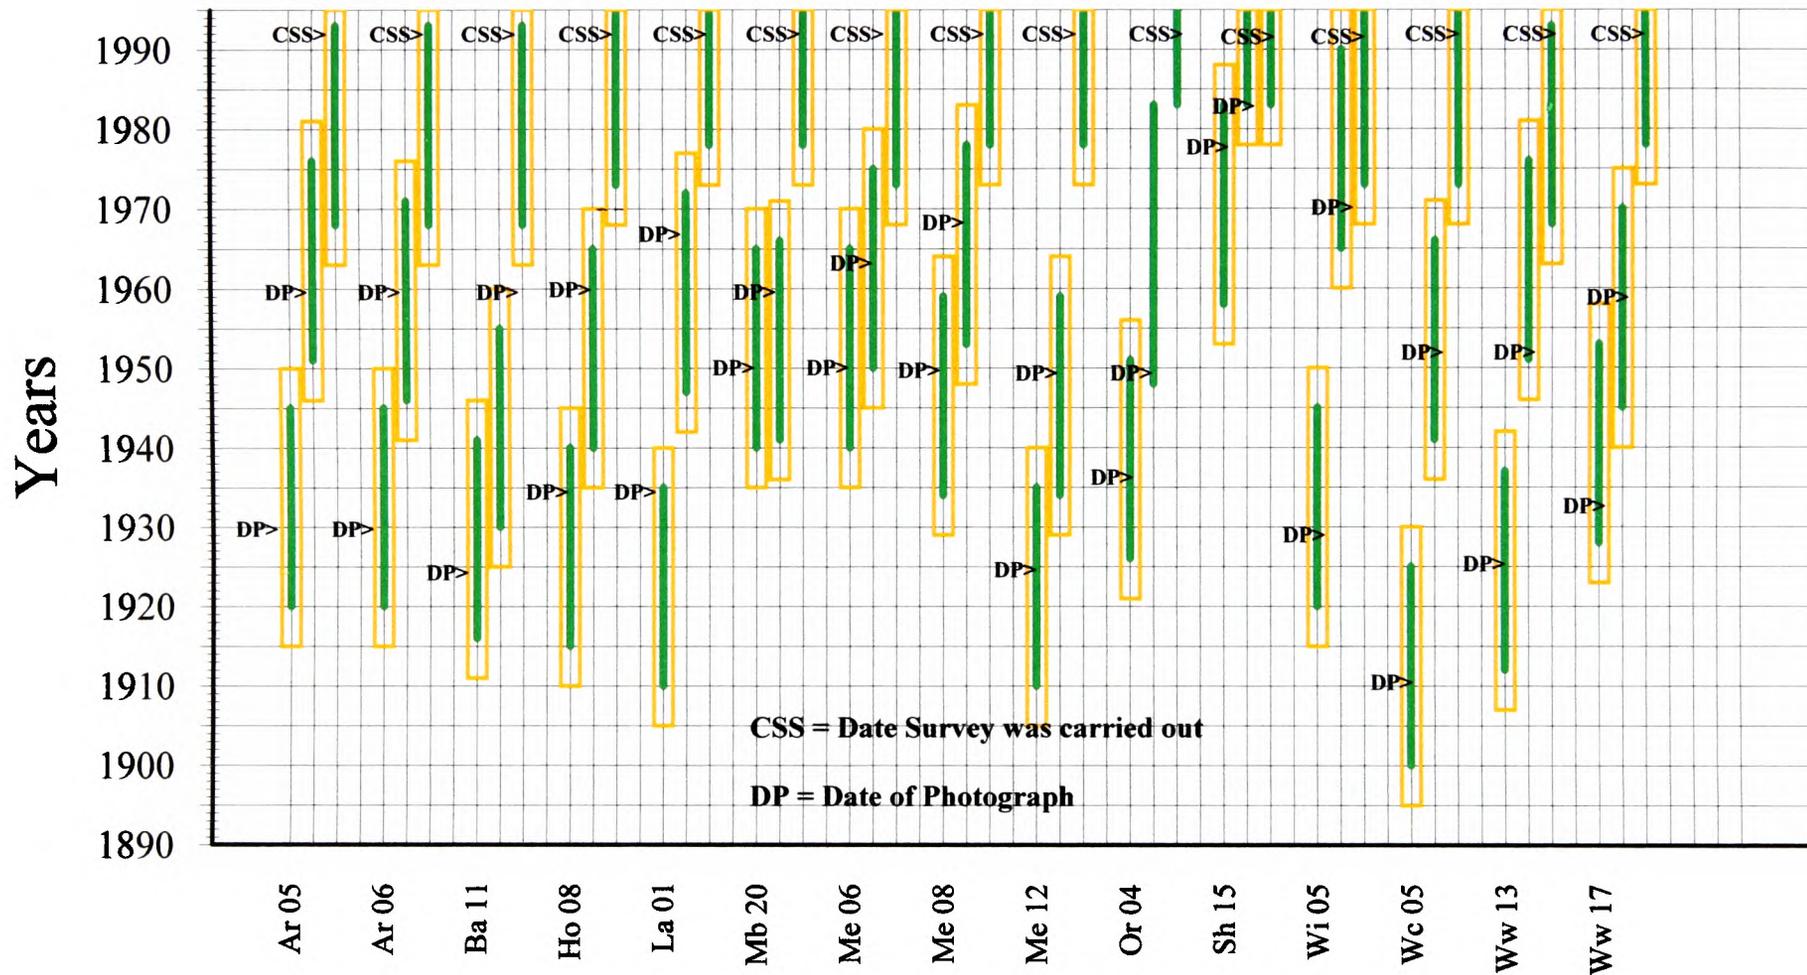
Graph showing max & min life spans of Thatch weathering coats

Individual Dwellings based on 25-35 year period

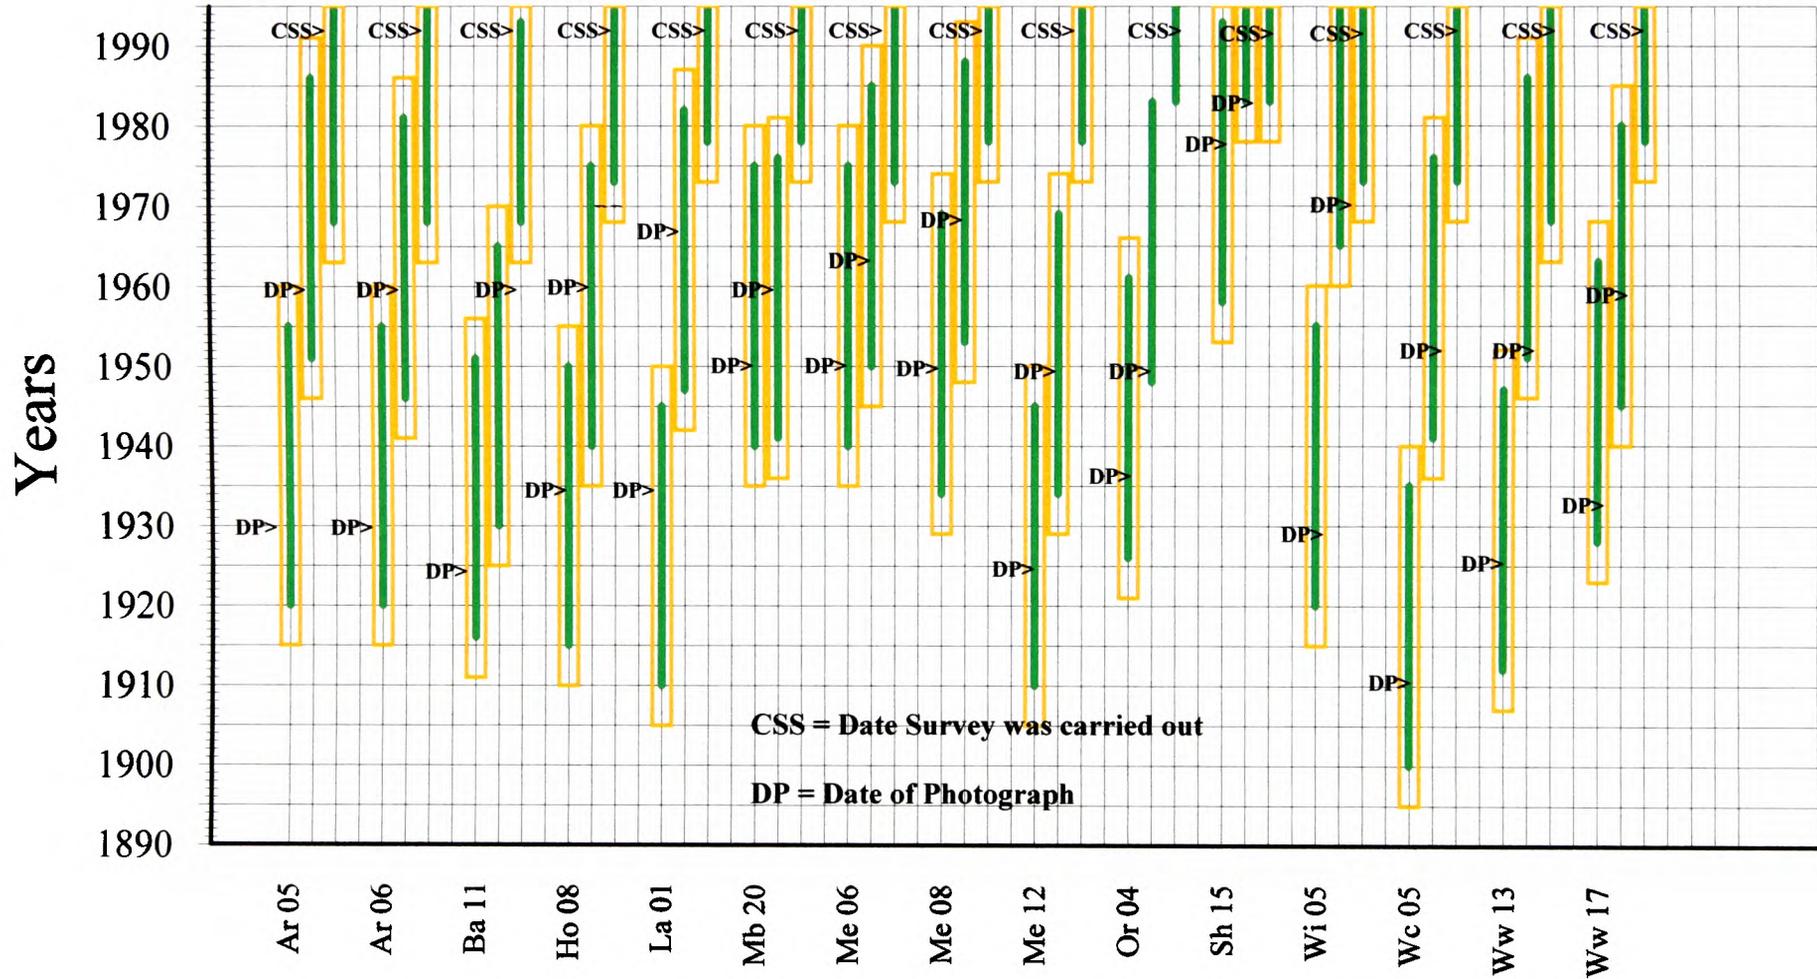
Graph showing max & min life spans of Thatch weathering coats

Individual Dwellings based on 35-45 year period

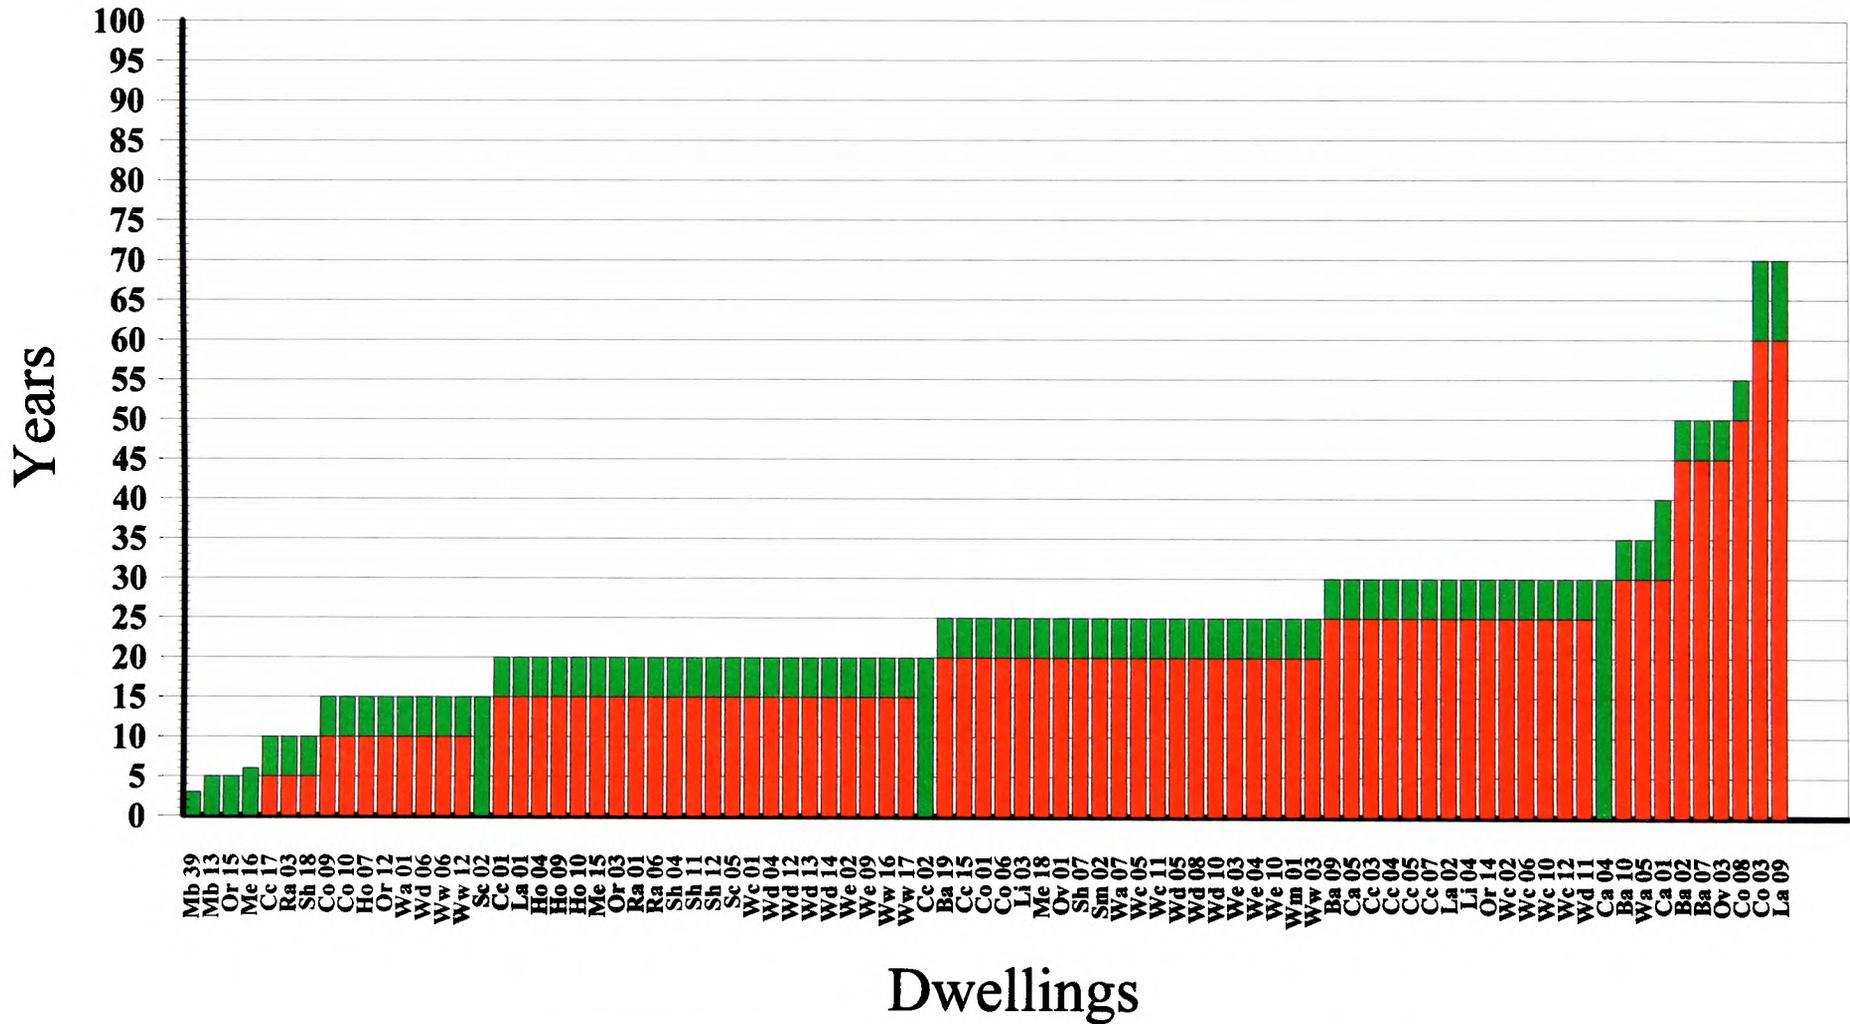
# Longevity of Water Reed Thatched Roofs in Cambridgeshire
