# Basic Construction: An introduction to Walls

(Housing and Health Series - Booklet IV)

# Housing Construction: An Introduction to Walls

Housing and Health Series, Booklet 4

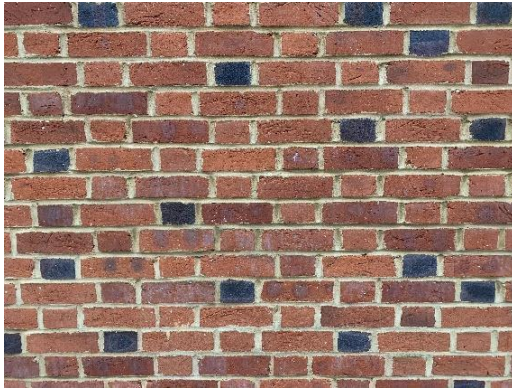
Solid wall with Flemish bond - alternate headers and stretchers in the same course.

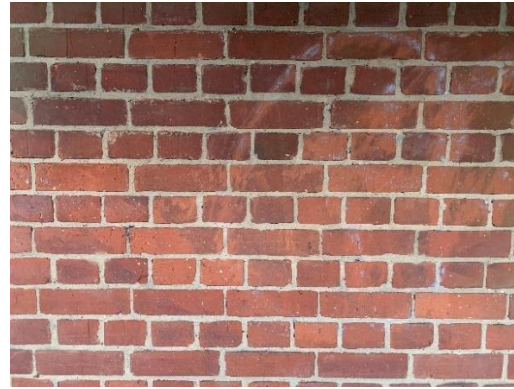
Solid wall with English bond - common until the end of the 18<sup>th</sup> century when Flemish bond became predominant.

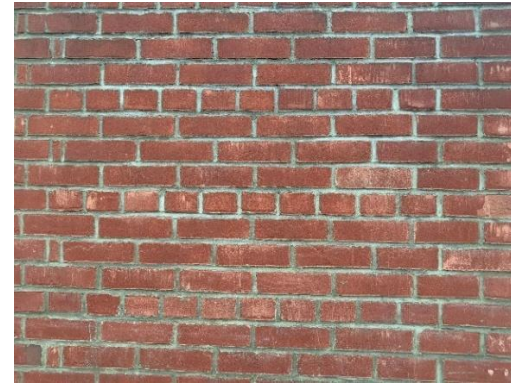
Solid wall with English Garden Wall bond. Found more rarely in house construction and more prevalent in free standing boundary walls.

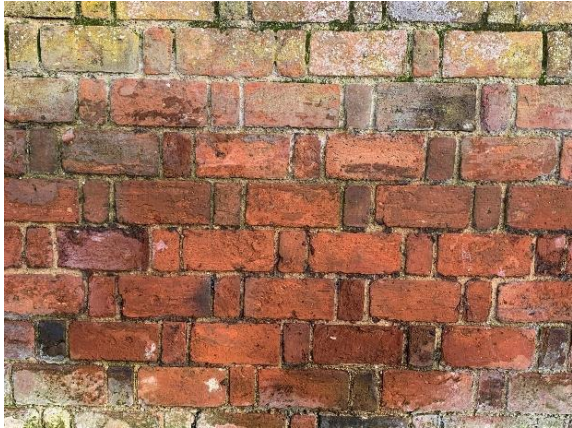
Solid wall with a Rat Trap bond pattern. The bricks were laid on their sides, which was cost saving but left voids within the wall providing shelter to vermin. Not common but may be seen occasionally, especially in garden/boundary walls.

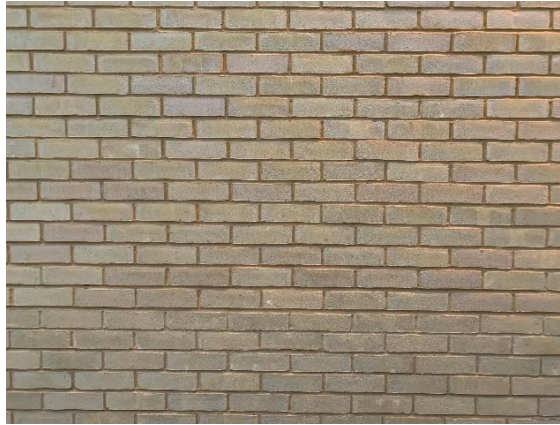
Stretcher bond which may indicate the outer skin of a cavity wall.

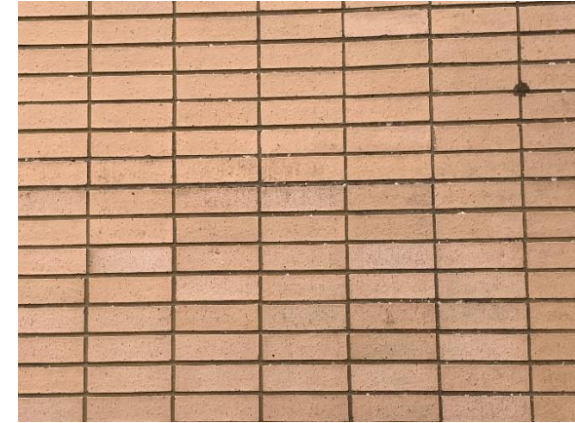
Beware, as sometimes not all is as it first seems! The use of brick slips or veneers can give the appearance of solid or cavity brickwork but are a form of wall cladding. This brick slip panel forms cladding to a framed building. Panels can match any bond pattern.

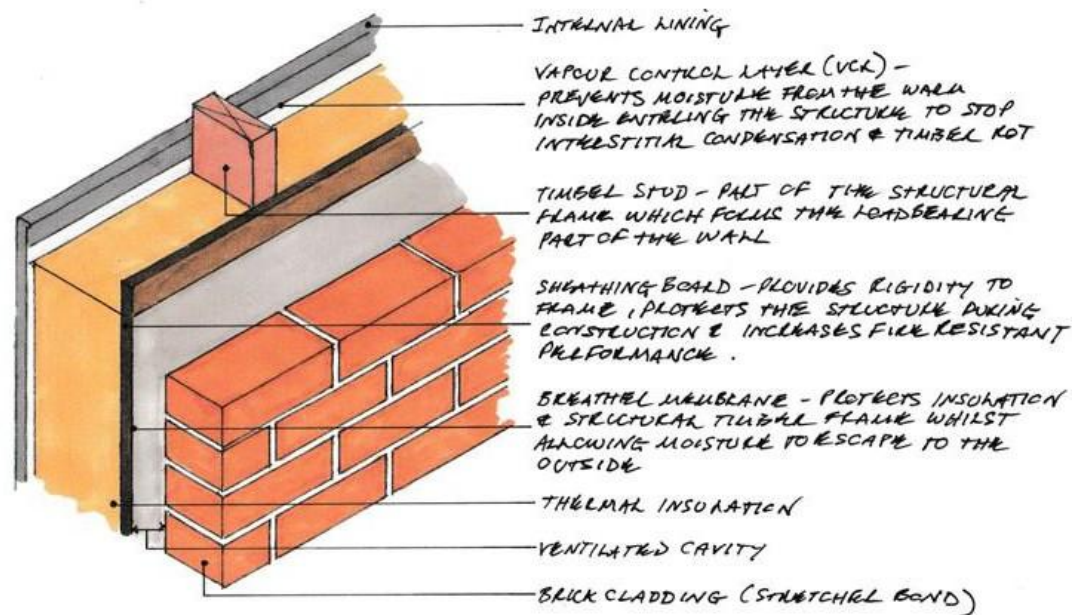
TIMBER FRAMED WALL

The outer skin to a timber framed wall, may have weep holes to ventilate the frame at eaves level and/or at the base of the wall above or below the damp proof course (DPC), although cavity walls may also have weep holes above flashings, doors, windows and other features, to ventilate the cavity and to allow water to drain out of it. Original windows, where present, may be set flush with the frame, thus appearing to be recessed in the wall when viewed from the outside. Doors and windows have weather sealed gaps around them to allow for differential movement as the timber frame shrinks over time. A triangular timber frame of sheathing material fixed to the frame at gable ends, may be visible when inspected from the roof void. The gable ends of buildings with cavity wall construction tend to be built with brick or concrete blockwork. Any openings in the wall for metering, telecoms access points and vents may reveal the timber frame behind a brick outer skin.

The thickness of the walls in timber framed buildings tends to lie between 250mm-300mm depending on the precise form of construction and the type of external cladding used.

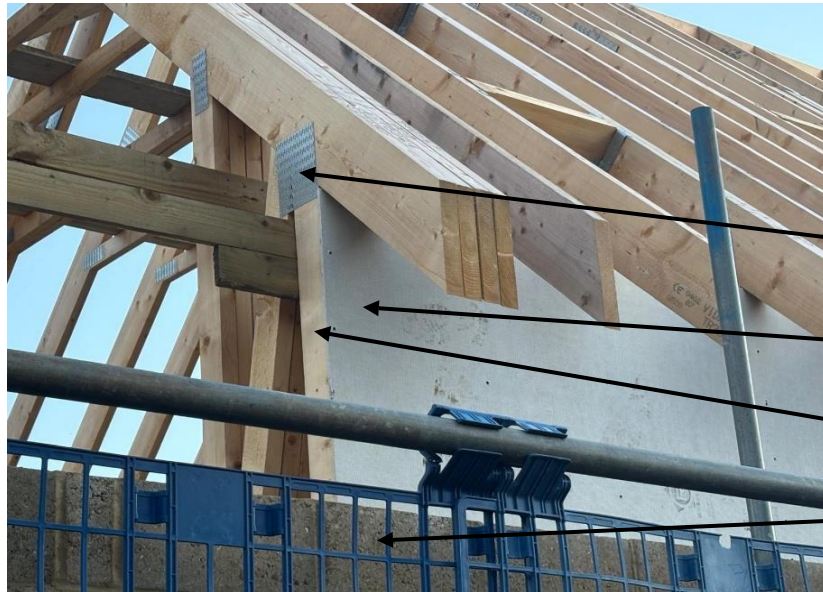
A timber framed house during construction. Here the cladding consists of concrete blockwork which will likely be rendered or some form of cladding applied.

Gangnail plate

Sheathing

Stud to timber frame

Blockwork cladding

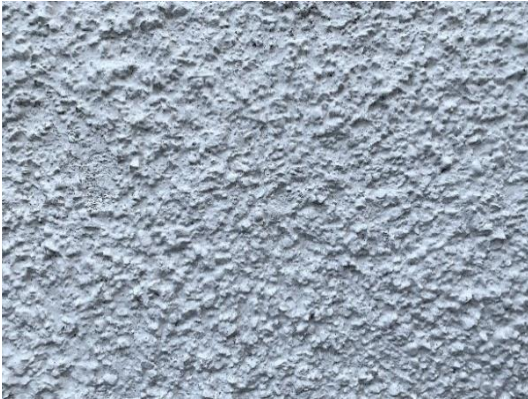
Wet dash render (roughcast)

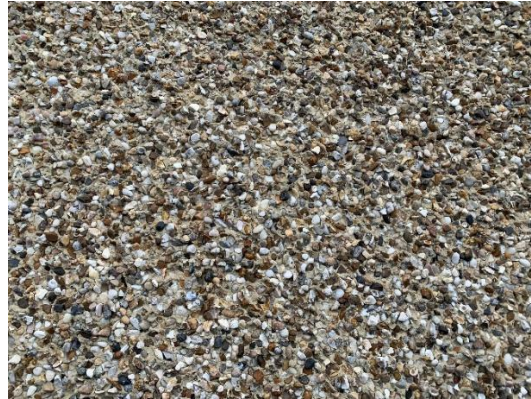
Dry dash

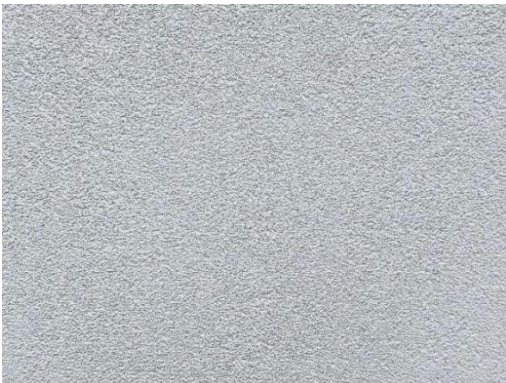
Tyrolean

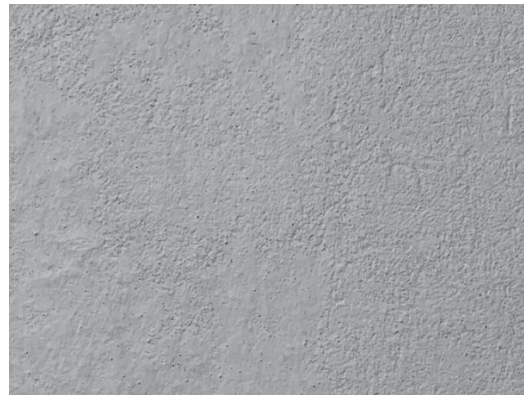
sand and cement

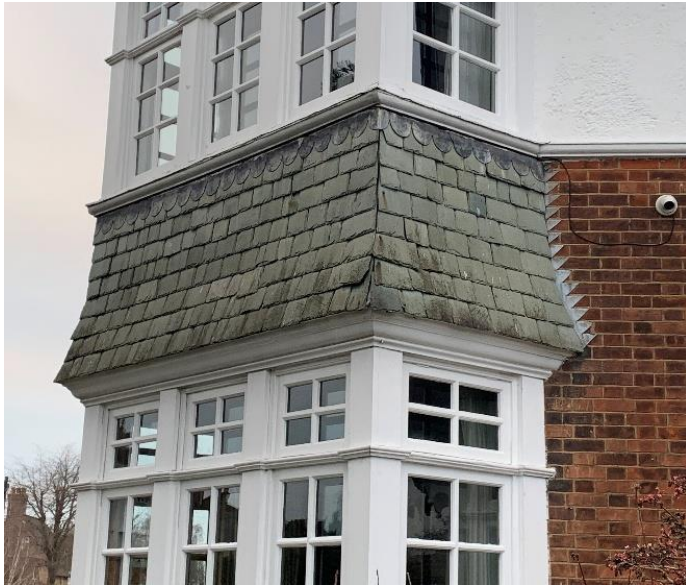
A natural Westmoreland slate hung feature between the floors of a two-storey bay window to this house built in and around 1910. The slates will be nailed to timber battens and often mask timber framing at first floor level. Note the scalloped lead apron beneath the sill to prevent rainwater ingress.

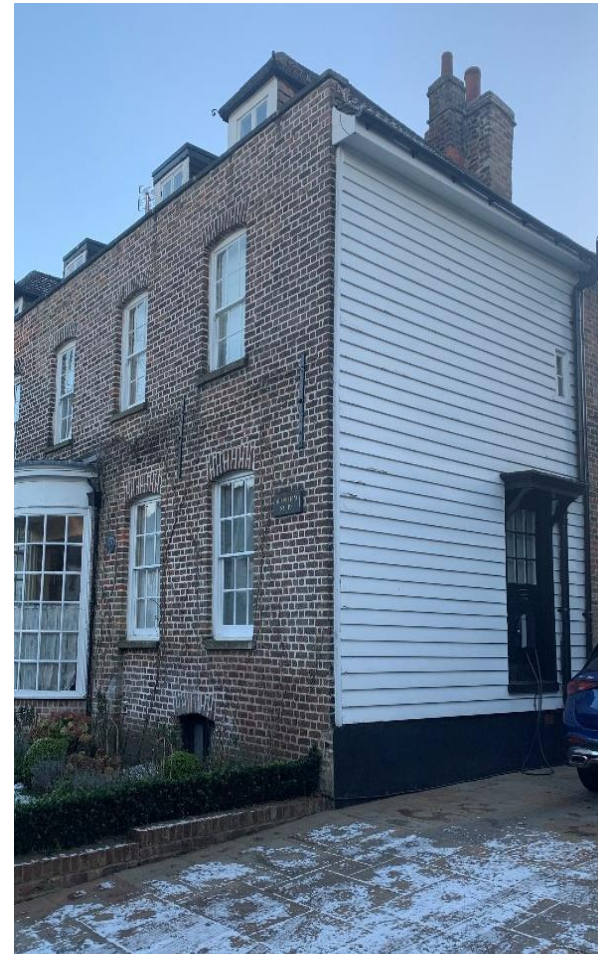
The flank wall of this end of terrace house is clad with painted timber weatherboarding

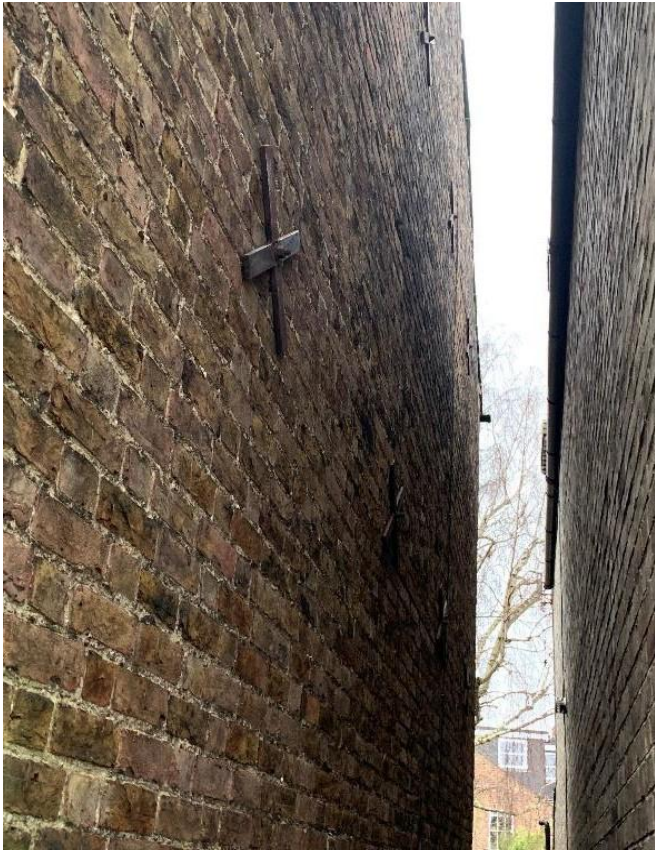
A solid wall (left) to an end of terrace house circa 1890. The wall has a pronounced bow. The presence of tie bars indicates that the wall may have lacked adequate restraint from the floor at first floor level and in this case, also from the roof.

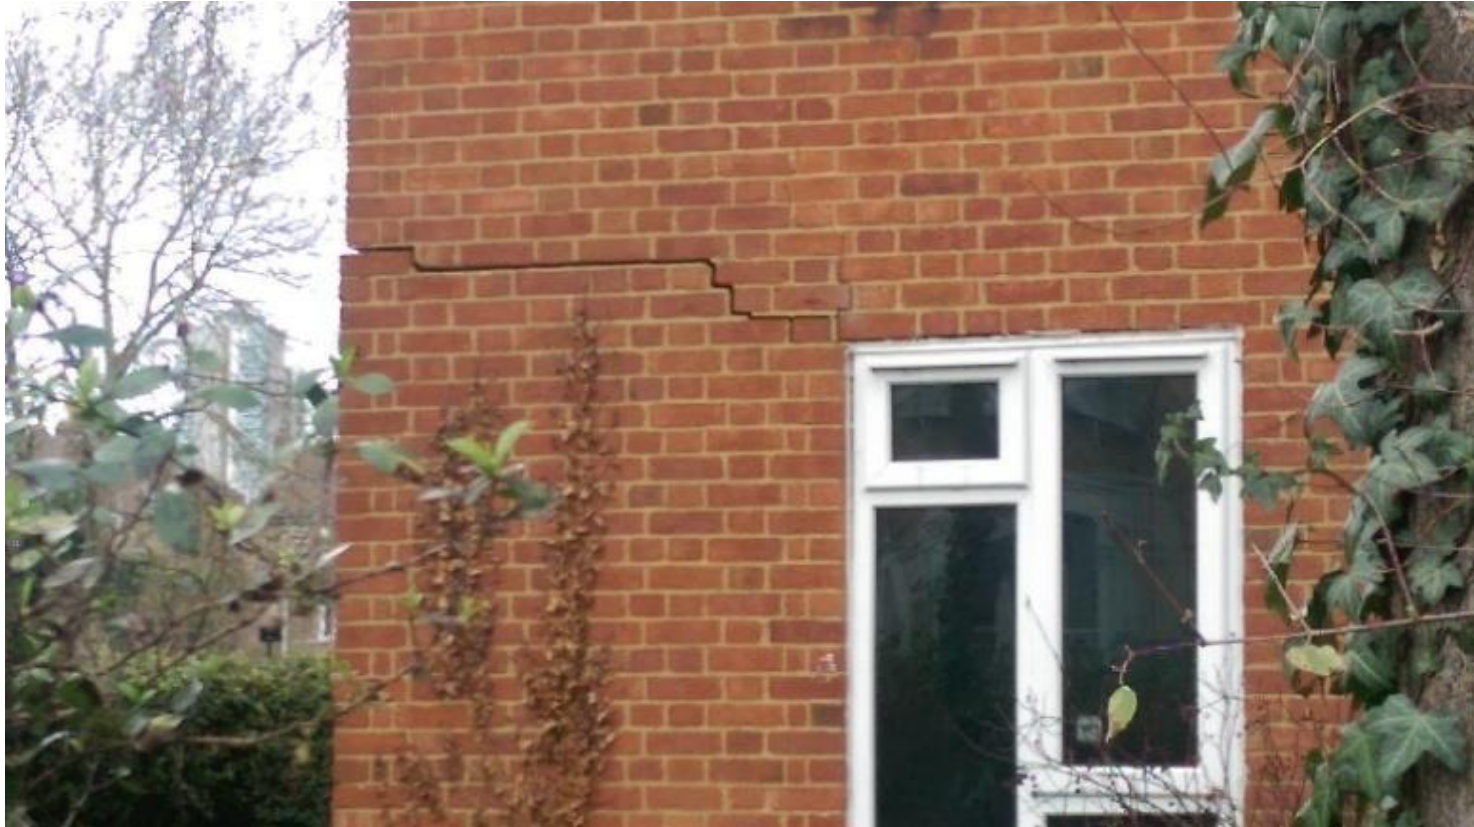
Crack diagnosis is a specialised business. There is a significant horizontal crack along the brickwork joint here which is repeated on the return wall. There is also displacement to the brickwork at the corner. Cracks often find their way to a door or window opening as these represent a weakness in the wall's structure. There may be sympathetic cracks on the inside of the wall. There is no indication of any previous attempt at repairs. Monitoring and further investigation will be required to determine the cause and progress (if any) of the movement. The crack is around 10mm wide and is considered to present moderate damage. Weathertightness may be compromised and remedial repairs will be necessary once the cause of movement has been identified.

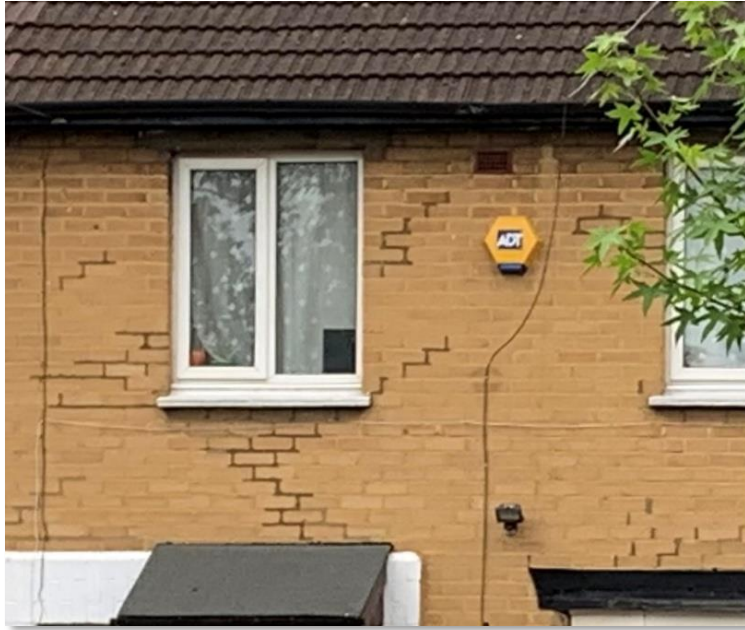
One might suspect that the building here has subsided, but this is not the case. The outer leaf of the cavity wall has been built with calcium silicate bricks which are prone to thermal expansion and contraction. Thermal movements associated with these bricks are about 1.5 times greater than that of clay brickwork. A stronger mortar mix used for jointing, fails to accommodate this movement and cracks along the joints result. The cracks in this wall have been repaired but have negatively affected the aesthetics of the house.

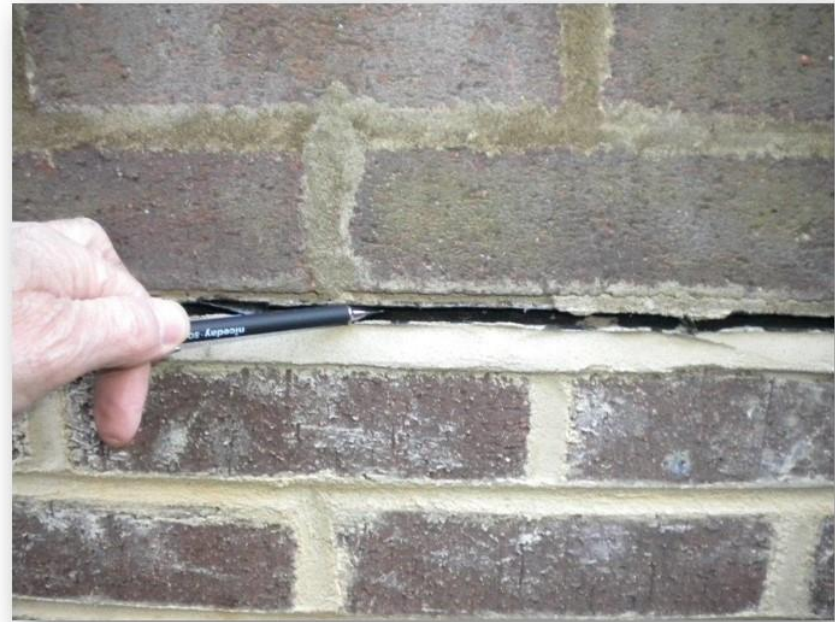
The bitumen DPC acts as a slip plane to accommodate to an extent, differential thermal or other movements between the brickwork above and below it in a cavity wall. The brickwork above the DPC here is oversailing the lower courses. This might indicate a structural issue requiring remediation.

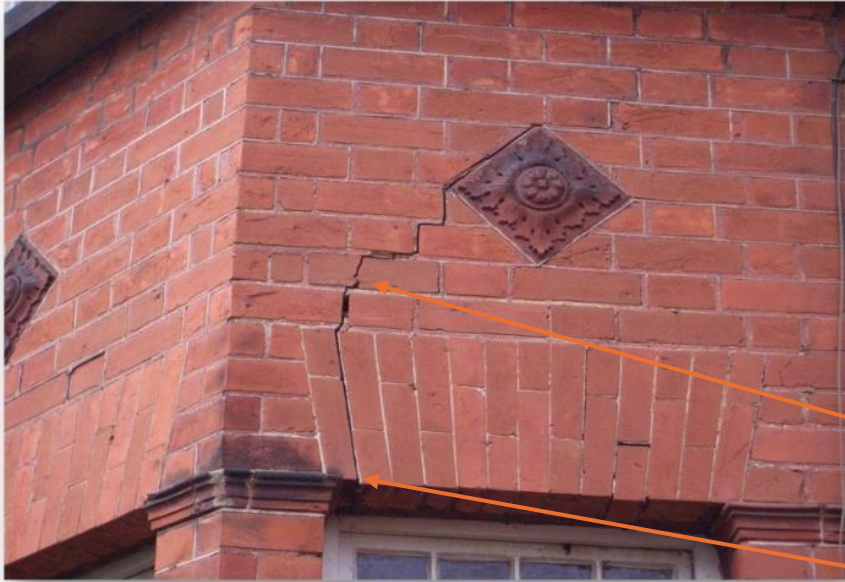
This flat gauged brick arch has dropped. A crack has developed above the arch where it is no longer adequately supporting the load of the wall. Any timber lintel behind the arch may be subject to decay as rainwater penetrates the cracks.

Diagonal crack in the wall above the arch

The arch has dropped

The section of wall above an opening must be supported. Brick and stone arches and lintels bear the load of the wall above the opening. Lintels may be timber, steel or reinforced concrete. The failure of arches or lintels can cause cracking and disturbance to brickwork above them. In the absence of an arch or lintel, the removal and replacement of windows previously supporting the wall above openings may lead to similar failures.

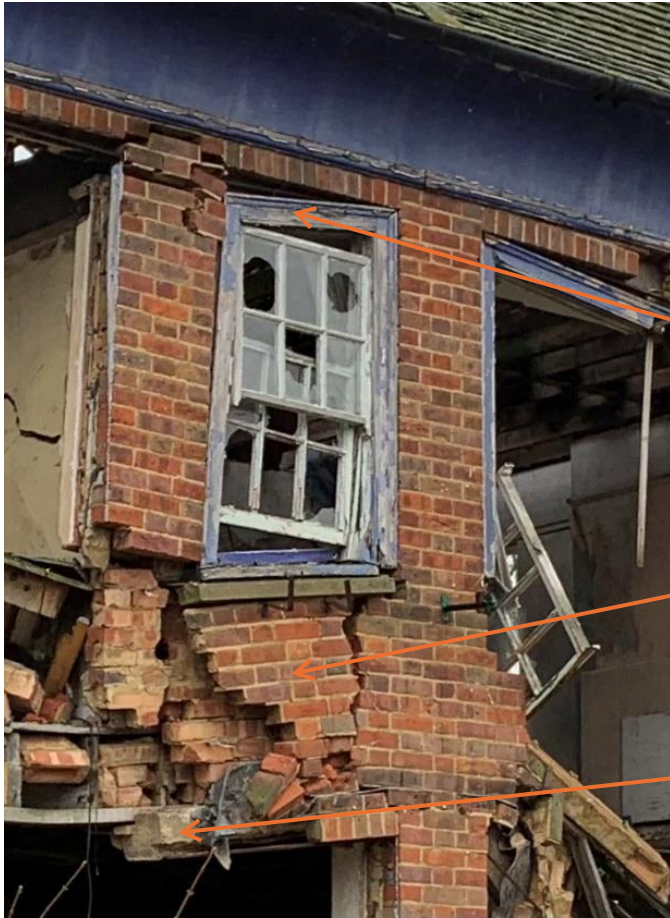
The window opening has deformed as the support below it has been lost

The brickwork has collapsed

Catastrophic failure of the concrete beam above a large structural opening in the wall below

An extreme example showing a fire damaged building. The concrete beam across the opening on the ground floor has failed. The damage caused to the unsupported wall above it is evident.

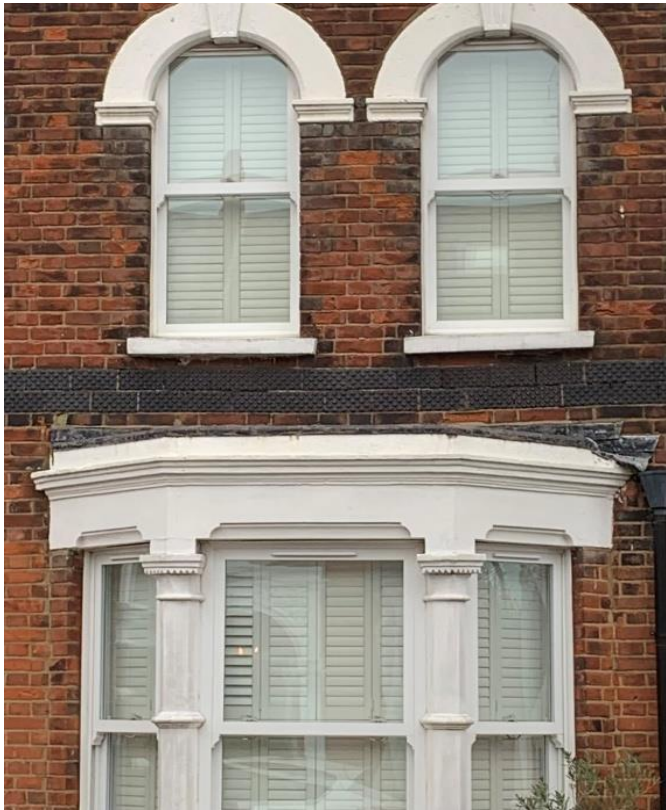
Timber beams were often used to carry the load of the wall above bay windows. If the beam was inadequate for the load or has become affected by dampness and decay or wood boring insect attack, it can fail to support the wall. Inadequacy of or defects to the flashing above the bay roof may be the cause of dampness affecting the beam.

The beam (not visible) supporting the wall above this bay window has deflected. There is a noticeable wave in the black patterned band course above the bay and the sills to the windows on the first floor are sloping toward one another. The pattern of brickwork in the panel between the first floor windows is also distorted. The issue may not be progressive. Thick mortar joints apparent to the top of the bay brickwork and the main wall on the right-hand side, may indicate repairs made necessary by possible movement in the bay historically. Again, this may not be ongoing.

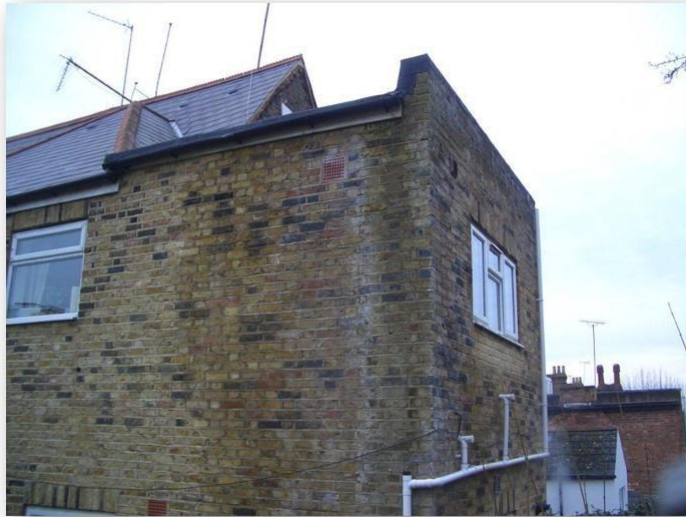
staining to the brickwork to this solid wall indicates saturation by rainwater and could be causing penetrating dampness evident to internal finishes and decorations, leading to their eventual deterioration. This may be caused by inadequate edge detailing to the felt roof covering and/or discharge behind the gutter, as well as by a defect to the gutter itself (here it has deflected). The exposed parapet wall to the rear elevation has no capping and water cannot be shed sufficiently far enough away from the face of the wall.

Heavy saturation of brickwork caused by leaking rainwater gutters, or downpipes, blocked or leaking waste and soil pipes, can lead to penetrating dampness, often visible as staining and sometimes accompanied by green vegetative growth. In addition, the inadequate projection of sills, copings and roof tiling or slating, can result in the wall below these features becoming saturated. Penetrating dampness through the thickness of a wall will appear as dampness, staining or spoilage/deterioration to the internal wall lining/finish. This is more common in a solid wall than a cavity wall but can occur in the latter where cavity insulation or wall ties have been incorrectly installed, are contaminated with mortar droppings or the cavity is bridged by an obstruction or filling material to form a moisture pathway from the outer to the inner leaf of the wall.

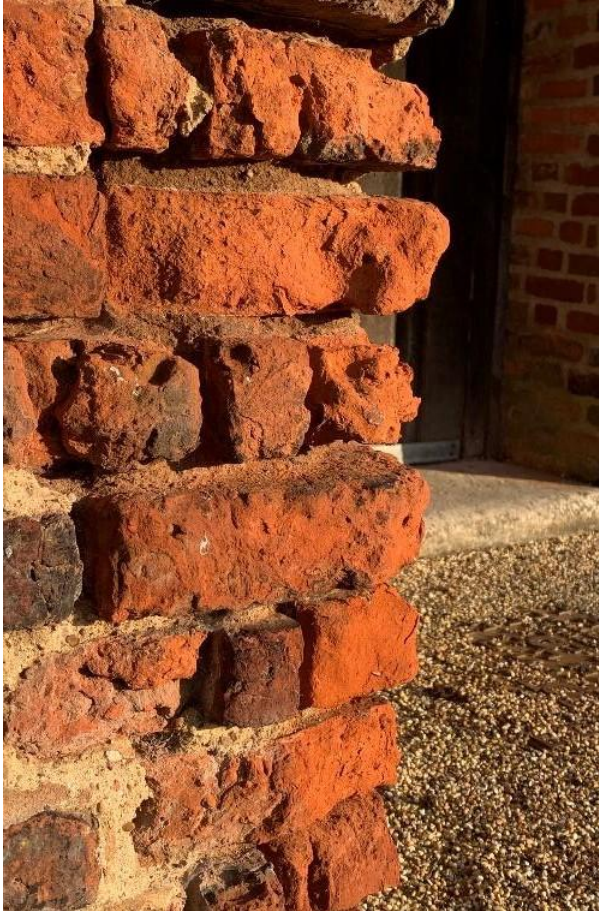
soft red clay bricks are prone to frost damage, leading to their eventual disintegration.

Frost attack and spalling to brickwork as well as reducing a wall's strength and structural integrity, can also make the wall less resistant to the passage of moisture. The condition of mortar joints should also be assessed.

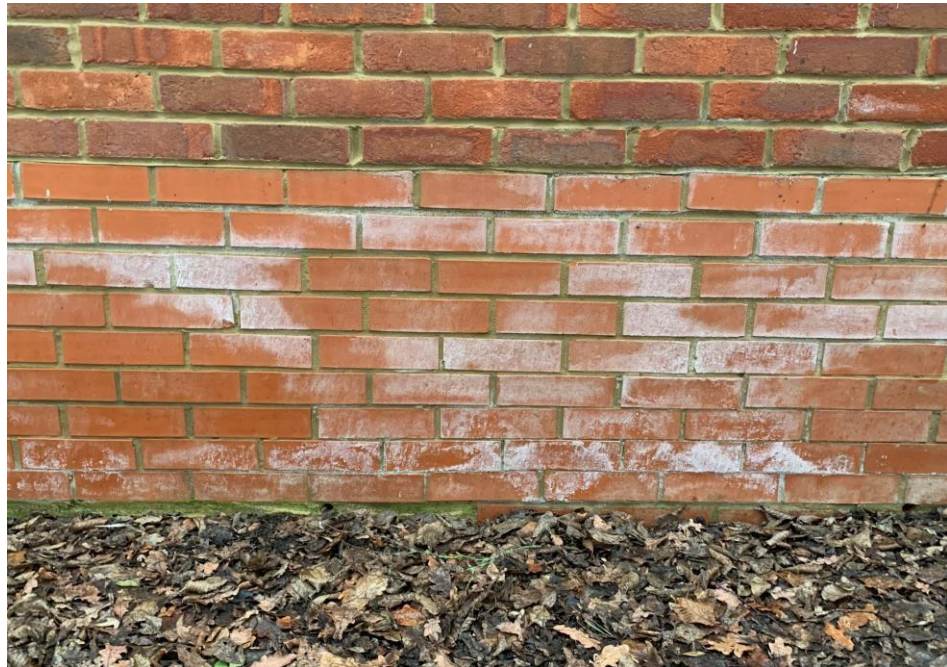
Efflorescence caused by the crystallisation of salts on the brick's surface. It is unsightly but often not damaging, although in some instances, this can suggest persistent damp conditions and in the worst cases, can result in spalling.

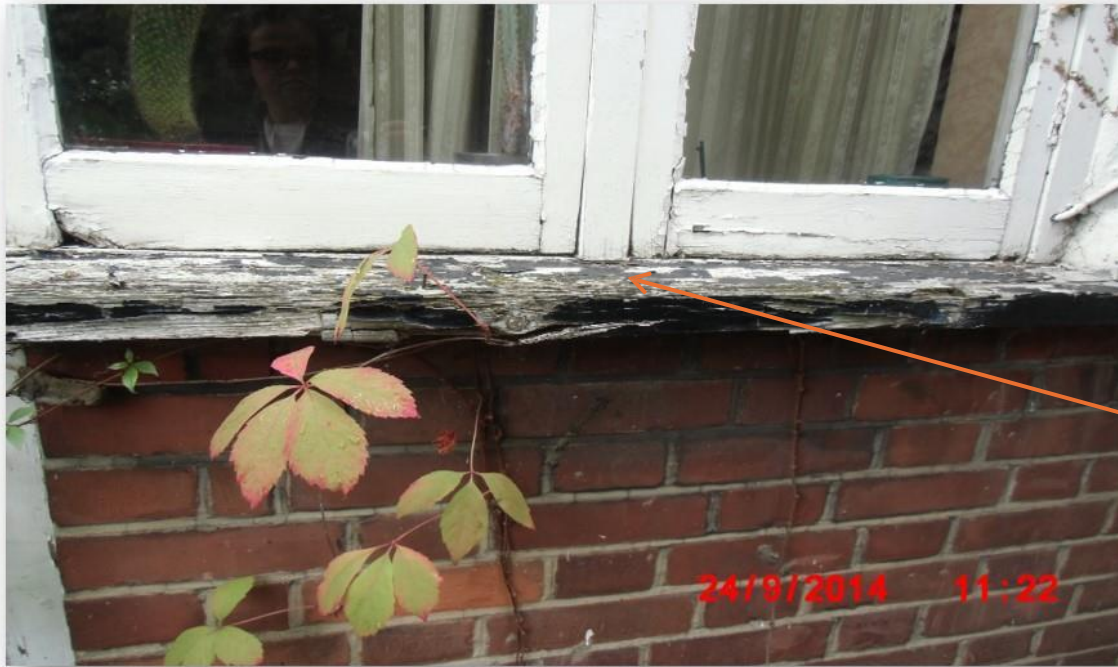
A rotted external timber windowsill leading to dampness penetration. The other issue here is that the sill will be less effective at throwing rainwater away from the wall below it. With the brickwork consequently becoming saturated, further penetrating dampness can result.

This timber windowsill has rotted and is now susceptible to letting in rainwater which will be evident to the wall below the window internally, potentially causing spoilage to decorations and the failure of plaster finishes.

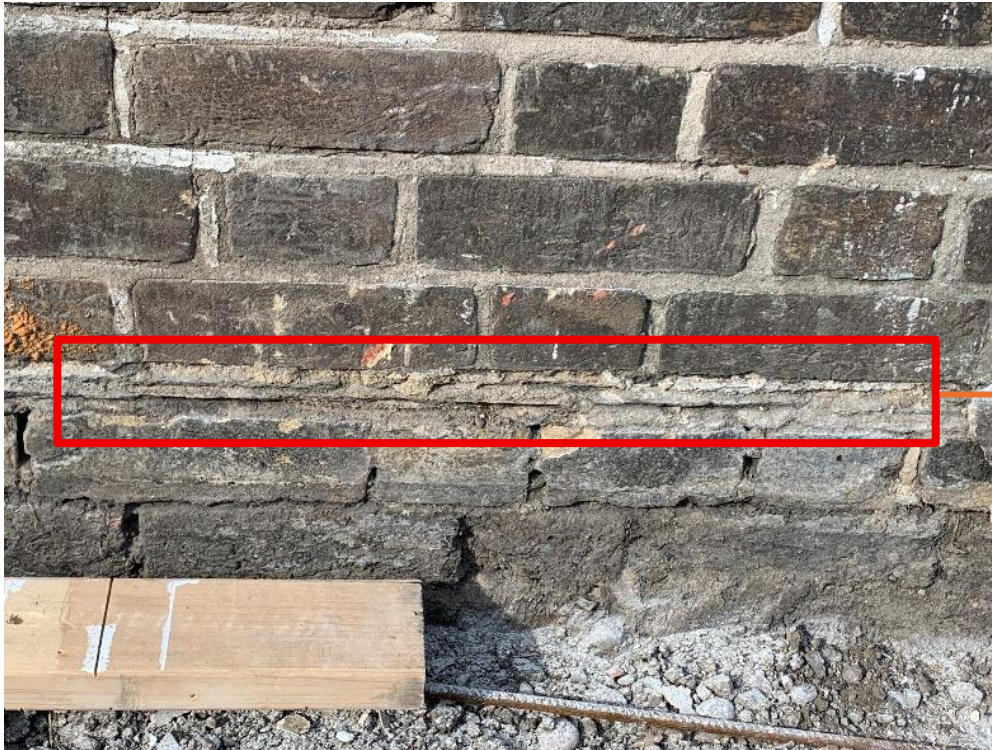
A slate DPC in this solid wall in a house built in the late 19<sup>th</sup> century is visible. Slates are laid in two courses to 'break joint' (staggered) in order to maintain continuity as a barrier to rising dampness. Usually this is hidden behind a thick mortar joint, but here the mortar over the DPC has deteriorated to reveal it. The slates are not tolerant to substantial movement and can fracture leading to failure.

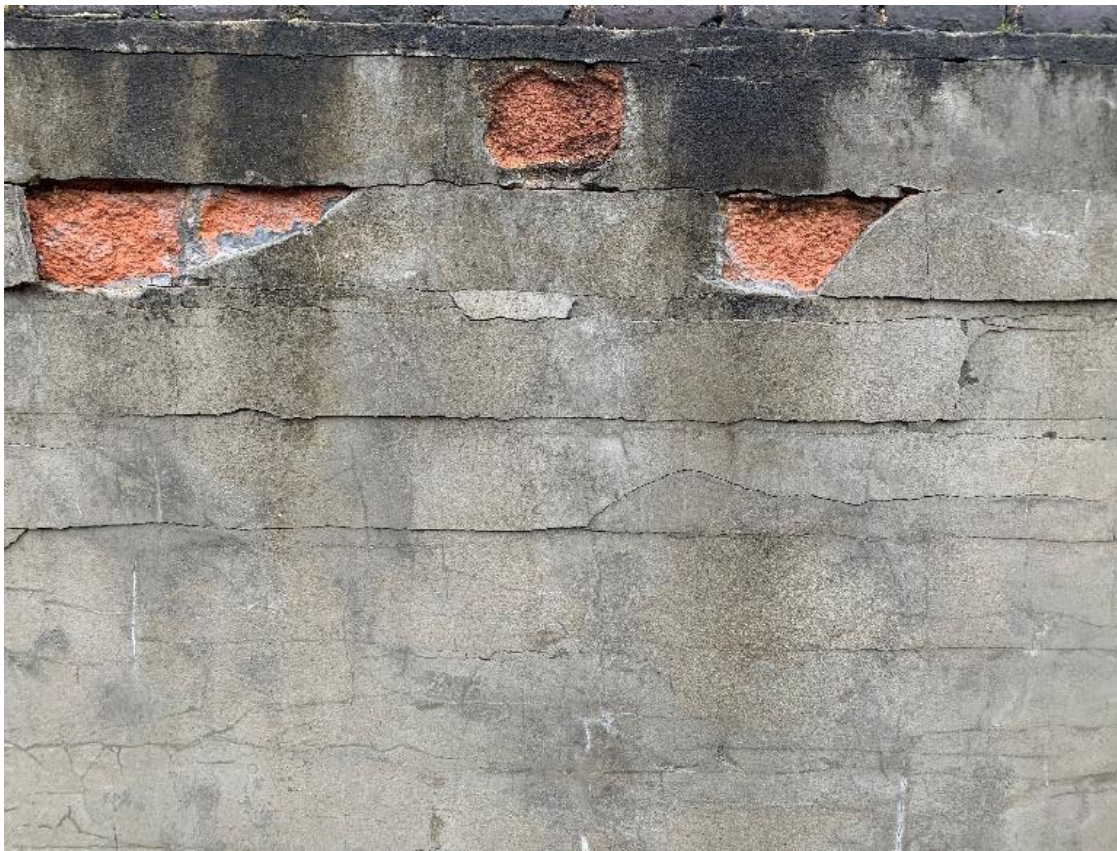
Fine shrinkage cracks in this render likely too rich in Portland cement. Rainwater has been drawn in and trapped behind it. Dissolved sulphates in the water have attacked the mortar joints in the brickwork, resulting in the more obvious horizontal cracks. The render is blowing because the trapped water has frozen, pushing it away from the wall. The render was likely applied to hide the spalling faces of the bricks in the wall behind. Sulphate attack is more prevalent to walls in exposed positions, including parapet and freestanding walls as well as to brick-built chimney stacks.

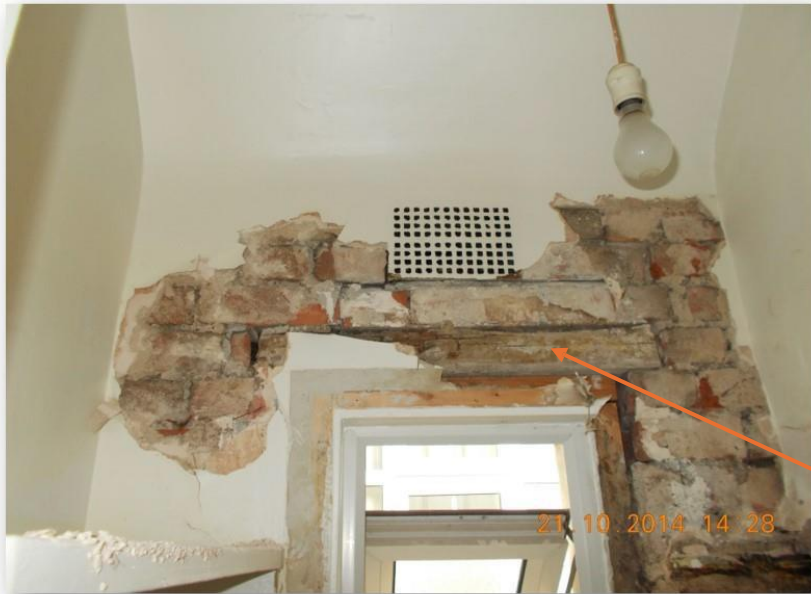
Timber 'backing' lintel affected with wet rot. The sagging lintel has lost its strength and load bearing capacity.

In older buildings behind a brick arch, timber lintels were used to carry the weight of the wall above it so that the wall was supported throughout its thickness. These are prone to decay as they are only a ½ brick away from the outside face of the wall and may fail without remedial works, which can involve replacement with a reinforced concrete or galvanised steel lintel.

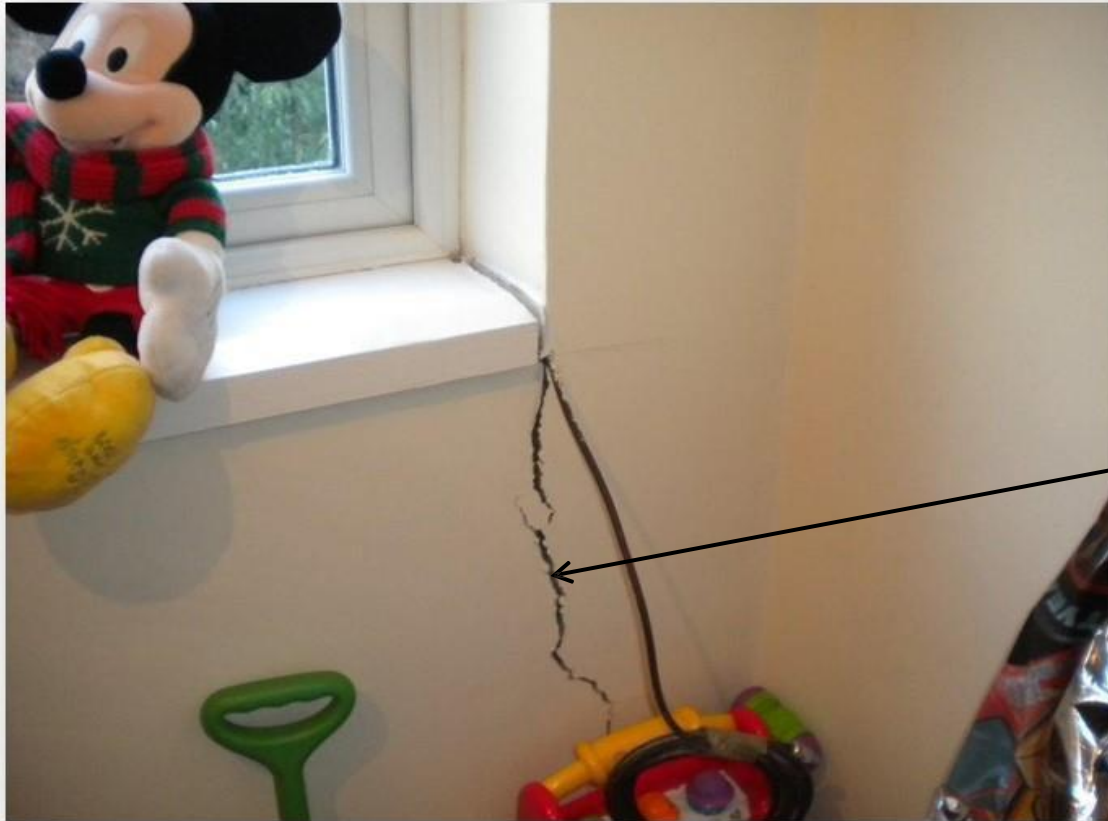
The crack in the wall below the window opening internally may have resulted from the replacement of the windows in the storey below and a failure to provide adequate support to the wall above it. It may also indicate subsidence. Further investigation is necessary and the pattern of any cracking to the wall externally noted.

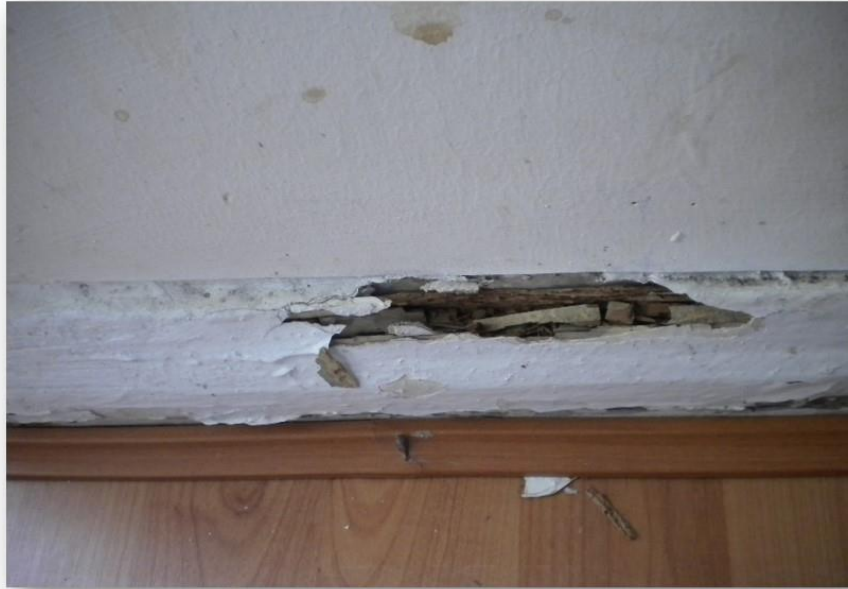
Rot in the timber skirting board in this room on the ground floor is the result of rising dampness in the wall behind. The same kind of damage may though have been caused by penetrating dampness or by a plumbing leak, especially one affecting a solid floor which can soak up the water like a sponge. It could also occur because of a failure of the DPM in a solid floor with which the skirting may be in contact.

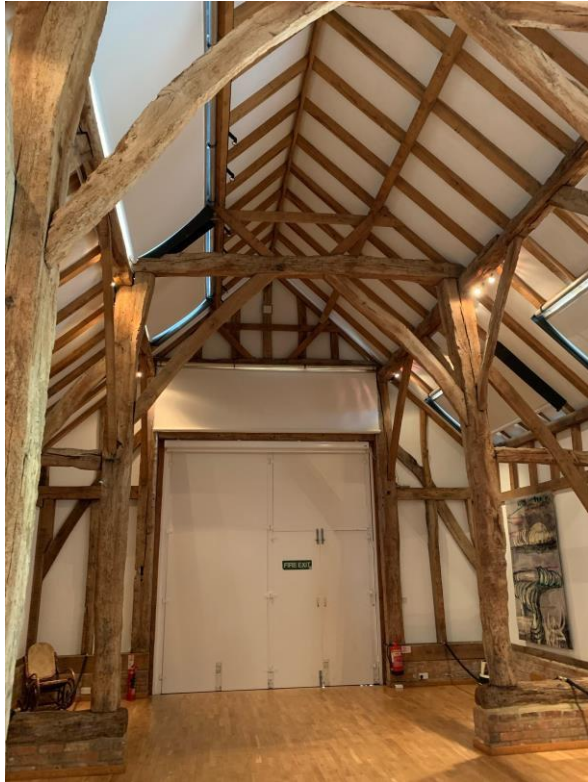
An oak framed timber building (not a house in this case but a barn). Their popularity in domestic construction waned after about 1700, particularly in urban areas until relatively recently (from the 1980s onward).

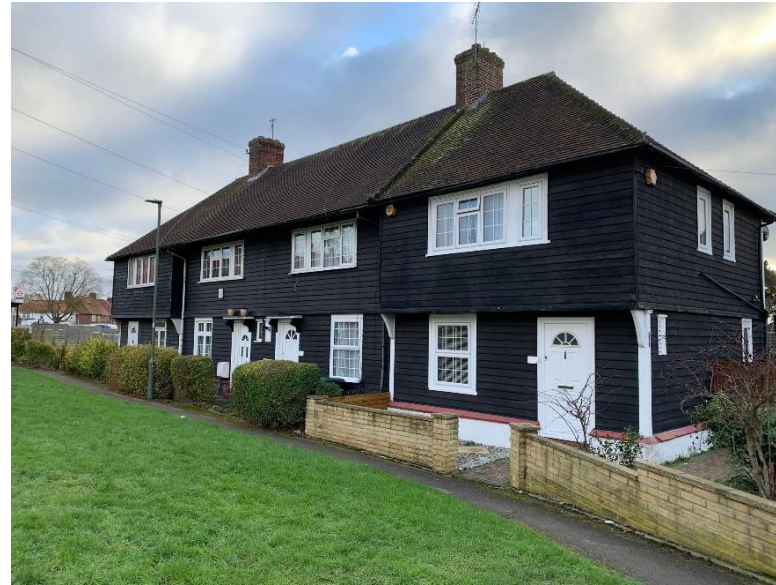
A London County Council system-built timber framed house, the Scano Type III, from 1925-1929. The timber frame is raised off a brick perimeter wall which stands just over 600mm above ground level. The outside of the frame was originally lined with bituminous felt and finished with a cladding of horizontal timber panels treated with creosote. The inside of the frame was lined with fibreboard. This variant features a jettied (projecting) first floor supported by timber posts which are visible in this photograph.

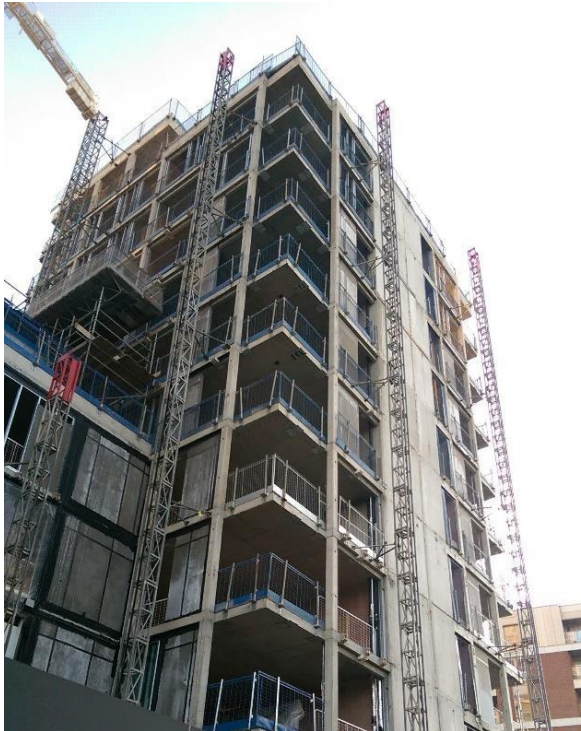
In the process of construction, this block of flats shows off its concrete structural frame.

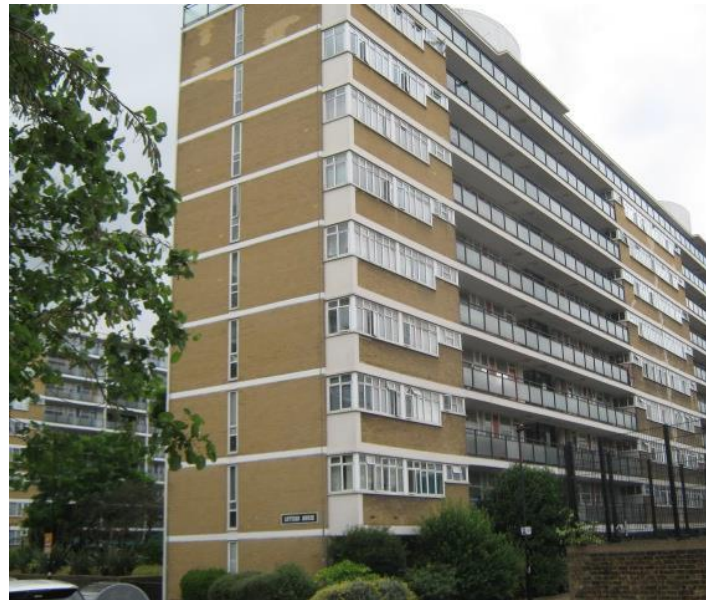
One of 32 concrete framed tower blocks of varying styles on the same London estate designed in 1946. The estate was not completed until 1962.

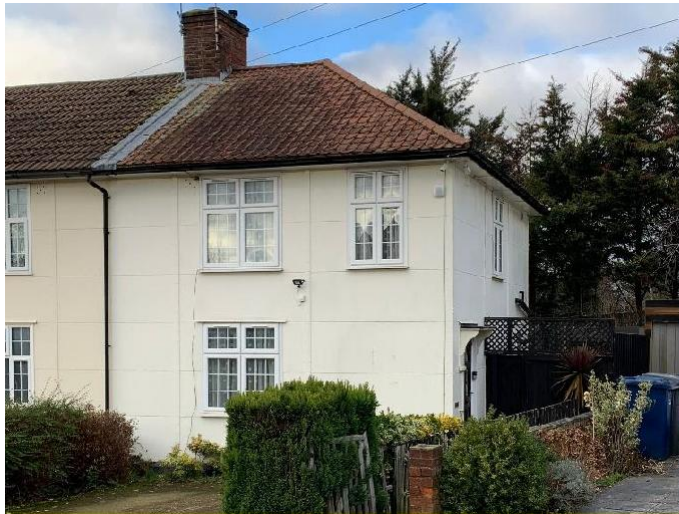
A steel framed house, the Atholl 1926 (1926-1928). As built, external walls are clad with painted flat steel sheets bolted to upright steel framed members (stanchions). Internal linings are fixed to timber battens.

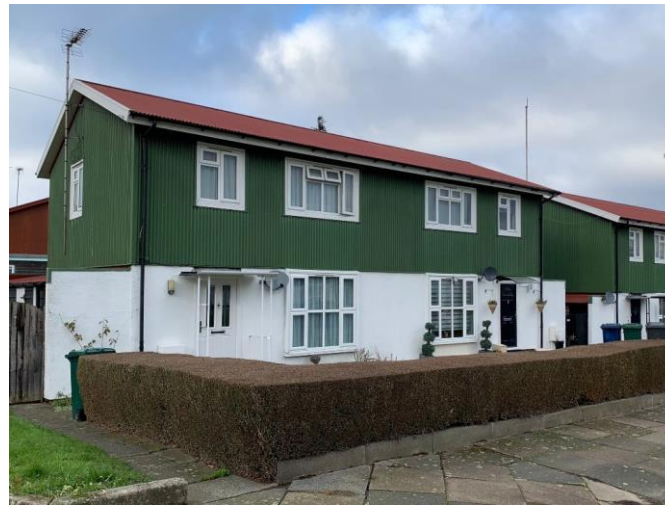
A British Iron and Steel Federation (BISF) house with a steel frame and clad on the first floor with steel profiled sheeting and a cement render on metal lathing to the ground floor. Timber battens on the inside of the frame provide a fixing point for plasterboard linings.

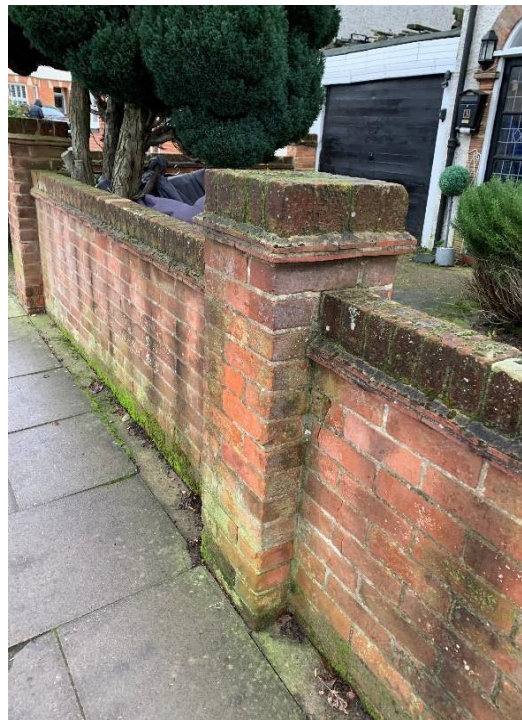
A low half brick boundary wall with brick and half end terminal and intermediate piers.

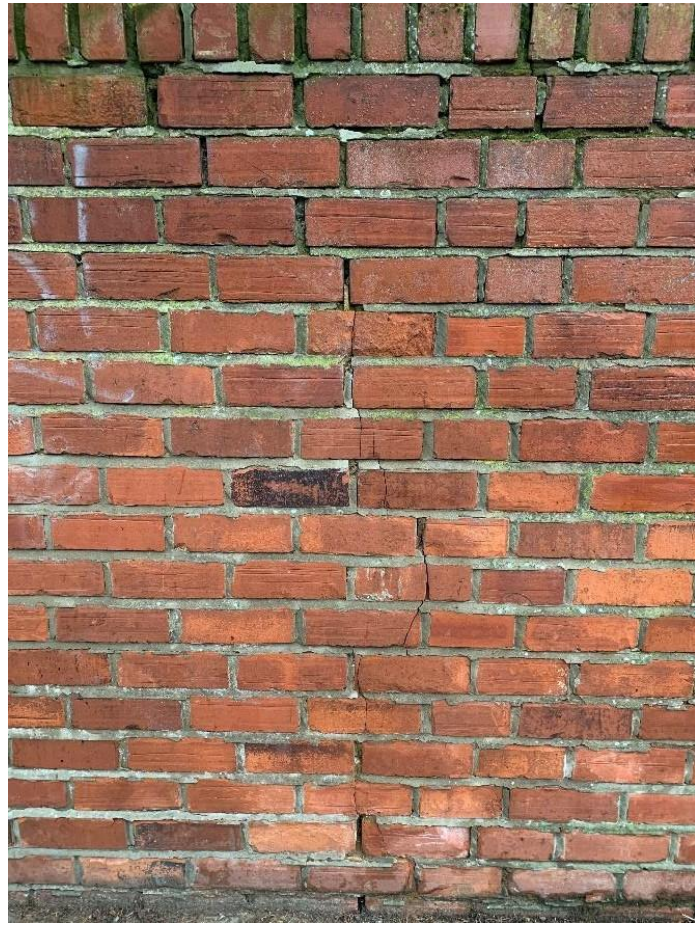
A crack in a long boundary wall without expansions joints caused by thermal movements.

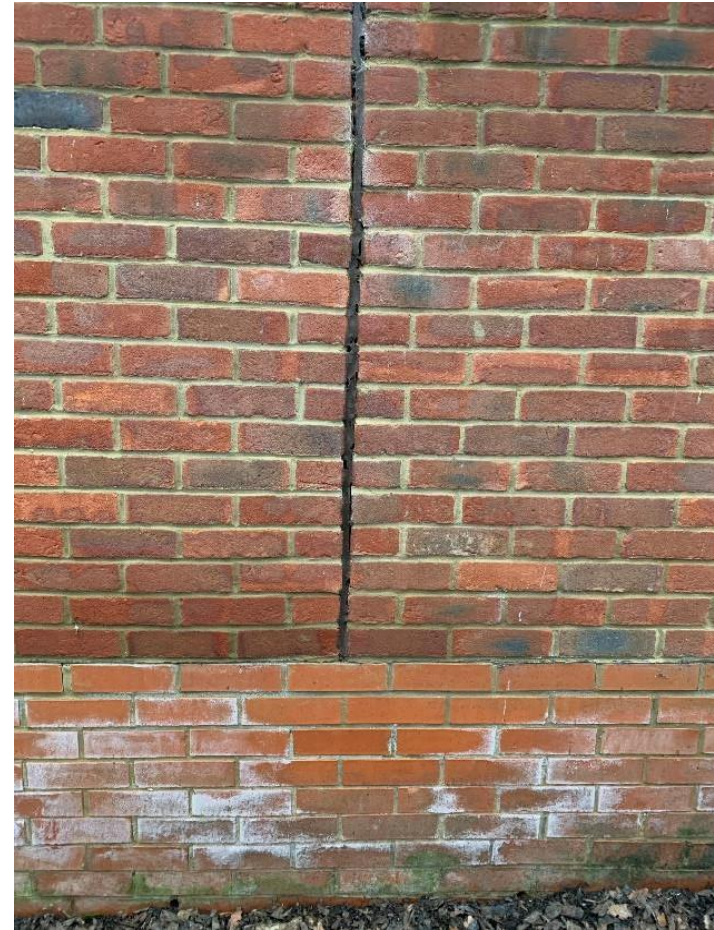
An expansion joint in a tall boundary wall. This is filled with a flexible filler and pointed with a mastic sealant. They should be provided every 6m to accommodate thermal movement.
