# Basic Construction: An introduction to Walls

(Housing and Health Series - Booklet IV)

# Housing Construction: An Introduction to Walls

Housing and Health Series, Booklet 4

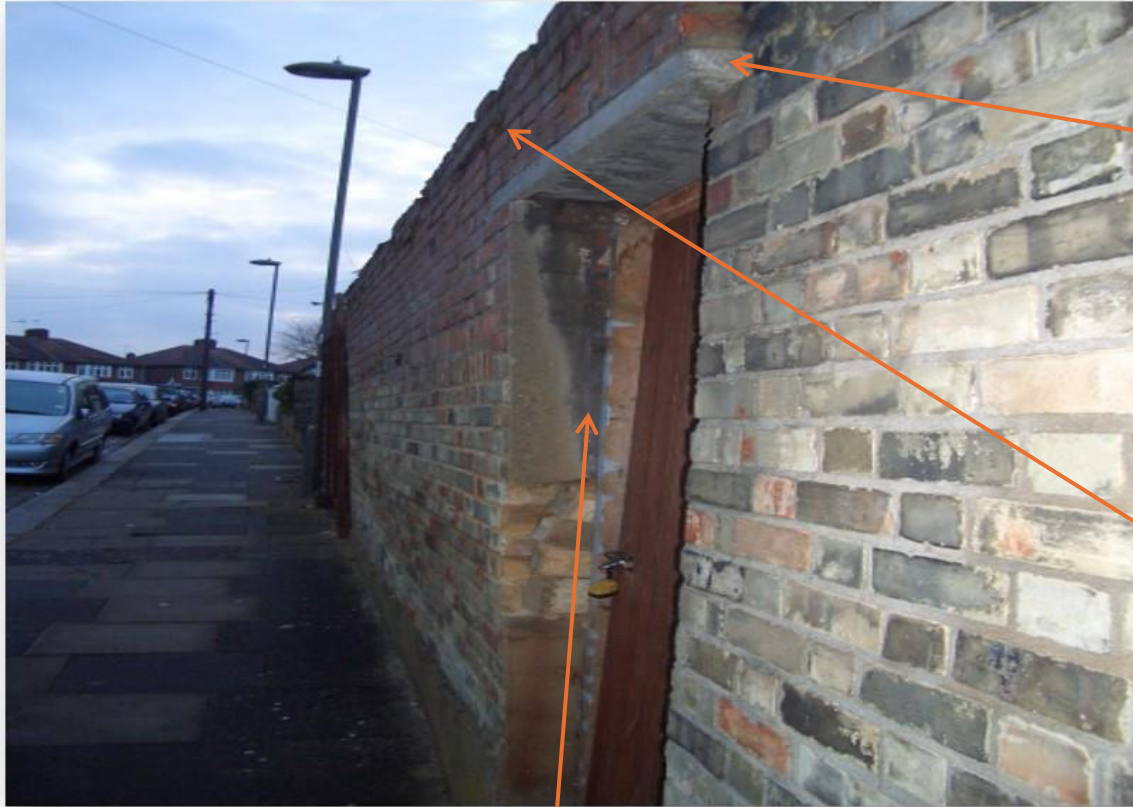
The degree of movement in the wall can be seen here as the lintel above the side door opening has broken away from its bearing above the near part of the wall, which has remained true to the vertical. Without remedial work, the wall may eventually collapse posing a significant danger to those using the public footpath

The brick-on-edge copings protecting the top of the wall are spalling and some of them are loose.
