Bioactive Materials

Open-porous magnesium-based scaffolds withstand *in vitro* corrosion under cyclic loading: A mechanistic study

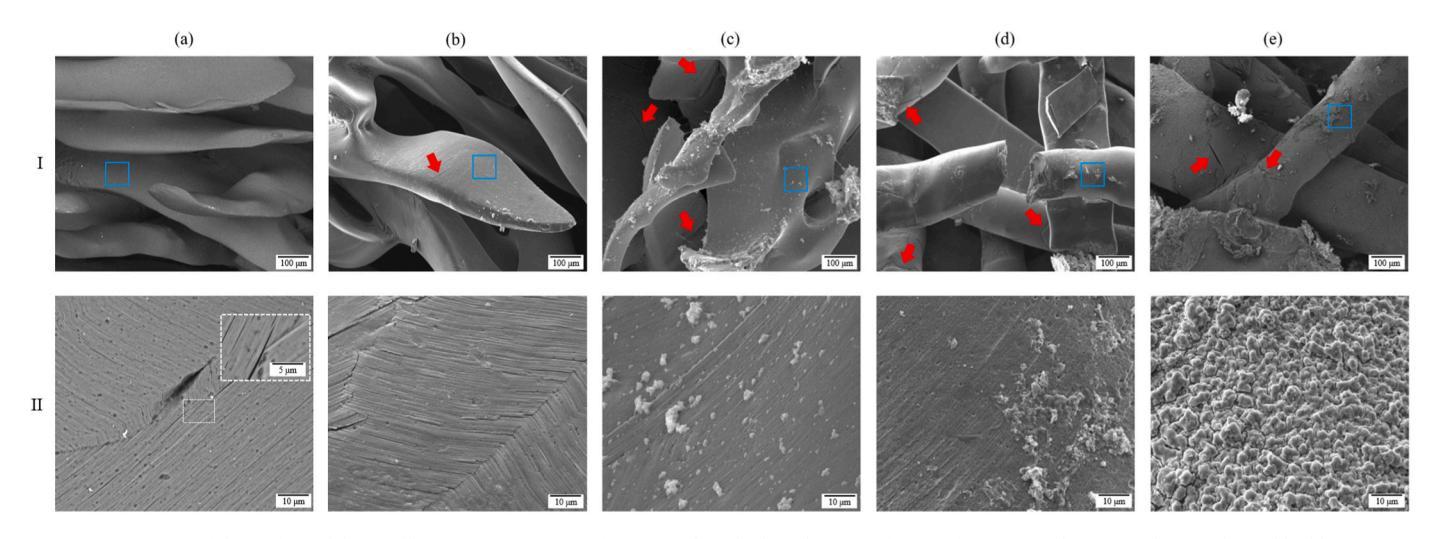
Fig. 1. SEM images of the surface of the Mg fibres at (I) 500X magnification and (II) higher 5kX magnification focusing on the coating layer indicated by blue squares in (I) at (a) 0, (b) 2, (c) 2 cyclic, (d) 8 and (e) 14 days of *in vitro* corrosion in HBSS. Red arrows indicate microcrack initiation.

The surface of the pre-corroded fibres showed no apparent microdamage at the macro scale (Fig. 1Ia). However, at the micro level, the coating layer of pre-corroded specimens showed an inhomogeneous covering, highlighted by the presence of coating microcracks of 0.5–1 µm in diameter (Fig. 1IIa). After corrosion, the coating layer displayed a rougher surface contrasting with the smooth surface of the pre-corroded coating. Particle deposition started to occur after 2 days of *in vitro* corrosion in HBSS, along with the initiation of transverse microdamage, that substantially increased after 8 and 14 days, leading to critical fibre failure identified by visual inspections (Fig. 1Id). The application of *in situ* cyclic compression (Mg2c) led to increased particle deposition on the coated surface compared to specimens without cyclic loading (Mg2).

While most of the fibres remained uncorroded, a localized accumulation of corrosion debris, trapped between the central fibres of the scaffold, appeared from day 2 and increased over 14 days (Fig. 2I). SEM cross-section images revealed a fragmented coating layer with long filiform pitting corrosion penetrating through the fibres that were aligned with microcracks (Fig. 2V). Considering the heterogeneous and stripe-like shape of the corrosion pattern of a few microns thickness, we hypothesise that the coating microcracks found on the surface of the coating layer initiate the corrosion process that continues and penetrates the fibres, forming corrosion microcracks that lead, with longer immersion time, to complete fibre failure (Fig. 1Id).

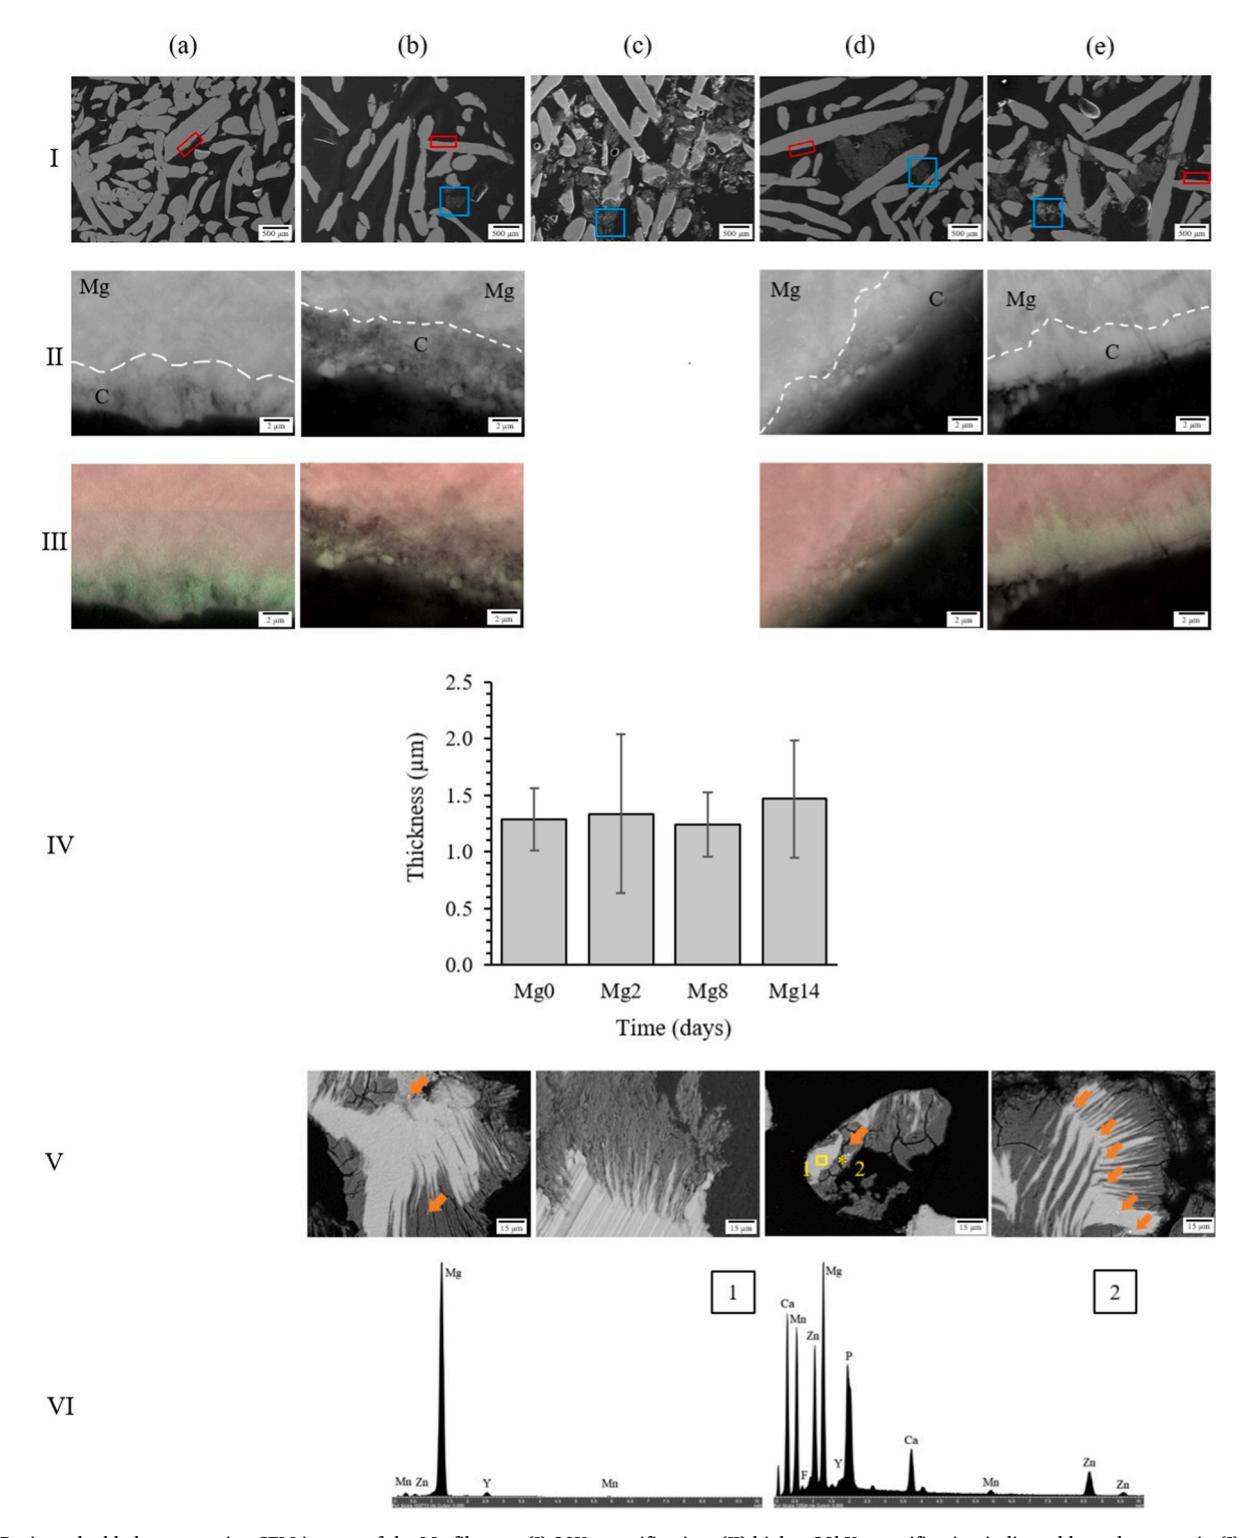
Fig. 2. Resin embedded cross-section SEM images of the Mg fibres at (I) 80X magnification, (II) higher 20kX magnification indicated by red squares in (I) targeting the coating/fibres interface highlighted by a dashed white line and (III) its corresponding EDX mapping where Mg is shown in red and fluorine in green at (a) 0, (b) 2, (c) 2 cyclic, (d) 8 and (e) 14 days of *in vitro* corrosion in HBSS. No images could be obtained for Mg2c as the interface between the Mg fibres and the coating layer could not be clearly identified due to their greater degree of corrosion preventing a sufficiently flat surface to be obtained after polishing. (IV) Thickness of the coating layer over time. (V) 1kX magnification indicated by blue squares in (I) targeting corrosion debris, and (VI) EDX spectrum of areas 1 and point 2 delimitated by the yellow square and star in (Vd), investigating the non-corroded area and particle deposition, respectively. Mg., Mg-based alloy; C., coating layer. Orange arrows indicate brighter Ca, P, Zn and Mn-enriched particle deposition.

The resin embedded sections of the samples showed that most of the fibres remained uncorroded with a few localized accumulations of corrosion debris within the pores (Fig. 2I). Distinct textures allowed for visual differentiation between the Mg-based fibres and the coating layer, confirmed by explicit variations of Mg and fluorine (F) content assessed by EDX mapping (Fig. 2II and III). While the Mg fibres displayed a homogenous structure in all cases, the aspect of the coating layer changed over time. First, it appeared more fragmented and less dense than precorrosion for Mg2. Then, it was subjected to a redensification process producing a more compact layer after 8 days of *in vitro* corrosion in HBSS. The average thickness of the coating layer was $1.3 \pm 0.2 \,\mu\text{m}$ and no significant changes were observed over time (Fig. 2IV).

The 2-day cyclic specimens showed a higher volume of corrosion particles trapped between the inner fibres (Fig. 2Ic). The structure of the residual corrosion particles was investigated in more detail using higher magnification (Fig. 2V). Two different Mg phases were identified, with a highly irregular interface, and deep penetration of dark areas (dark grey) into brighter areas (light grey) in the form of filiform corrosion. Intense microcrack propagation occurred within the darker areas, starting from the surface of the fibre and then propagating towards the centre. Severe fragmentation of the outer layer and the formation of debris was observed at 14 days. High-intensity particle deposition was observed after corrosion and their elemental content was analysed by means of EDX examinations (Fig. 2VI) in contrast to the central regions of the fibres. Although Mg remained the main component in both cases, large variations in zinc (Zn) and manganese (Mn) content, which were lower in area 1 than in point 2, were observed. Besides these different proportions of alloying elements, additional chemical elements were

corrosion in HBSS. The cross-sectional sections first revealed a dissolution of the coating layer after 2 days of corrosion compared to the precorroded state, followed by a re-densification probably due to the precipitation of calcium-phosphate crystals that tended to stabilize the coating and form a more protective corrosion layer. Similar deposition of round-shaped particles on magnesium alloys has already been observed and attributed to calcium phosphate (CaP) particles [41,80, 81], with a Ca:P ratio close to 1.67, suggesting hydroxyapatite formation. Due to the presence of fluoride in the coating layer of the alloy, it is most likely that fluorapatite crystals have formed that can explain the slight divergence in Ca:P ratio (1.78 ± 0.14) obtained in this study [82]. Therefore, besides providing a protective layer that slowed down the corrosion process (Fig. 4a), the fluoride coating promoted the deposition of calcium-phosphate crystals, crucial for the mineralization of bone tissue *in vivo* and indicative of an osteoconductive surface.

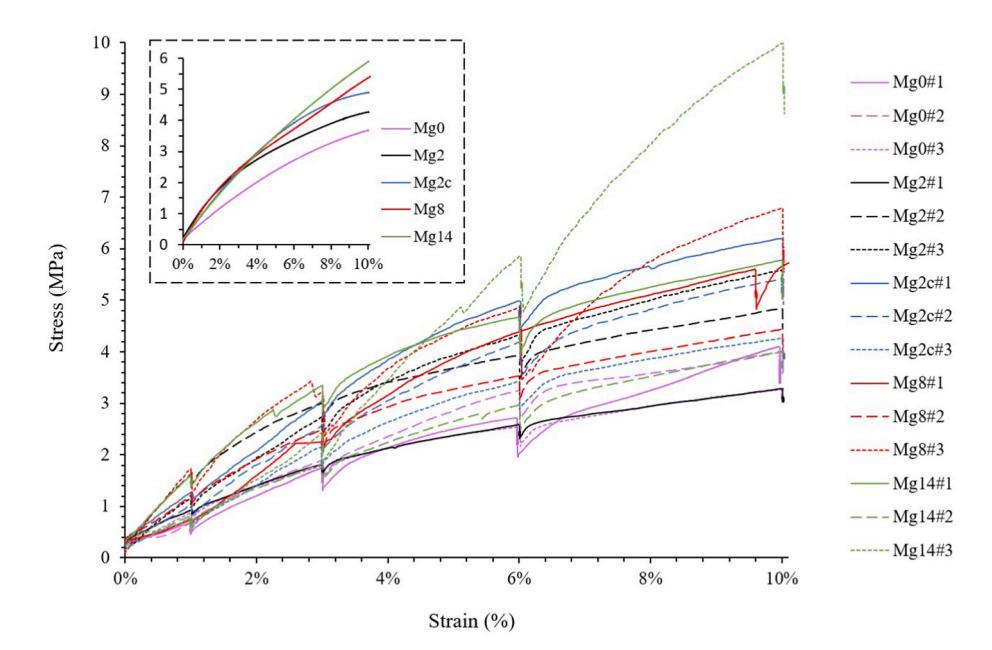
Fig. 3. Compressive stress-strain curves of Mg-based scaffolds after 2, 2 cyclic, 8 and 14 days of *in vitro* corrosion, the dashed square contains the average curves of the 3 samples. The data for the non-corroded Mg-based scaffolds (Mg0) were obtained from a previous study [14].

The stress-strain curves for Mg2, Mg2c, Mg8 and Mg14 (Fig. 3) displayed similar trends without obvious distinction between the different immersion times, except for Mg14#3 where the apparent maximum stress reached at 10% compression was twice as high. The stress/strain curves started with a linear elastic region followed, between 2 and 3% compression, by a long strain hardening region where the stress increased up to 10% compression. No critical failure occurred in any of the samples. However, the mechanical properties (i.e. apparent Young's modulus and yield stress) increased with immersion time (Table 1). Mg14 exhibited higher Young's modulus and yield stress (Young's modulus of 89 \pm 39 MPa and 110 \pm 38 MPa, and yield stress of 2.2 \pm 0.6 MPa and 3.0 \pm 1.3 MPa for Mg2 and Mg14, respectively). Interestingly, Mg2c showed a Young's modulus closer to Mg2 (89 \pm 39 MPa and 86 ± 8 MPa for Mg2 and Mg2c, respectively), but yield stress as high as Mg14 (2.9 \pm 0.5 MPa and 3.0 \pm 1.3 MPa for Mg2c and Mg14, respectively).

The structural changes caused enhanced mechanical behaviour, including higher Young's modulus and yield stress (Fig. 3) without critical failure and lower ε_{p3} accumulation (Fig. 7), thus preserving mechanical integrity despite a corrosive environment. In addition, these mechanical values fell within the range of trabecular bone reported in literature; 0.01–2 GPa for Young's modulus and 0.2–80 MPa for yield stress [96]. This resemblance to trabecular bone and its ability to deform without fracturing would be beneficial in preventing premature failure *in vivo* and would lead to a more uniform strain distribution, providing a better mechanical stimulus for bone regeneration [97,98]. Furthermore, the strain range employed to deform the Mg-based scaffolds after corrosion exceeded, by one order of magnitude, the physiological strain of bone tissue generated during daily activities such as walking or running (500–2000 μ) [99], suggesting that, in theory, the corroded scaffold would also endure any high-intensity impact.

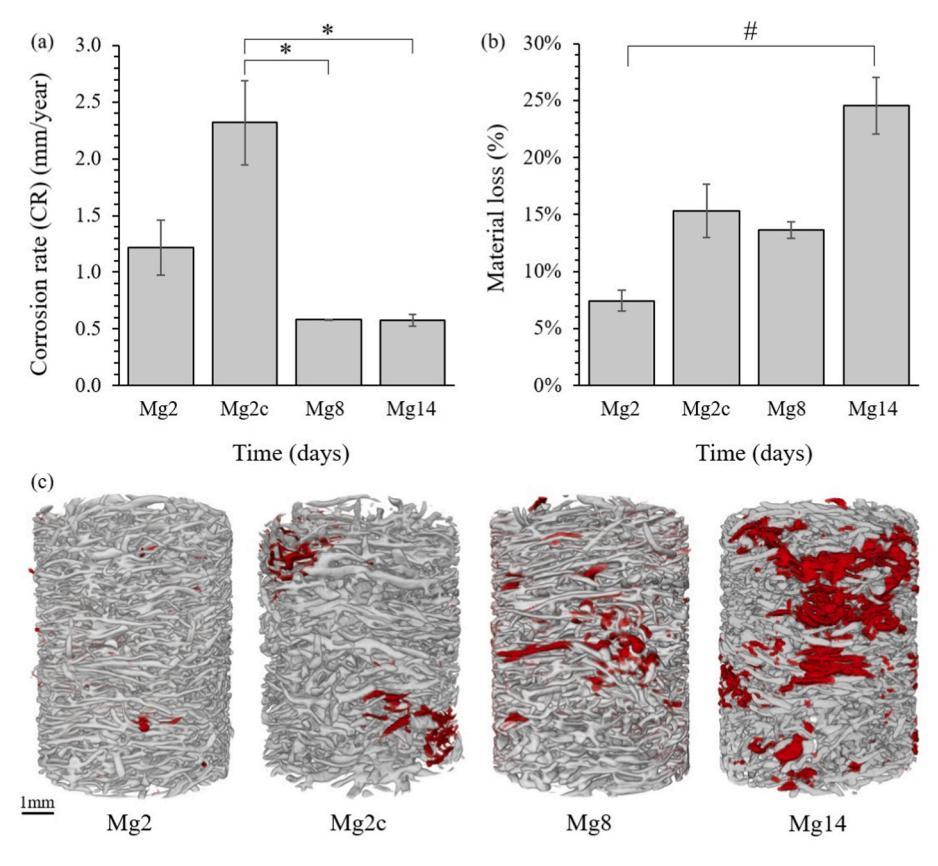
Fig. 4. (a) Corrosion rate and (b) material loss volume with immersion time. Data are reported as mean \pm SD (n = 3). (c) Reconstructed XCT tomograms for a representative Mg-based specimen. Red areas indicate material loss after *in vitro* corrosion. *p < 0.05 and #p < 0.01 significant differences.

The corrosion rate was higher during the first 2 days of incubation, then decreased, although not significant, with longer immersion time (1.2 \pm 0.2 mm/year and 0.6 \pm 0.1 mm/year after 2 and 14 days, respectively) reaching a plateau after 8 days where the rate was maintained up to 14 days (Fig. 4a). The fastest corrosion rate (CR) was obtained for Mg2c when *in situ* cyclic compression was applied in combination with dynamic immersion. Although the CR was not significantly different from Mg2, it was significantly higher (p < 0.05) than Mg8 and Mg14. In contrast, the amount of material loss calculated as a volume, increased significantly (p < 0.01) from 2 to 14 days (7.4%–24.5% for Mg2 and Mg14, respectively). Mg2c, although subjected to a shorter corrosion time, achieved a similar material volume loss as Mg8 (Fig. 4b). In all cases, the material volume loss was heterogeneous and occurred in restricted areas mainly located at the periphery of the scaffolds (Fig. 4c).

1.22 ± 0.24 mm/year after 2 days and this then significantly decreased from day 2 to day 8 (0.58 \pm 0.01 mm/year) to remain unchanged until day 14 (Fig. 4a). Although this trend is commonly observed when Mg-based materials are immersed in corrosion media [37,41,67,68], the

during a recovery period of approximately 2–3 months [56]. The addition of cyclic compression increased the corrosion rate, that in turn accelerated material loss, to levels comparable to those of 8 days (Fig. 4), apparent densification (Fig. 5) and accumulation of corrosion debris (Fig. 2). The increase in corrosion rate can be explained by the stresses applied to the alloy during cyclic loading which induced local disruptions of the coating layer through the formation of fatigue microcracks [76]. The cyclic movement of the scaffolds can also be responsible for the accelerated detachment of weakly bonded corrosion products that tend to reduce the protective corrosion layer usually formed during

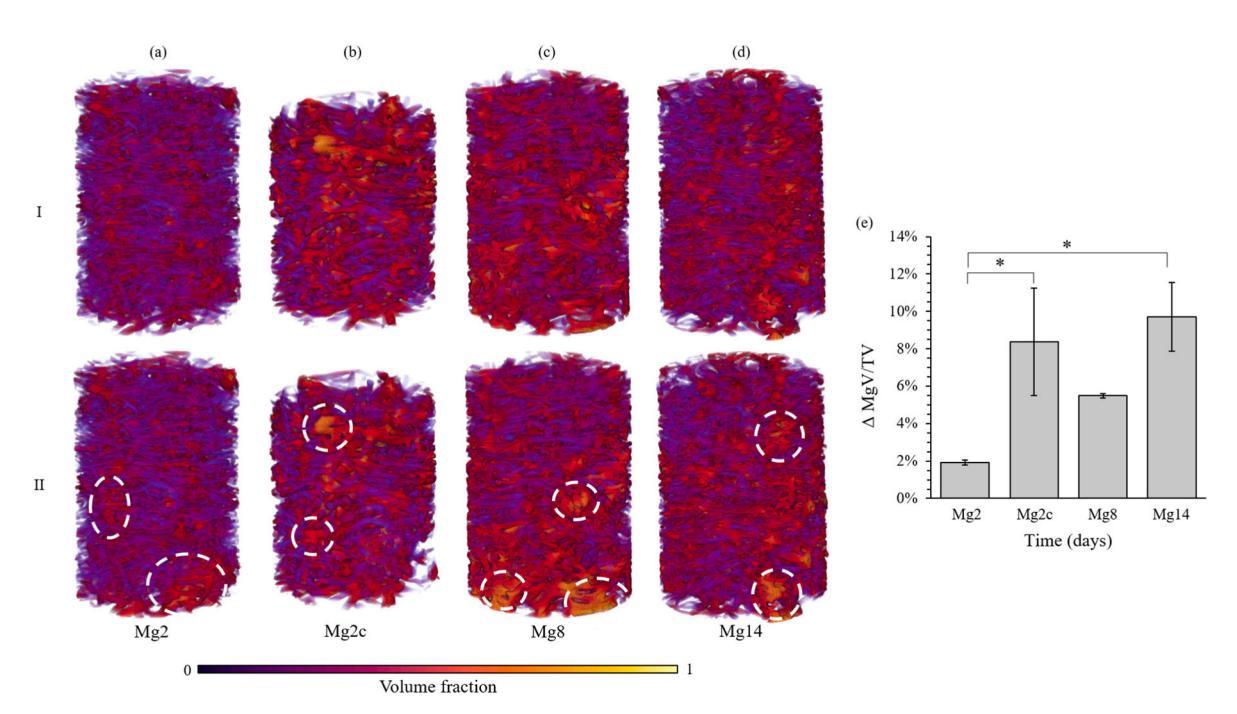
Fig. 5. Volume fraction maps for a representative Mg-based specimen (I) before and (II) after (a) 2, (b) 2 cyclic, (c) 8 and (d) 14 days of *in vitro* corrosion. (e) Variation in average volume fraction equal to the difference between the initial and post corrosion values. Data are reported as mean \pm SD (n = 3). White ovals indicate local densification after corrosion. *p < 0.05.

The immersion of the Mg-based scaffolds in HBSS solution induced local changes in microstructure. The initial structures displayed heterogeneous local volume fractions ranging from 0.15 to 0.50 (Fig. 5). In all cases, these variations were amplified after *in vitro* corrosion (Fig. 5II), with the occurrence of denser local areas up to 0.70, and were

mostly found at the periphery of the scaffolds. Mg14 exhibited a significant (p < 0.05) increase in overall volume fraction (9.7 \pm 1.8%) compared to Mg2 (1.9 \pm 0.1%, Fig. 5e). Mg2c also presented a significant (p < 0.05) increase in volume fraction (8.4 \pm 2.9%), equivalent to that obtained for Mg14.

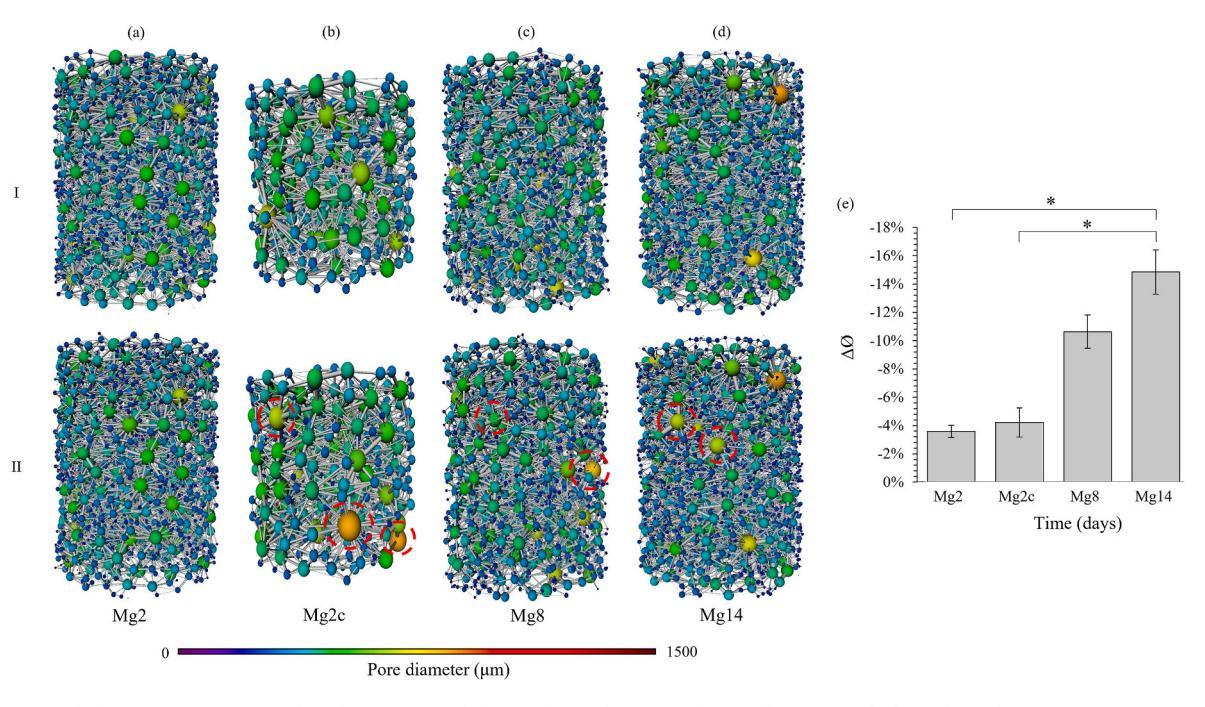
Fig. 6. Pore network for a representative Mg-based specimen (I) before and (II) after (a) 2, (b) 2 cyclic, (c) 8 and (d) 14 days of *in vitro* corrosion. (e) Variation in average pore diameter equal to the difference between the initial and post corrosion values. Data are reported as mean \pm SD (n = 3). Red ovals indicate local pore diameter increase after corrosion. *p < 0.05.

The pore network also showed a heterogeneous distribution before corrosion with a majority of smaller pores in the centre of the scaffold (300 µm) and larger pores (600 µm) at the periphery (Fig. 61). Despite local enlargement of the external pores from 450 µm before corrosion to 700 µm after 14 days, the corrosion led to a significant (p < 0.05) overall reduction in pore diameter (Fig. 6e), which became more pronounced with longer corrosion times (reduction of 3.6 \pm 0.4% and 14.9 \pm 1.6% for Mg2 and Mg14, respectively).

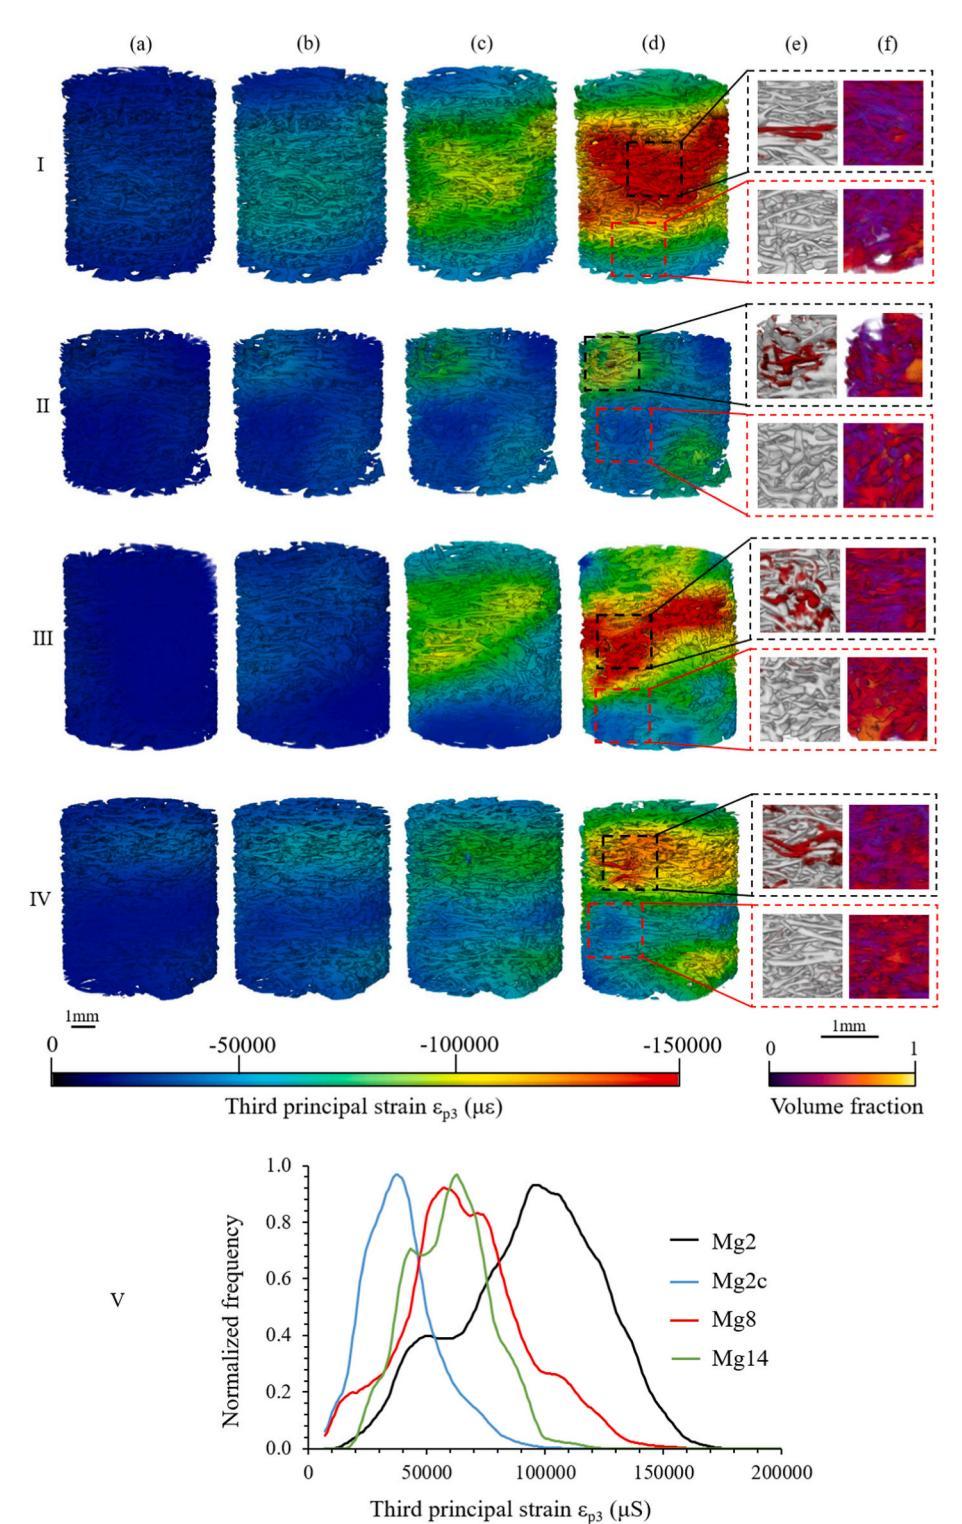
Fig. 7. Full-field third principal strain (ε_{p3}) distribution at (a) 1%, (b) 3%, (c) 6% and (d) 10% for a representative Mg-based specimen at (I) 2, (II) 2 cyclic, (III) 8 and (IV) 14 days of *in vitro* corrosion. (V) Normalized histogram of the average third principal strain after apparent yielding at 10% compression of the three specimens tested per corrosion time. Normalization was performed by dividing the number of counts by the mode (i.e. most frequent value) of each histogram. (e) Reconstructed XCT image where red parts indicate material loss and (f) volume fraction maps associated with high-strain (dotted black square) and low-strain (dotted red square) regions.

Local third principal strain (ϵ_{p3}) distributions computed by DVC are shown in Fig. 7. In all cases, the strain distribution was heterogeneous with large variations ranging locally from $-10000~\mu\epsilon$ to $-150000~\mu\epsilon$ at 10% compression. However, the apparent high-strain region was evenly distributed in the core of the scaffold for Mg2 and Mg8, while Mg2c and Mg14 multiple areas of higher strains were located at the edges of the structures. A gradual increase in strain was observed across the compression steps in all cases ($-4617\pm2008~\mu\epsilon$ and $-63230\pm17954~\mu\epsilon$ in average for 1% and 10%, respectively). Interestingly, lower strain accumulation occurred with longer corrosion times, as well as in Mg2c (Fig. 7V), where the average ϵ_{p3} strain decreased from $-91000\pm6361~\mu\epsilon$ to $-60093\pm2414~\mu\epsilon$ and $-40791\pm1321~\mu\epsilon$ after yielding at 10% compression for Mg2, Mg14 and Mg2c, respectively.

A local structural analysis was carried out by examining the selected volume of interest of the preload XCT tomograms corresponding to the high (>–100000 $\mu\epsilon$) and low-strain regions (\leq –100000 $\mu\epsilon$) at 10% compression in order to explain their distribution. In all cases, greater material loss and a lower volume fraction (Fig. 7e and f) were observed in the high-strain region compared with the low-strain region (0.3 and 0.5 average volume fraction in the high and low-strain regions, respectively).

The third principal strain (ε_{p3}) accumulation decreased on average from 2 to 14 days (Fig. 7V) but was higher than measured in the noncorroded samples (–26243 \pm 7870 $\mu\epsilon$, average ϵ_{p3} at 10% compression) [14]. This suggested that during the first two days, when the corrosion rate was faster, the trade-off between the external material loss and internal accumulation of corrosion products seemed unfavourable resulting in lower mechanical performance, while after 2 days the structure regained strength and load-bearing properties similar to that seen prior to corrosion. The strain distribution also displayed a more heterogeneous pattern after corrosion (Fig. 7), while regions of high strain were largely spread over the structure before corrosion [14], they were more localized in specific areas after corrosion. Local morphometric observations revealed a higher volume fraction (Fig. 7f) as well as higher material loss (Fig. 7e) in the high-strain regions than in the low-strain regions, indicating that local variations in morphometric properties led to higher local deformation. It appeared therefore, that the corrosion pattern, which caused structural changes, was actively and directly involved in the overall strain distribution and mechanical behaviour of the Mg-based scaffold.
