EARTHQUAKE SPECTRA

Emilia Earthquake: the Seismic Performance of Precast RC Buildings

Gennaro Magliulo^{a)}, Marianna Ercolino^{a)}, Crescenzo Petrone^{a)}, Orsola Coppola^{a)}, and Gaetano Manfredi^{a)}

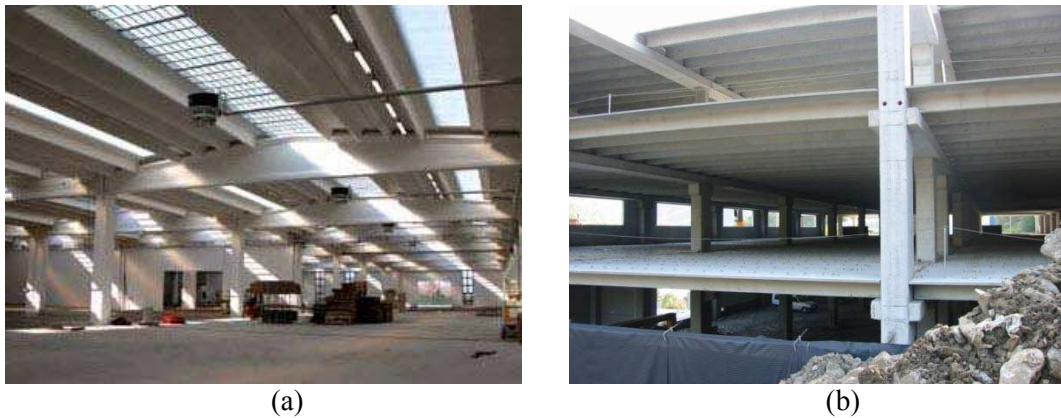
Figure 1. Examples of (a) single-story and (b) multi-story precast buildings

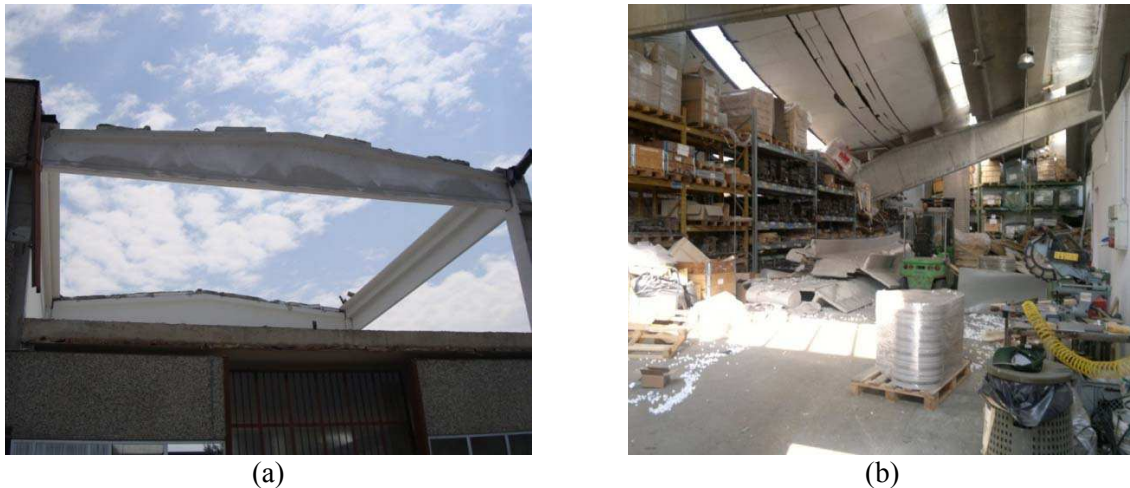
Most of the damaged precast buildings provides friction connections between horizontal elements (beams and roof elements) or between horizontal (beam) and vertical (columns) members. The lack of connection devices is the main cause of damage in precast structures, in which the low strength given by friction mechanism causes the loss of support of both roof elements from beams and beams from columns. The consequences are disastrous: Figure 5a shows the loss of support of the roof elements from the main beam due to the use of friction connections and a very limited support width. Figure 5b shows the loss of support of a beam from the column and the consequent collapse of the roof elements, causing the failure of the whole structure.

Figure 5. (a) Roof elements collapse due to the loss of support from main beam. (b) Loss of support of beam from column.

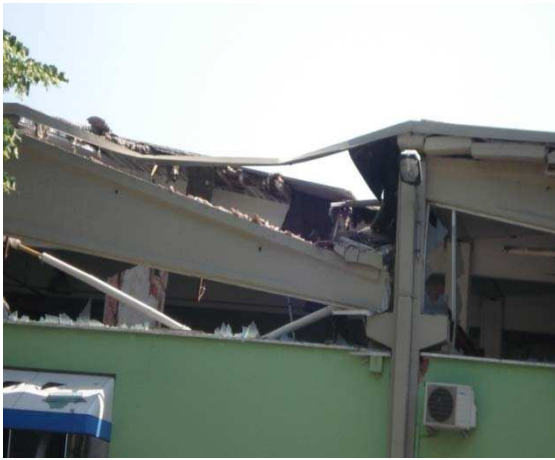
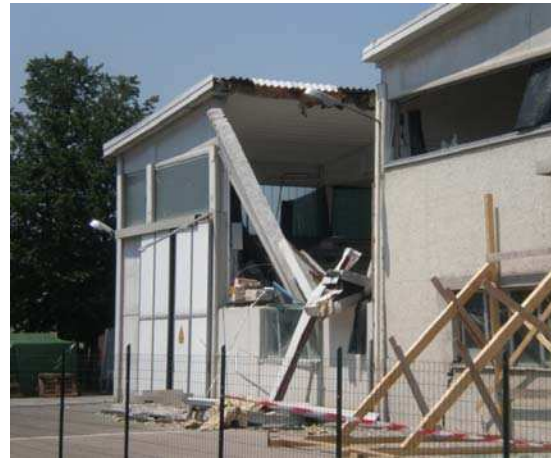
The lack of mechanical devices causes the loss of support of the beams from the columns also in Figure 6a. In other cases the loss of support causes the change of the beam restraints, that let the beam act as a cantilever, and make it collapse under the weight of the roof elements (Figure 6b). The vulnerability recorded in precast structures is certainly larger than the vulnerability exhibited by similar precast structures in Turkey after 1999 Kocaeli earthquake (Saatcioglu et al. 2001, Sezen et al. 2000); the main reason is the common presence of connections relying on friction in Emilia region, contrasting with the doweled connections used in Turkey.

Figure 6. (a) Loss of support of beam from column. (b) Collapse of main beam due to the loss of support on column.

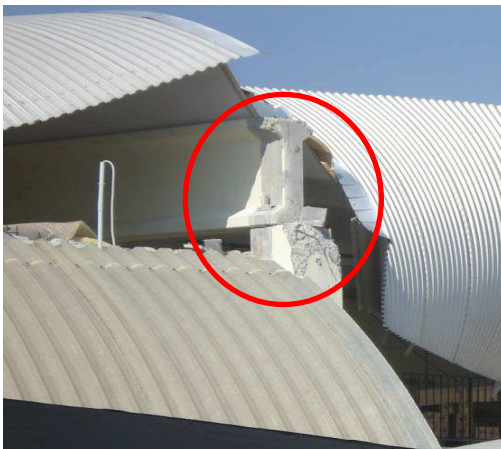
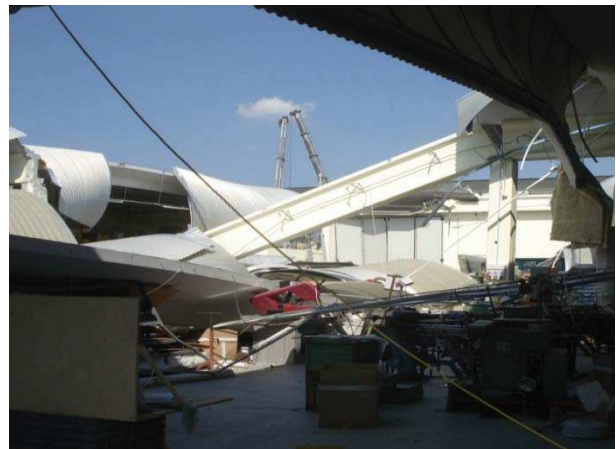
Some precast structures show the failure of the connections even in cases in which pin beam-to-column connections are used, due to the inadequacy of the connection design. Figure 7 represents a significant example of unsuitable design of the connection. The strength of the pin connection is evaluated in correspondence to the failure of the dowel; instead in Figure 7a, the spalling of concrete cover occurs before the yielding of the dowel, due to the small size of the cover and to the lack of dense stirrups close to the supporting zones. Consequently, it causes the collapse of the beam and roof elements which are supported by the beam (Figure 7b).

Figure 7. (a) Pinned beam-to-column connection failure and (b) consequent loss of support of the beam from column.

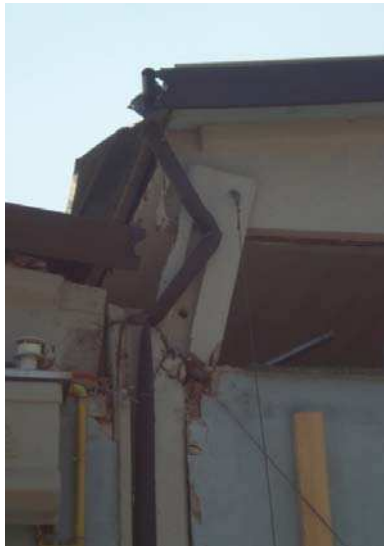
Figure 9. Shear collapse of column due to the interaction with infill masonry panel.

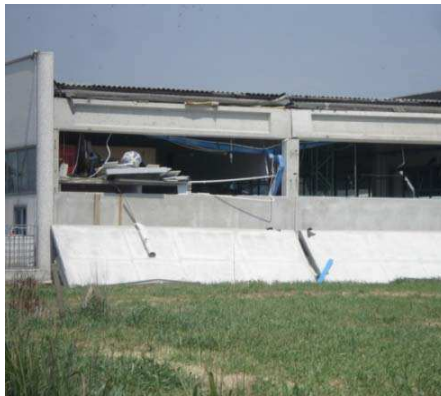
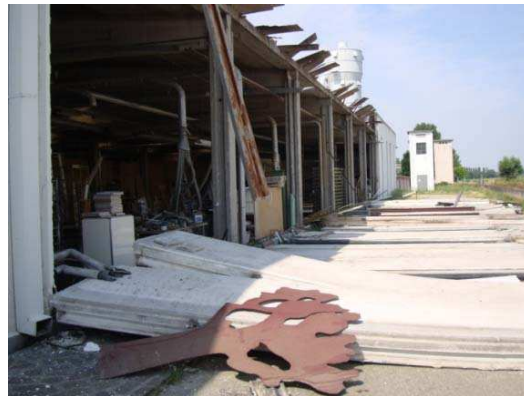
Precast buildings infill systems in Emilia region are mostly constituted by precast cladding panels. Horizontal (Figure 10a) and vertical (Figure 10b) panels collapse is the most frequent damage in precast buildings.

- a) the lack of seismic design in cladding panel-to-structural element connection devices;
- b) the pounding of roof elements, columns or other precast panels;
- c) the panel-to-structure interaction that causes additional lateral forces in the connection devices, not considered during the design process.

Figure 10. (a) Collapse of horizontal precast panels. (b) Collapse of vertical precast panels.

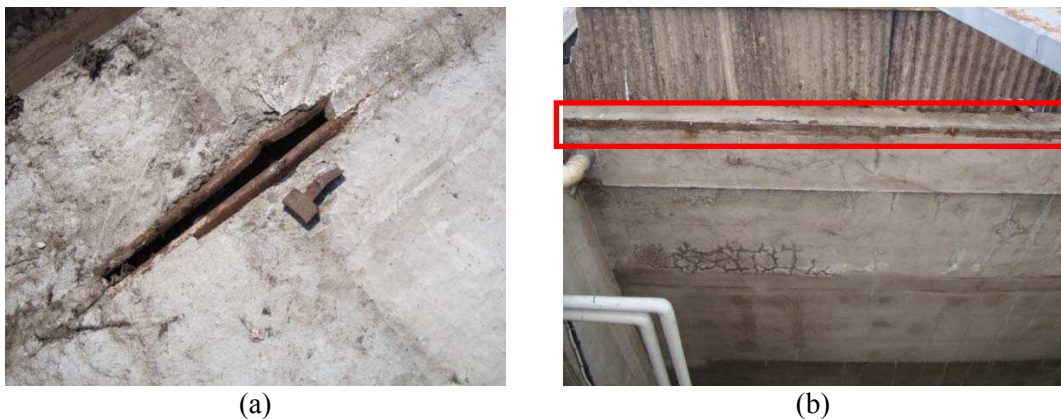
the steel angle plate that joints the panel to the structure (Figure 11b); details of the hammer head screw can be observed in Figure 11c. Figure 12 shows the collapse of a vertical panel-to-beam connection: in this case a particular connection device is used, i.e. a steel profile is embedded in the beam (highlighted in Figure 12b) and some hammer head elements are welded to the profile and inserted into the anchor channel of the vertical precast panels (Figure 12a). Under the seismic action the screw-to-profile welding fails and causes the collapse of the panels.

Figure 12. Collapse of vertical precast panel connection: (a) the anchor channel embedded in the panel and the failed hammer head element; (b) profile located in the beam which the hammer head elements are welded to.
